**Wilmington Harbor, North Carolina
Navigation Improvement Project**

**Integrated
Section 203 Study
&
Environmental Report**

**APPENDIX H
HARDBOTTOM RESOURCES**

June 2019

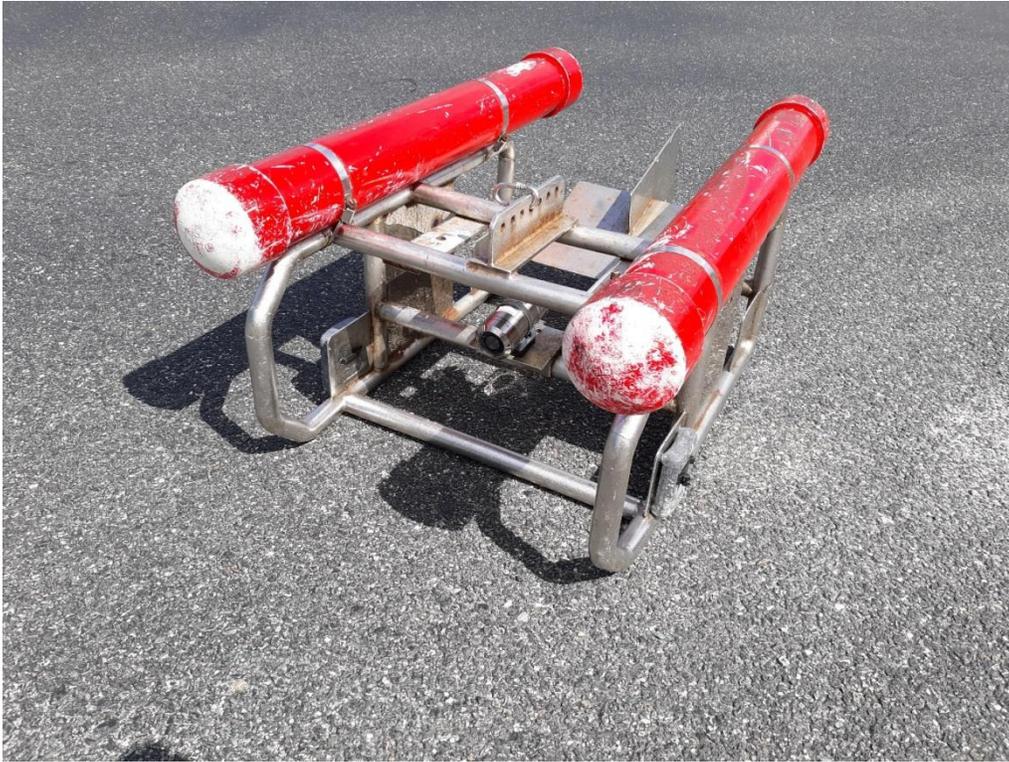
Photograph 1
Towed Video Sled used for Groundtruthing Potential Hardbottom

To verify potential hardbottom targets identified through interpretation of side-scan records, an integrated towed video system was used (Photograph 1). The towed video camera system was integrated with a Trimble DMS12/212 Global Positioning System and Hypack navigational software to provide real time overlays of the coordinate positions during the survey on the video record. The video feed was stored onboard and viewed on a monitor during the survey. The towed video transect lines surveyed are shown in Figure 1.

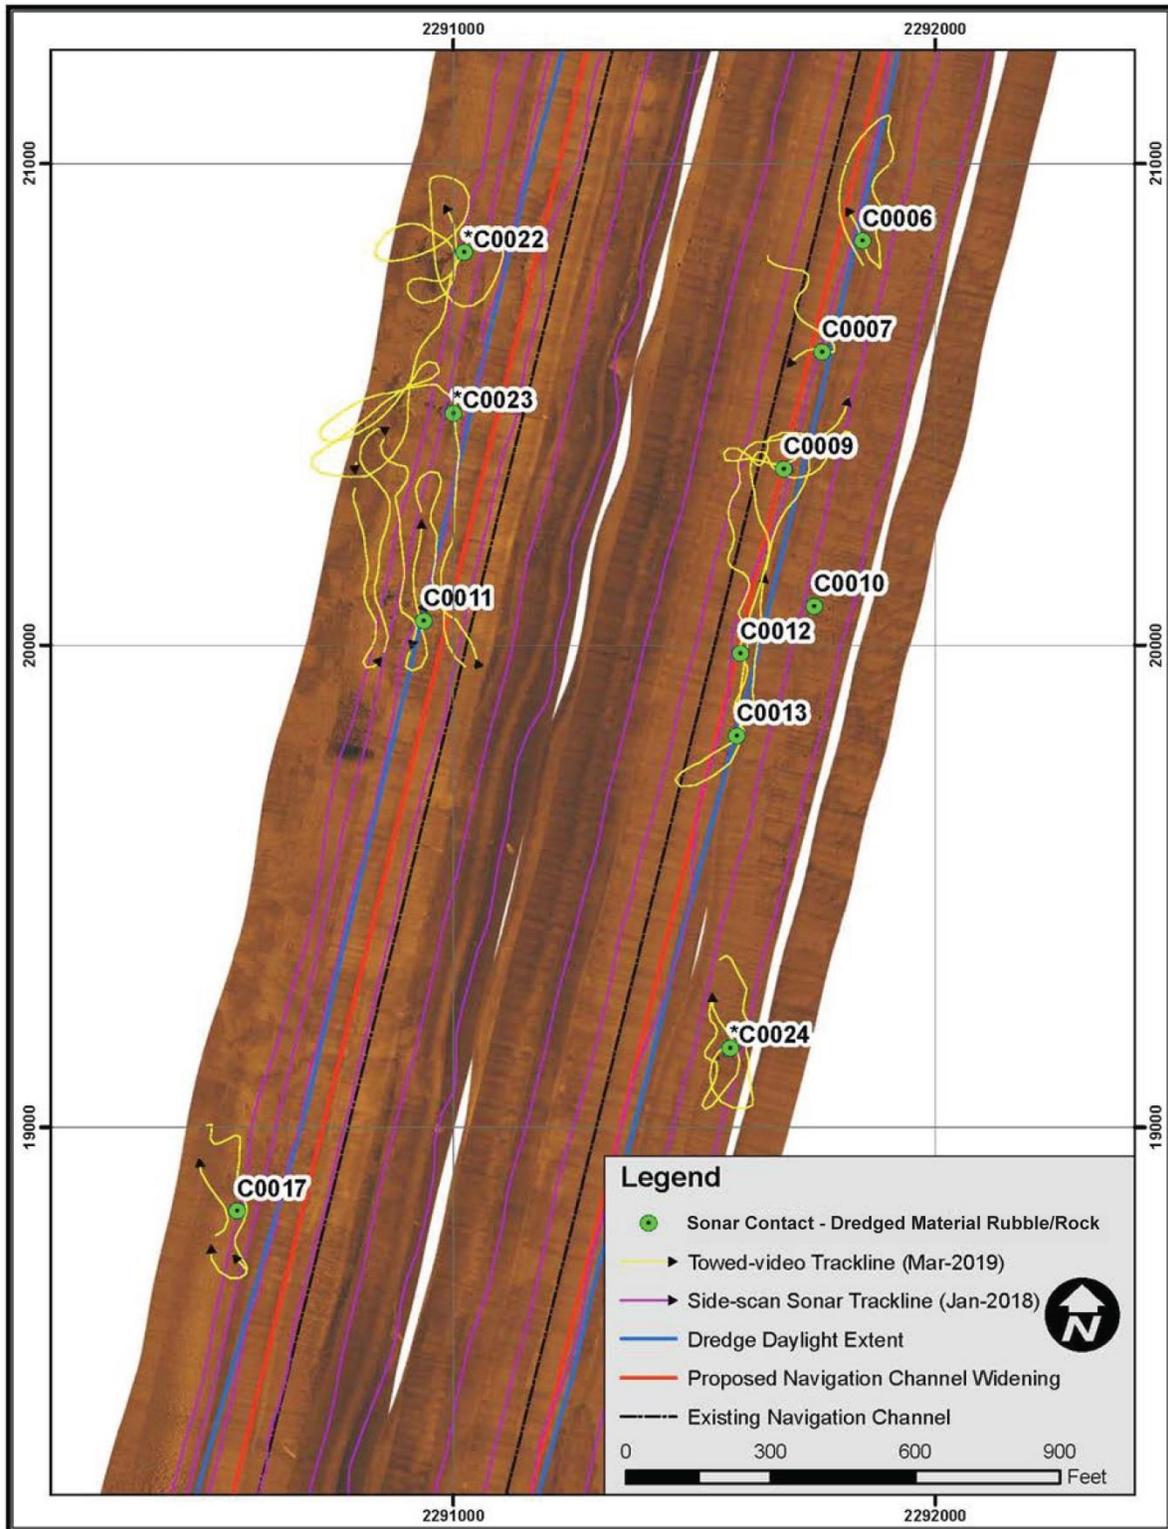
Figure 1
Track Lines of Towed Video Performed on 24 March 2019

A towed video survey was performed on 24 March 2019 to verify potential side-scan sonar signatures that showed scattered rubble and rock along the section of the proposed outer channel that passes through the old ODMDS. Based on the mapped targets identified from the side-scan sonar survey and subsequent towed video survey, the resources present in the ODMDS represent rubble, rock, and other finer material disposed of during past dredging projects, which used this disposal location. The towed video survey lines overlaying the sonar records are shown in Figures 2 and 3. Representative images from target locations C0023, C0011, and C0022 pulled from the video surveys are shown in Photographs 2 through 5. Due to very limited visibility during the survey, the video record provides a clearer view of the marine biological community present on the rubble piles present (available upon request). A summary of the results of the video survey are provided in Table 2. Rubble and rock has been colonized with marine algae, tunicates (*Tunicata* spp.), echinoderms (*Arbacia punctulata*, *Luidia clathrate*) octocorals (*Leptogorgia virgulata*, *L. hebes*, *Phyllangia americana*, *Astrangia* sp.) and other typical sessile and motile invertebrates common to hardbottom reefs. Fish observed on the video records included black sea bass, sheepshead (*Archosargus probatocephalus*), belted sandfish, and pinfish (*Lagodon rhomboides*).

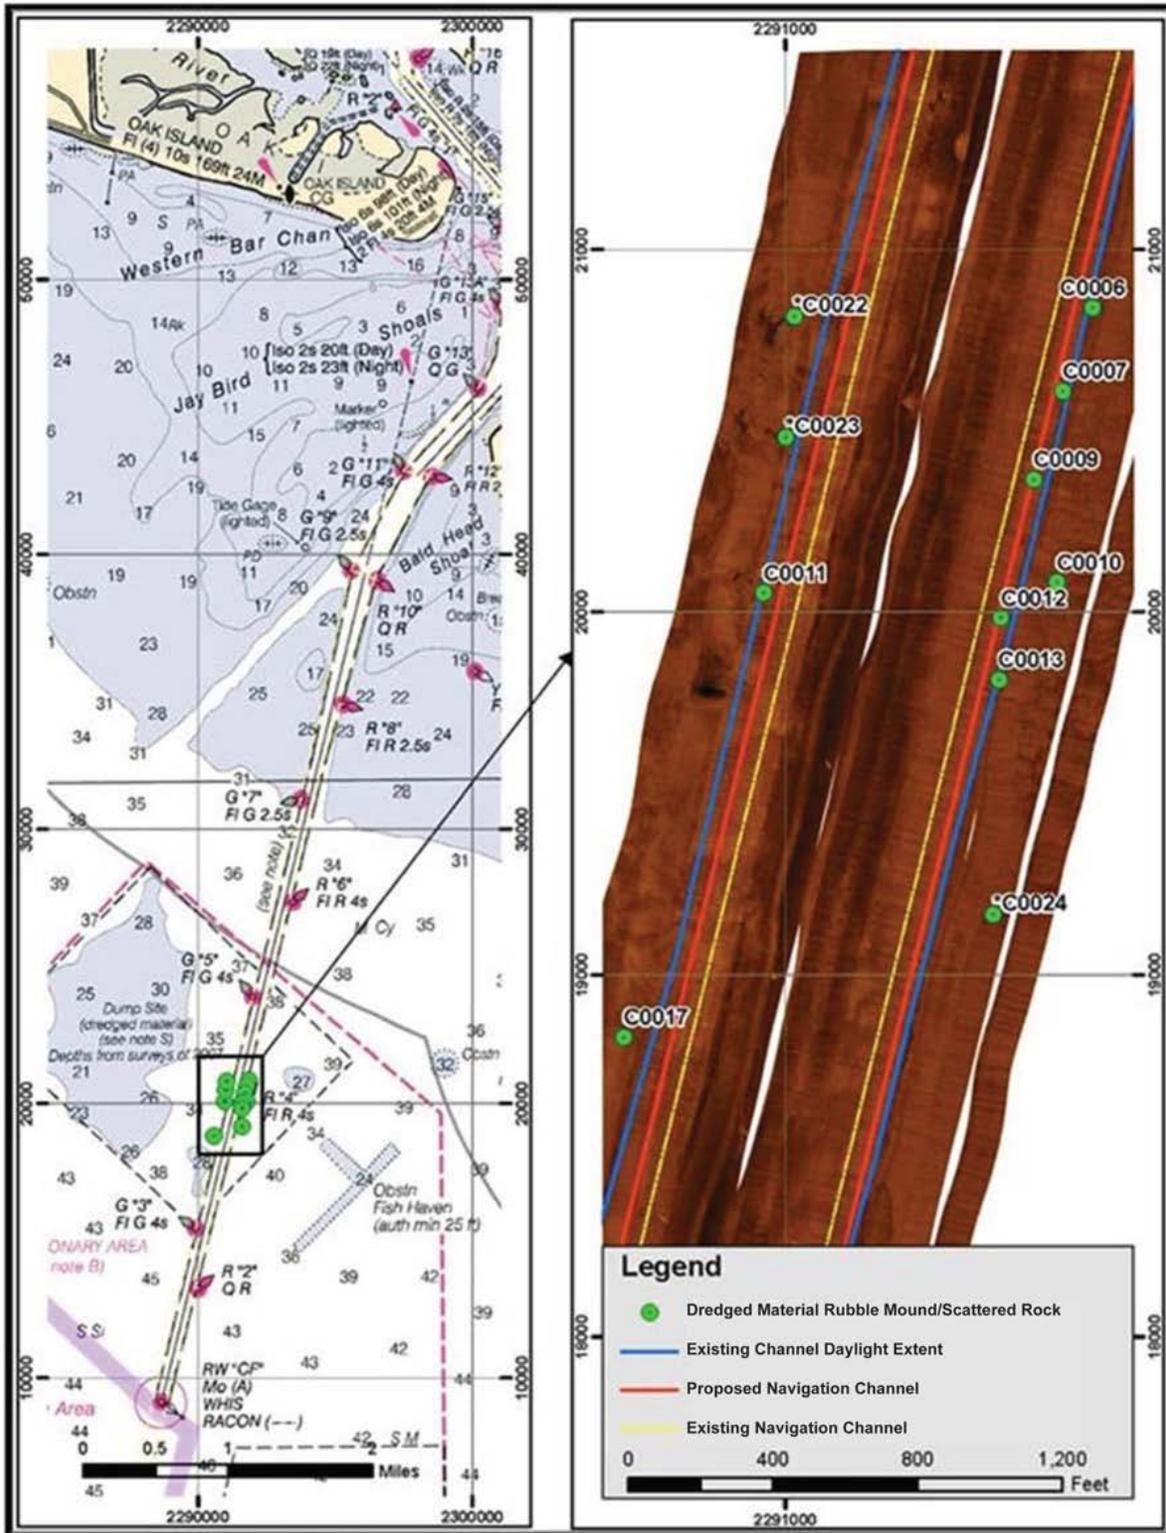
Figure 2
Side-scan Sonar Targets Identified in the Old ODMDS, Existing Channel, and Proposed Channel Widening Locations

Analysis of the survey data identified several targets along the existing channel and close to the proposed channel widening limits that appeared to be rubble/rock piles (Figures 2 and 3) or possibly debris (wire rope) from industrial shipping activities. Most of the targets were identified within the old Ocean Dredged Material Disposal Site (ODMDS) adjacent to the existing channel and proposed channel extension. Table 1 provides a summary of interpreted results of the side-scan records reviewed for subject targets.

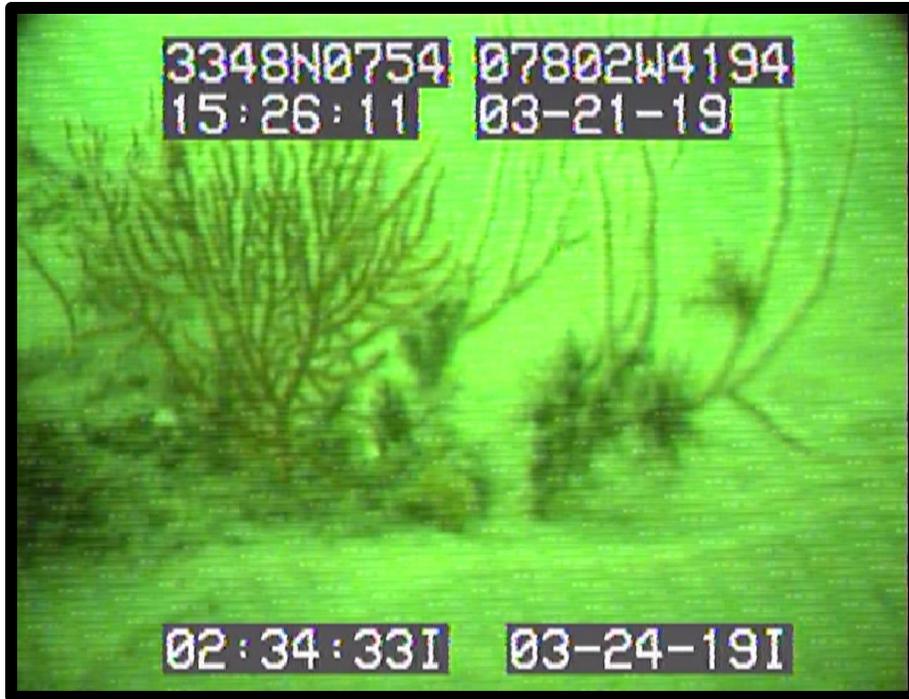
During the towed video survey, most rocks identified were surrounded by sand with very few consolidated into piles. These rocks appeared to be consistent with the expected dredged material from previous dredging activities in the federal channel. The colonization of these rocks by hardbottom associated species has provided a functional habitat similar to any artificial reef in the adjacent project area. Two of the targets, C0022 and C0023 had an estimated relief of 1 - 1.5 meters and as such, provide the best hardbottom habitat in the surveyed area. (Figure 3). These two areas of higher relief would be mostly outside or on the edge of the proposed daylight (refers to top of slope) limits of the new channel width. Based on the surveys performed, any small realignment of the proposed channel to the east might help avoid impacts to the marine resources that have colonized past disposed dredged material. In the event this is not possible, it should be noted that the removal of the material and associated hardbottom community would occur in the old designated Wilmington ODMDS. Further coordination on effects of the proposed project on these resources should be minimal since they occur within the old ODMDS.

Photograph 2
Octocorals on Scattered Rubble

The targets identified during the remote sensing and subsequent ground-truthing through towed video showed that a hardbottom community has colonized on the disposed rock/rubble in the old Wilmington ODMDS. Most of the targets consisted of scattered rock with relatively low relief and some gorgonians protruding through a thin veneer of sandy material; however, targets C0022 and C0023 consisted of large deposits of rubble/rock with relief of 1 - 1.5 meters. These higher relief habitats on the northwest side of the channel are in close proximity to the proposed channel widening limits. These two targets represent the largest deposits surveyed and effects should be minimized, if possible. If the channel realignment could be shifted by a degree or two, it is possible that these targets would receive little to no disturbance. Further regulatory compliance regarding these features should be minimal given that they are located in the old Wilmington ODMDS.

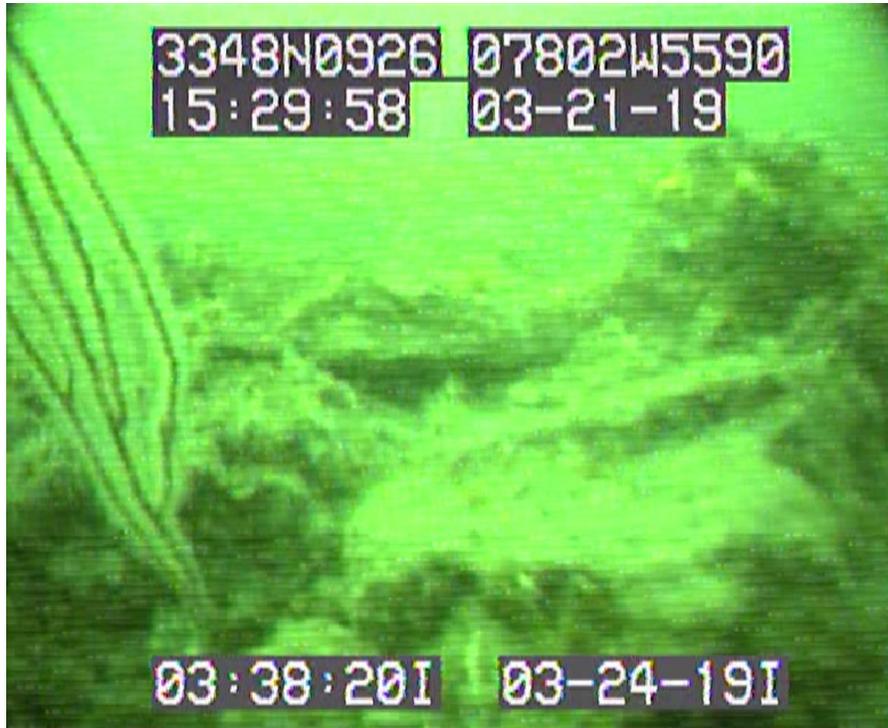
Photograph 3
Sea Whip (*Leptogorgia virgulata*) Attached to Rubble

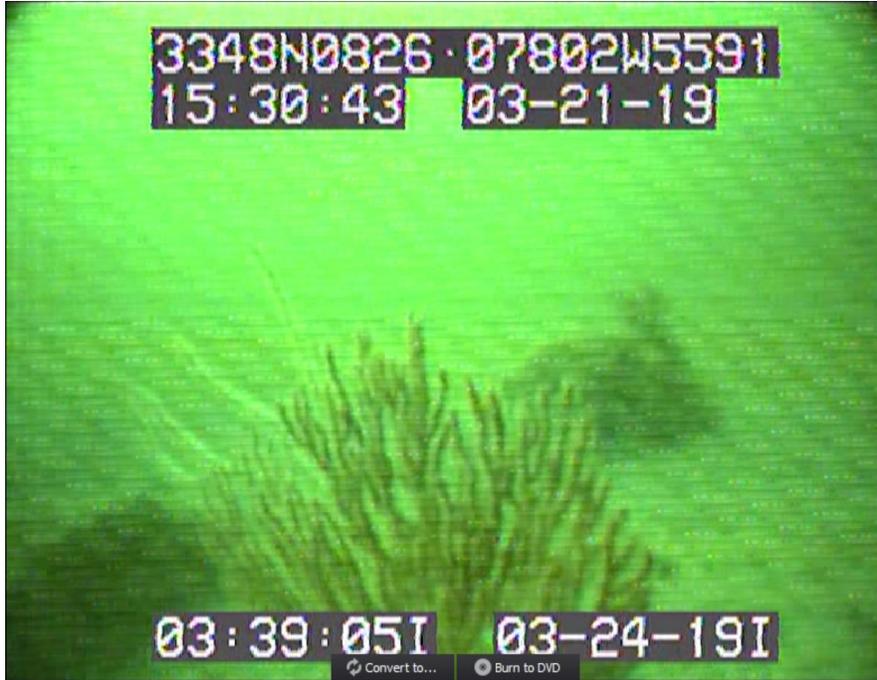
Photograph 4
Gorgonians Attached to Scattered Rubble

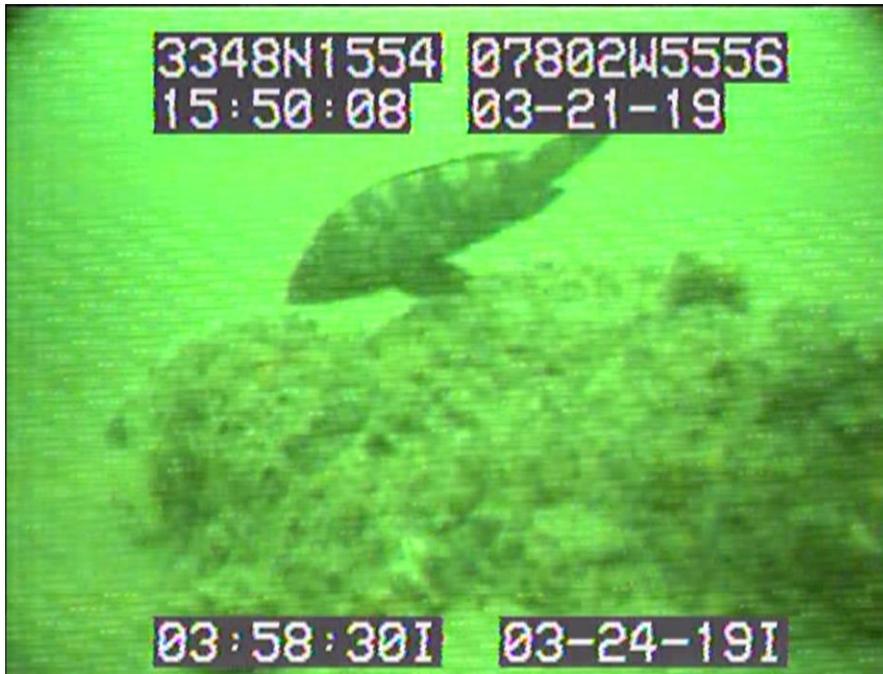
Photograph 5
Black Sea Bass (*Centropristis striata*) over Observed Rubble
