**US Army Corps
of Engineers®**
Wilmington District

**PHYSICAL MONITORING
WILMINGTON HARBOR NAVIGATION
PROJECT
REPORT 6:
October 2007 – September 2008**

JUNE 2009

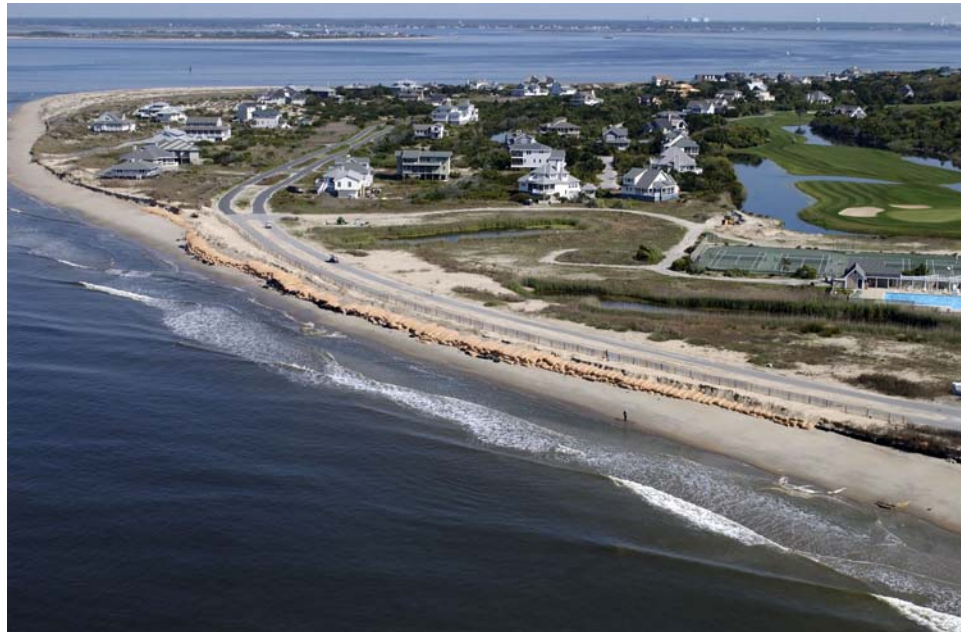
Figure 2.3 Sand Bag Revetment along South Bald Head Wynd, April 2003.

In 1994 a 645-foot-long sand bag revetment was placed along the badly eroding portion of western South Beach. In 2003-2004 the sand bag revetment was expanded by increasing the overall length by 200 feet, increasing the base width from 20 to 40 feet and increasing the crest elevation by 6 feet to +12 feet NGVD. A view of the expanded sand bags are shown in Figure 2.3, as it appeared in April 2003. This structure is now, for the most part, covered by the new sediment with the subsequent beach disposal operations.

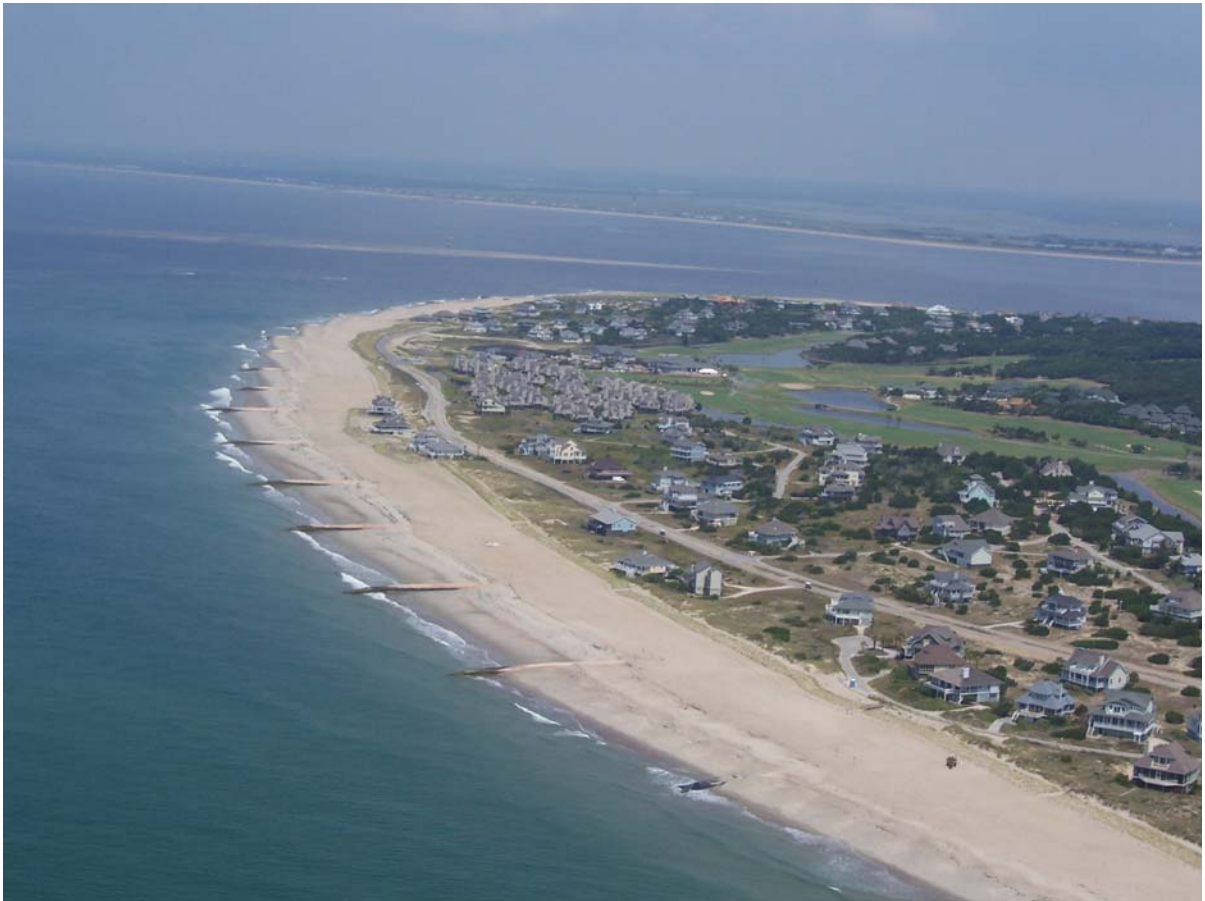
Figure 2.4 Reconstructed Groinfield along Bald Head Island, July 2006 (Courtesy of Village of Bald Head Island)

In 1996, the Village constructed sixteen geo-textile groins from station 49+00 to Station 114+00. The groins were 9 feet in diameter and 325 feet long. The spacing between the groins was about 450 feet. The groin field slowed the erosion for several years before they began to fail and ceased to function in 2000. Due to apparent effectiveness of the geo-textile groins, the Village of Bald Head Island decided to rebuild the groin field following the beach fill placement in 2005. As such a sixteen structure sand tube groinfield was reconstructed along South Beach between stations 47+00 and 105+00. The replacement geo-tubes were constructed between January and March 2005. Some modifications were made to the original 1996 plan. These modifications included: (1) the spacing was reduced from 450 feet to 385 feet thereby reducing the overall extent for the groinfield, (2) the tube lengths were 300 feet for 14 of the structures and 250 feet for the remaining two, (3) the individual tubes were tapered with a landward maximum diameter of 10 feet to 6 feet at the seaward end, and (4) the entire groin field was shifted westward to be more aligned with the problem area. Figure 2.4 shows an aerial view of the completed groins taken in July 2006, about 16 months following placement.

- Village of Bald Head reconstructed a geo-textile groin field following the placement of the January 2005 beach fill along about 6,500 feet of shoreline within the problem area at the western end of South Beach. The groin field appears to have had a positive effect in retaining the beach, particularly within the upper portions of the beach profile. However, the groin field is beginning to deteriorate and is losing its' effectiveness.

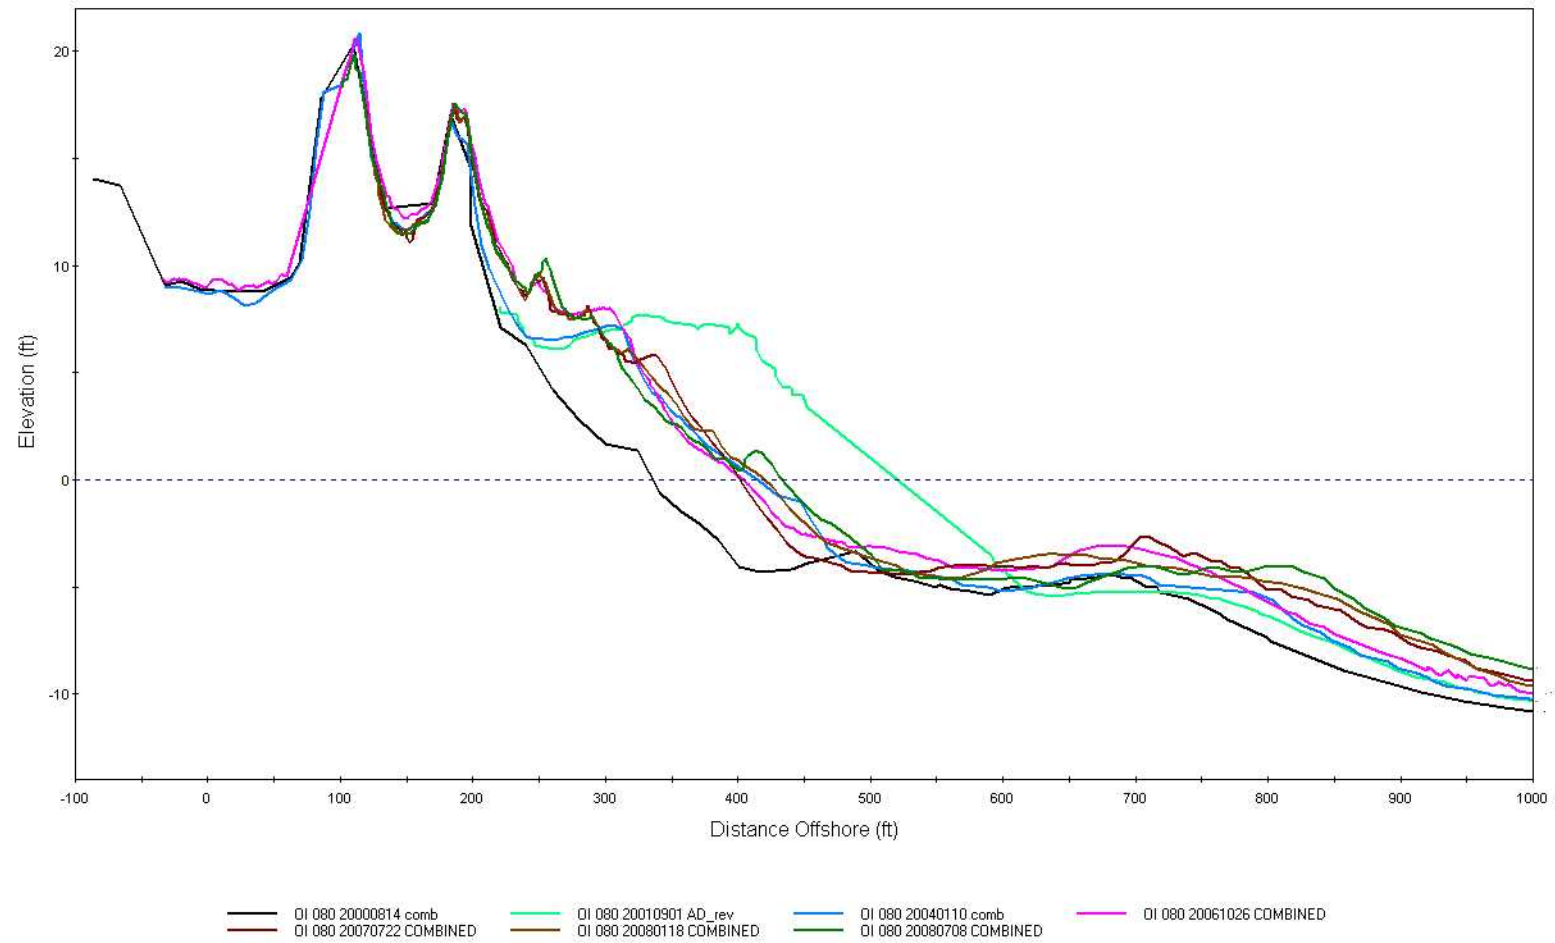
Figure 3.8 Oak Island Profile 80

shoreline at Profile 80 has varied between about 70 and 95 seaward of its August 2000 position. For Profile 220, the shoreline has also remained relatively stable following the initial fill adjustment; however a slight erosional trend is noticeable over the last five years.

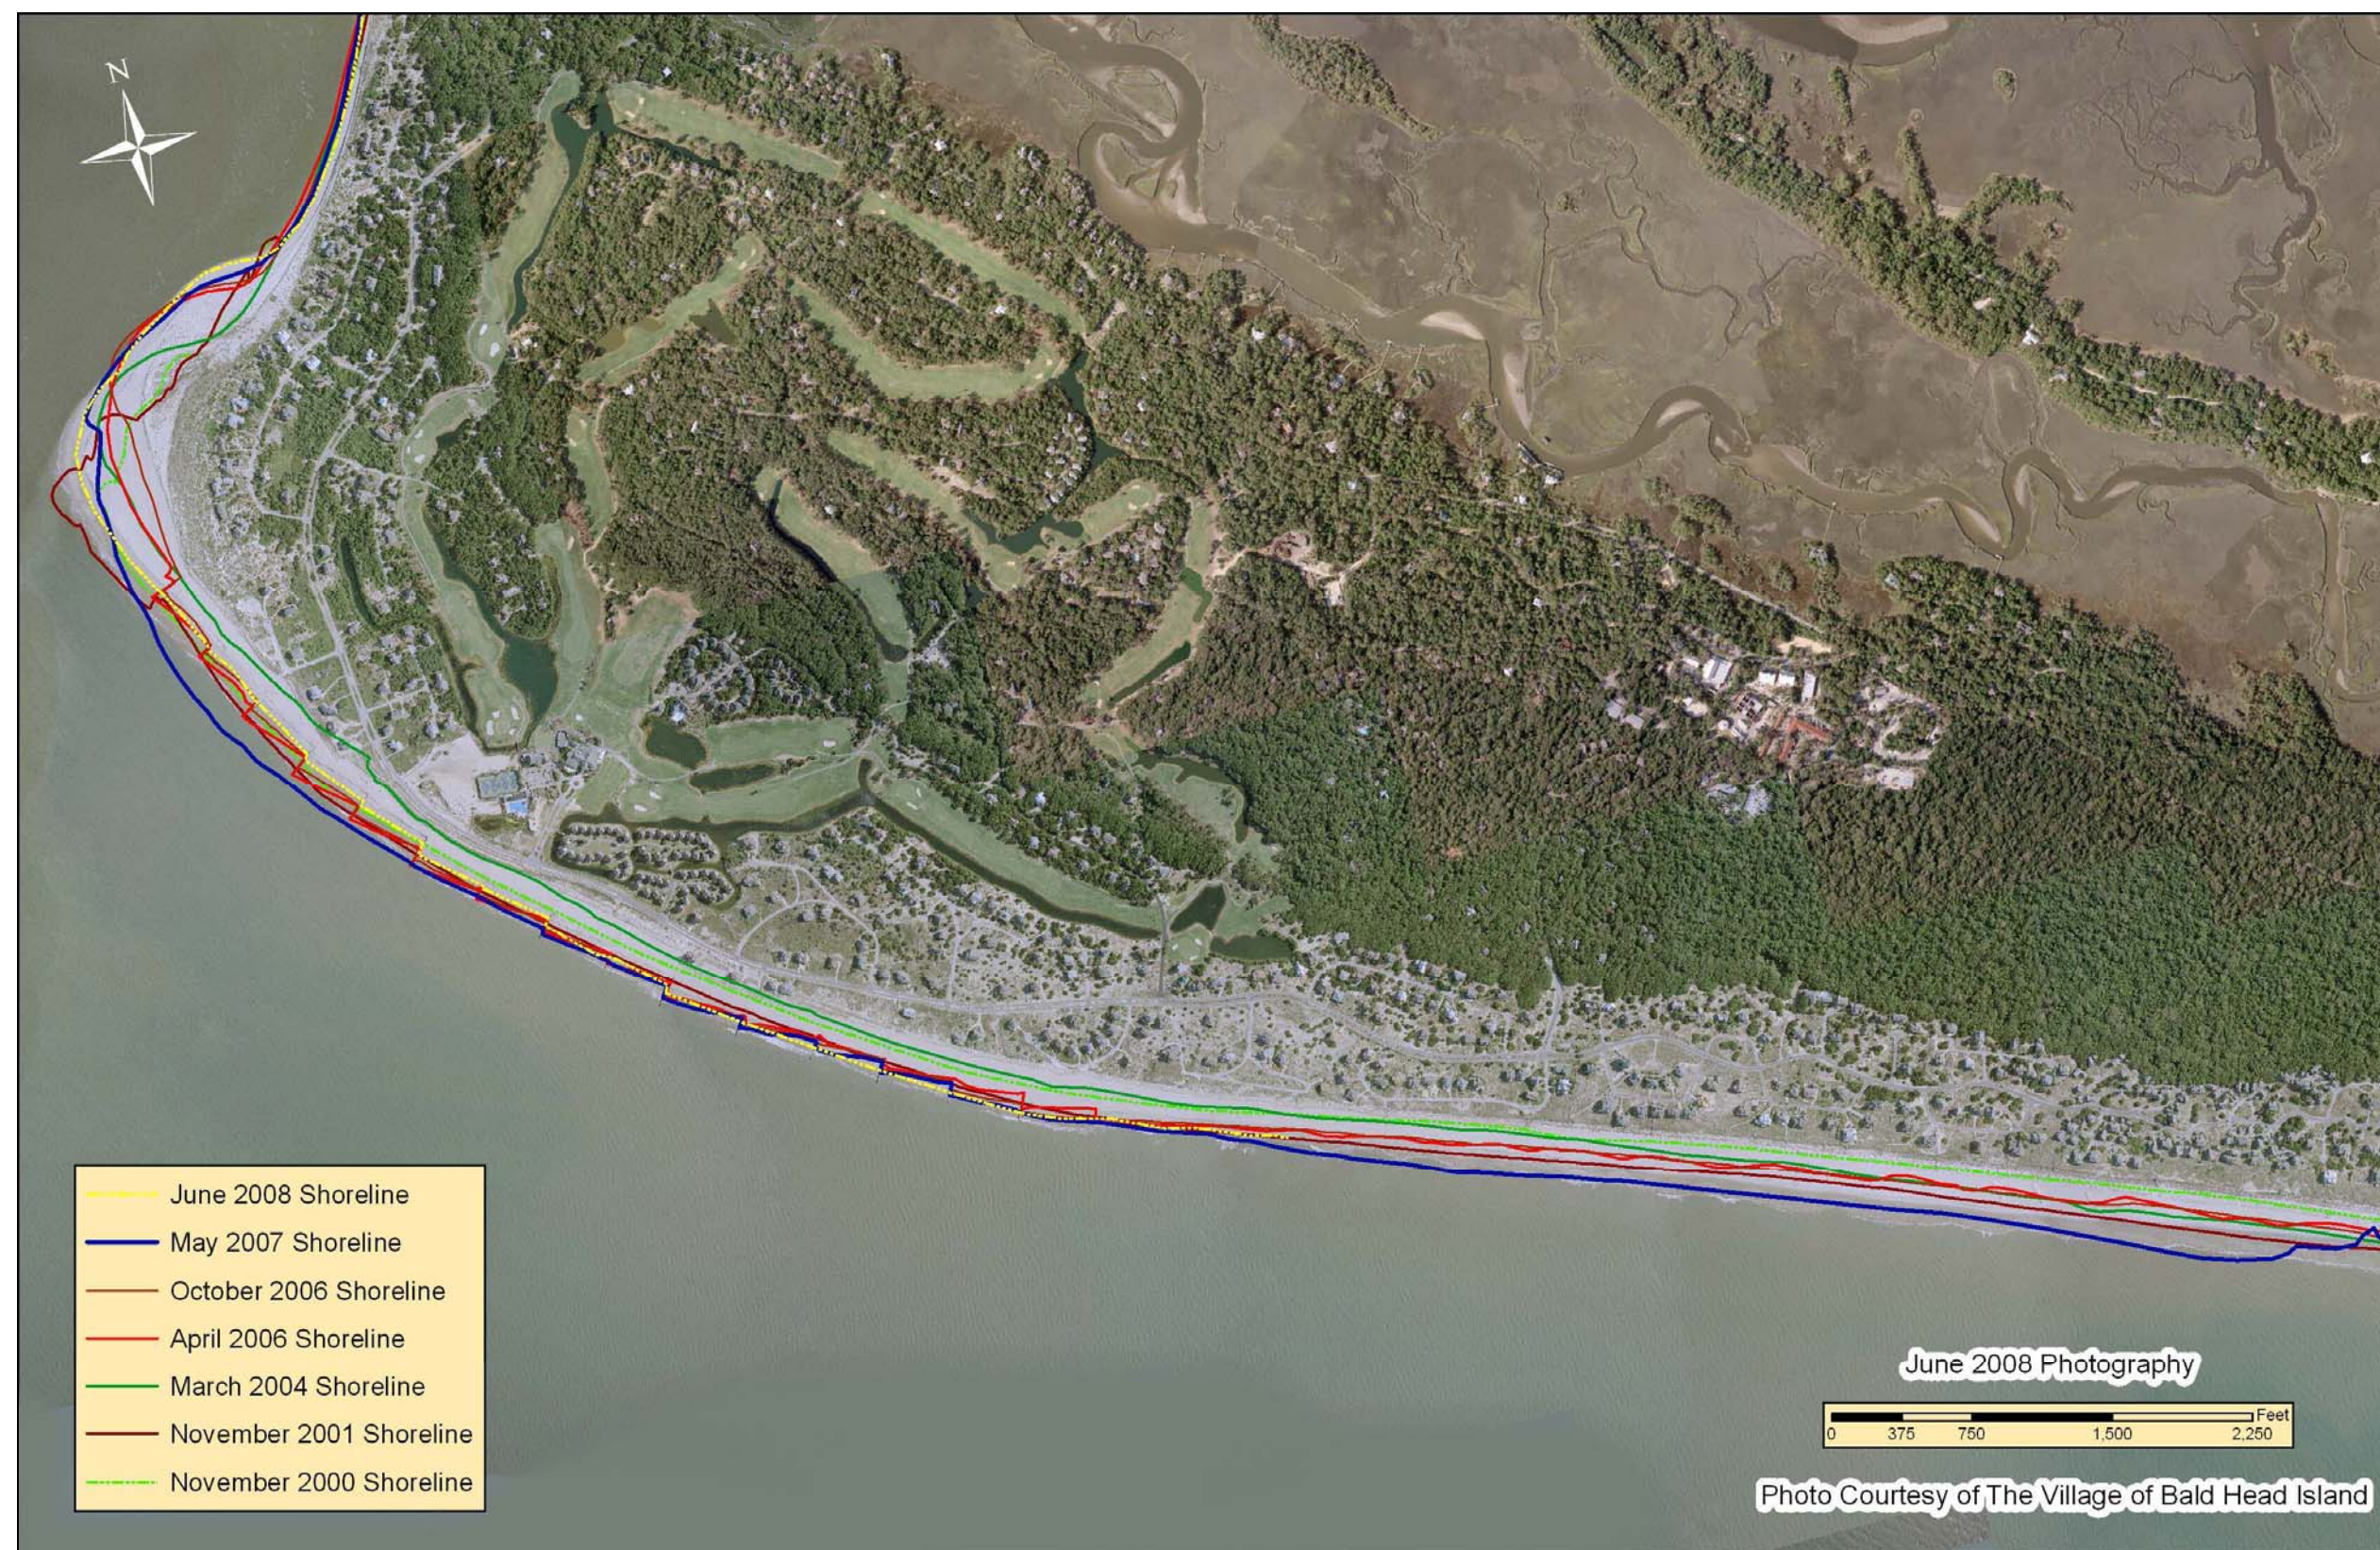
Figure 4.12 Shoreline Comparison: Pre and Post groin field reconstruction and beach disposal

The influence of the reconstructed groin field is shown in Figure 4.12. From this figure it is evident that the sediment transport along the groin field is from the East to West, creating a saw-tooth shoreline. Comparing the current June 2008 shoreline position with the May 2007 shoreline position included in Monitoring Report 5, shows that significant erosion has occurred along the west end of South Beach. The shoreline between stations 45+00 and 66+00 has eroded past the location of the November 2000 shoreline exposing much of the existing groin field. Erosion in this area is measured to be as much as 250' in the vicinity of station 53+00. A small section of the beach between stations 40+00 and 43+00, which is the point closest to the navigation channel, accreted as much as 130'. The eroding shoreline along South Beach is evident within the area of the April 2007 fill placement as well; however, this is most likely due to equilibration of the fill to a more natural and stable profile shape.

Among the possible explanations for this slower spit growth rate are: (1) sand tube groin field constructed immediately after the 2004/2005 placement has been effective in retaining the fill as shown in Figure 4.12, (2) smaller volume of material placed in the 2004/2005 placement dispersed from the island at a slower rate, (3) smaller volume of material placed at a lower density over longer reaches during the 2007 dredge disposal, (4) different location of placement with the second fill being farther away from the channel, and/or (5) possible dissimilar wave and current conditions for each period of record.
