**PHYSICAL MONITORING  
WILMINGTON HARBOR NAVIGATION PROJECT  
REPORT 8:  
October 2009 – September 2010**

January 2011

## EXECUTIVE SUMMARY

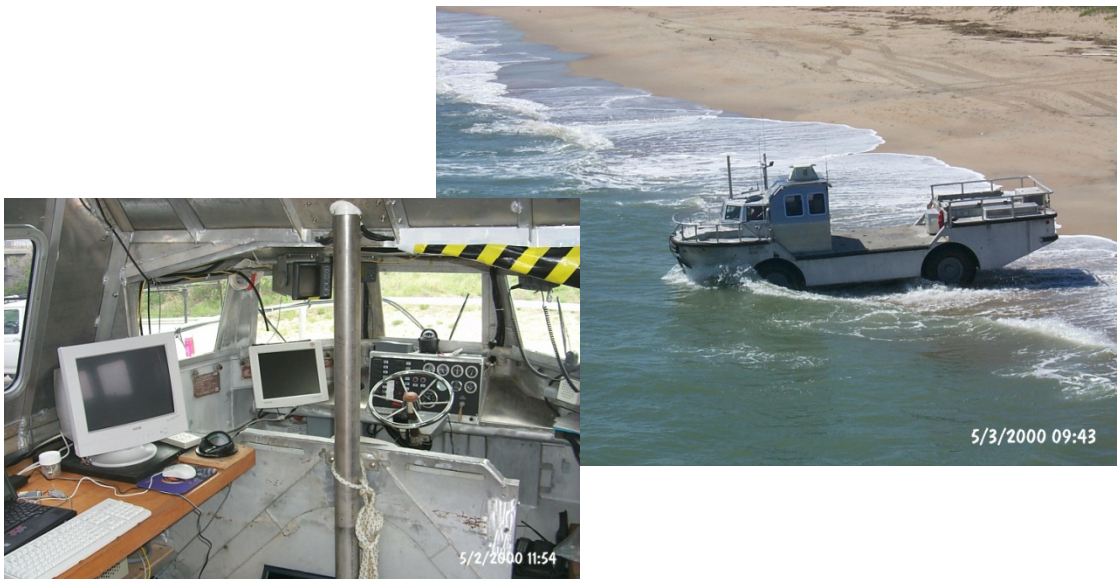
**Figure 1.5 FRF Hydro-LARC Survey System**

The most difficult areas to obtain accurate bathymetric surveys are through the surfzone and over the shoal areas that border each side of the Cape Fear entrance channel, and those near Frying Pan Shoals. Access to these locations is very difficult for conventional watercraft due to breaking waves and shallow depths. Under the present monitoring effort these access problems are largely eliminated through the use of the FRF's Lighter Amphibious Re-supply Cargo (LARC) survey system. The LARC vehicle, shown in Figure 1.5, is uniquely designed to transit through the water, across shoals, and through the surf zone up to the base of the beach dunes. The LARC is equipped with a Trimble Real-Time Kinematic Global Positioning Satellite (RTK-GPS) survey system for accurate horizontal and vertical positioning of the vehicle and a Knudsen Echosounder to measure depth while traversing the profile lines.

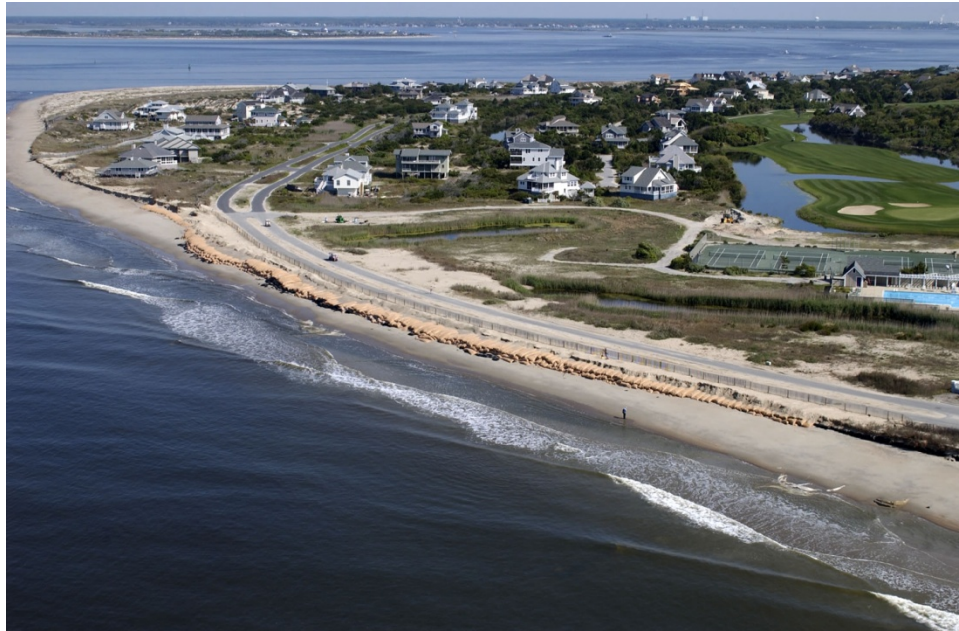
**Figure 2.3 Sand Bag Revetment along South Bald Head Wynd, April 2003.**

In 1994 a 645-foot-long sand bag revetment was placed along the badly eroding portion of western South Beach. In 2003-2004 the sand bag revetment was expanded by increasing the overall length by 200 feet, increasing the base width from 20 to 40 feet and increasing the crest elevation by 6 feet to +12 feet NGVD. A view of the expanded sand bags are shown in Figure 2.3, as it appeared in April 2003.

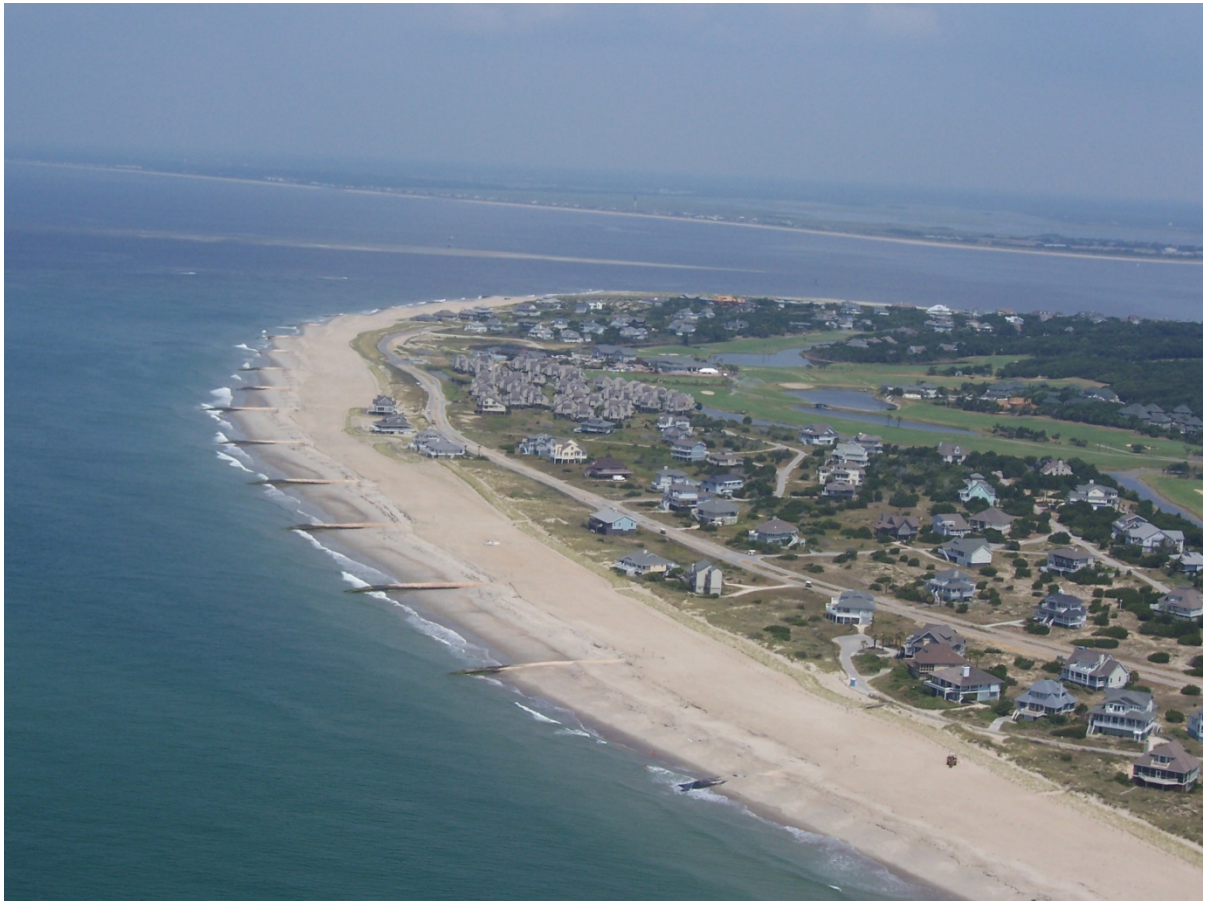
**Figure 2.4 Reconstructed Groin field along Bald Head Island, July 2006 (Courtesy of Village of Bald Head Island)**

In 1996, the Village constructed sixteen geo-textile groins from station 49+00 to Station 114+00. The groins were 9 feet in diameter and 325 feet long. The spacing between the groins was about 450 feet. The groin field slowed the erosion for several years before they began to fail and ceased to function in 2000. Due to apparent effectiveness of the geo-textile groins, the Village of Bald Head Island decided to rebuild the groin field following the beach disposal in 2005. As such a sixteen structure sand tube groin field was reconstructed along South Beach between stations 47+00 and 105+00. The replacement geo-tubes were constructed between January and March 2005. Some modifications were made to the original 1996 plan. These modifications included: (1) the spacing was reduced from 450 feet to 385 feet thereby reducing the overall extent for the groin field, (2) the tube lengths were 300 feet for 14 of the structures and 250 feet for the remaining two, (3) the individual tubes were tapered with a landward maximum diameter of 10 feet to 6 feet at the seaward end, and (4) the entire groin field was shifted westward to be more aligned with the problem area. Figure 2.4 shows an aerial view of the completed groins taken in July 2006, about 16 months following placement.

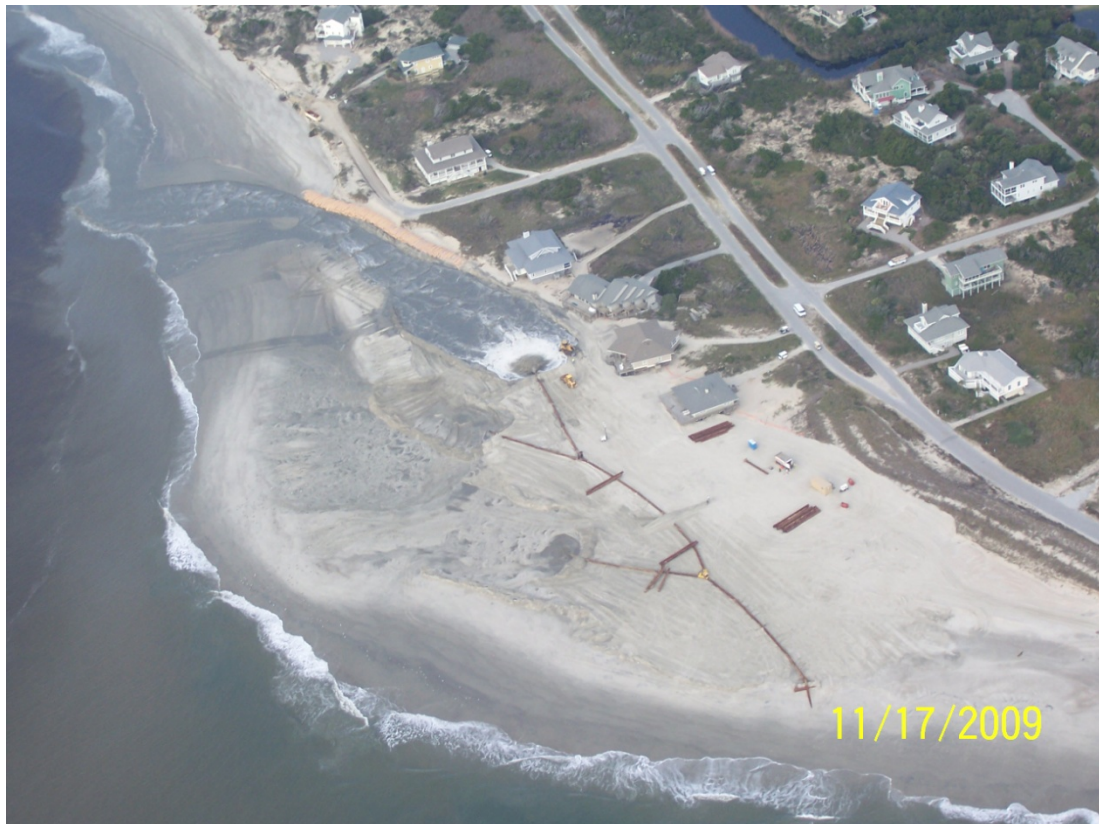
**Figure 2.5 Start of 2009-10 local Beach Disposal Project along Bald Head Island, November 2009 (Courtesy of Village of Bald Head Island)**

Most recently, Bald Head Island undertook a large beach re-nourishment project to cover portions of South and West Beach. The work commenced in November 2009 (Figure 2.5) with completion in March 2010. This operation was undertaken to cover the “open” maintenance cycle, when according to the sand management plan, material is designated to go to Oak Island. Approximately 1.6 million cubic yards of sand were dredged from an offshore borrow site comprising the seawardmost portions of Jay Bird Shoals. The contract also involved the replacement of the geotextile groins in conjunction with the disposal placement.

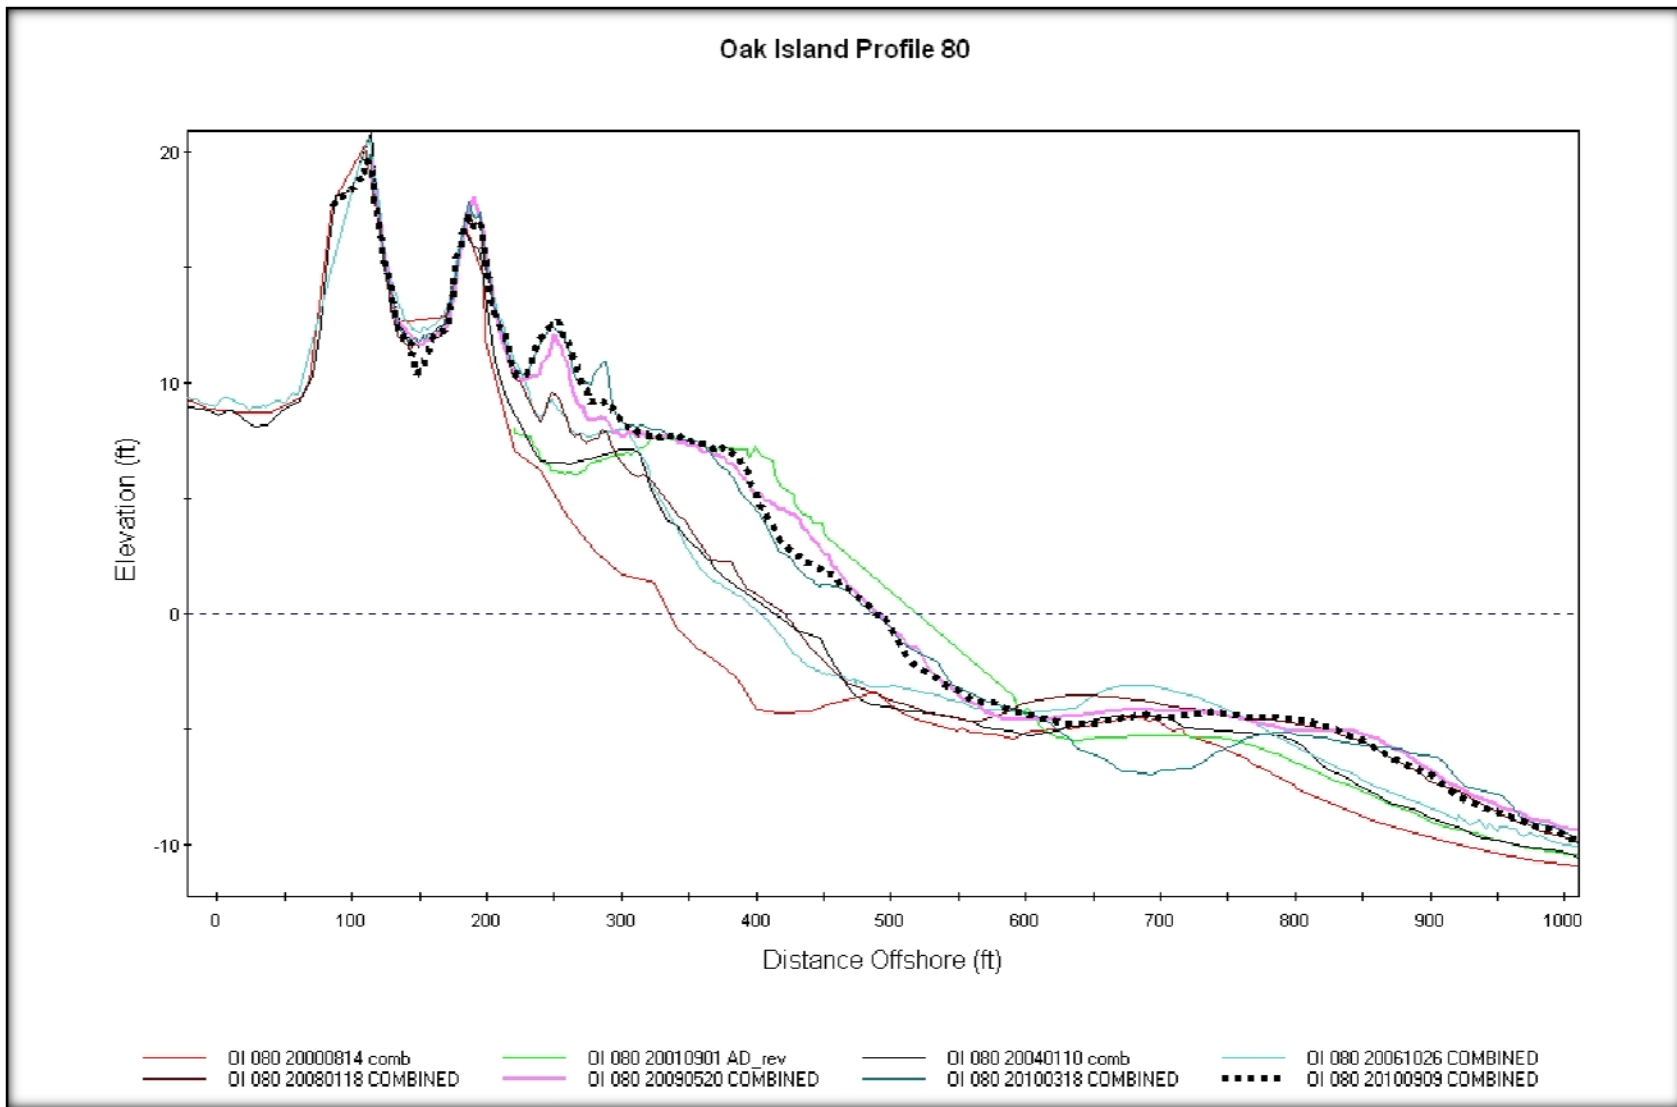
**Figure 3.8 Oak Island Profile 80**

Typical profiles along Oak Island are given in Figures 3.8 and 3.9. Figure 3.8 shows Profile 80 within the eastern portion of the disposal area and Figure 3.9 shows Profile 220 within the western portion of the disposal area. The plot of Profile 80 shows the seaward advance resulting from the initial disposal by a period of adjustment between the September 2001 and January 2004 surveys. Following this initial adjustment period, over which about half of the berm width was eroded, the profile remained stable. The beach was widened again with the 2009 disposal to near the approximate 2001 location. Relatively little change has occurred in the profile since the renourishment in 2009. A similar response is shown in Figure 3.9 for Profile 220; however, the berm remained generally wider through January 2009 leading up to the most recent disposal. Comparisons of the May 2009 survey with the September 2010 survey show that very little erosion has occurred at this location over the current monitoring period. Plots of the cumulative shoreline changes for each of these profiles are given on Figure 3.10. For Profile 80, the shoreline has remained generally stable over the last six years following the adjustment to the initial disposal. Over this time period (between June 2002 and January 2009), the mean high water shoreline at Profile 80 has varied between about 70 and 95 seaward of its August 2000 position. Following the 2009 beach disposal, the shoreline was advanced to 168 feet beyond what it was in 2000 and has since experienced a similar adjustment to the shoreline position as it did following the initial disposal. Currently the shoreline position at Profile 80 is 144 feet seaward of the September 2000 shoreline location. For Profile 220, the shoreline has also remained relatively stable following the initial profile adjustment to the disposal; however, an erosional trend is noticeable over the period following initial placement up through the January 2009 survey. With the latest disposal, the shoreline was pushed seaward to a point which was 185 feet beyond its initial location in 2000. The profile has eroded only 5 feet over the current monitoring period and is currently 180 feet seaward of its initial pre-project position.

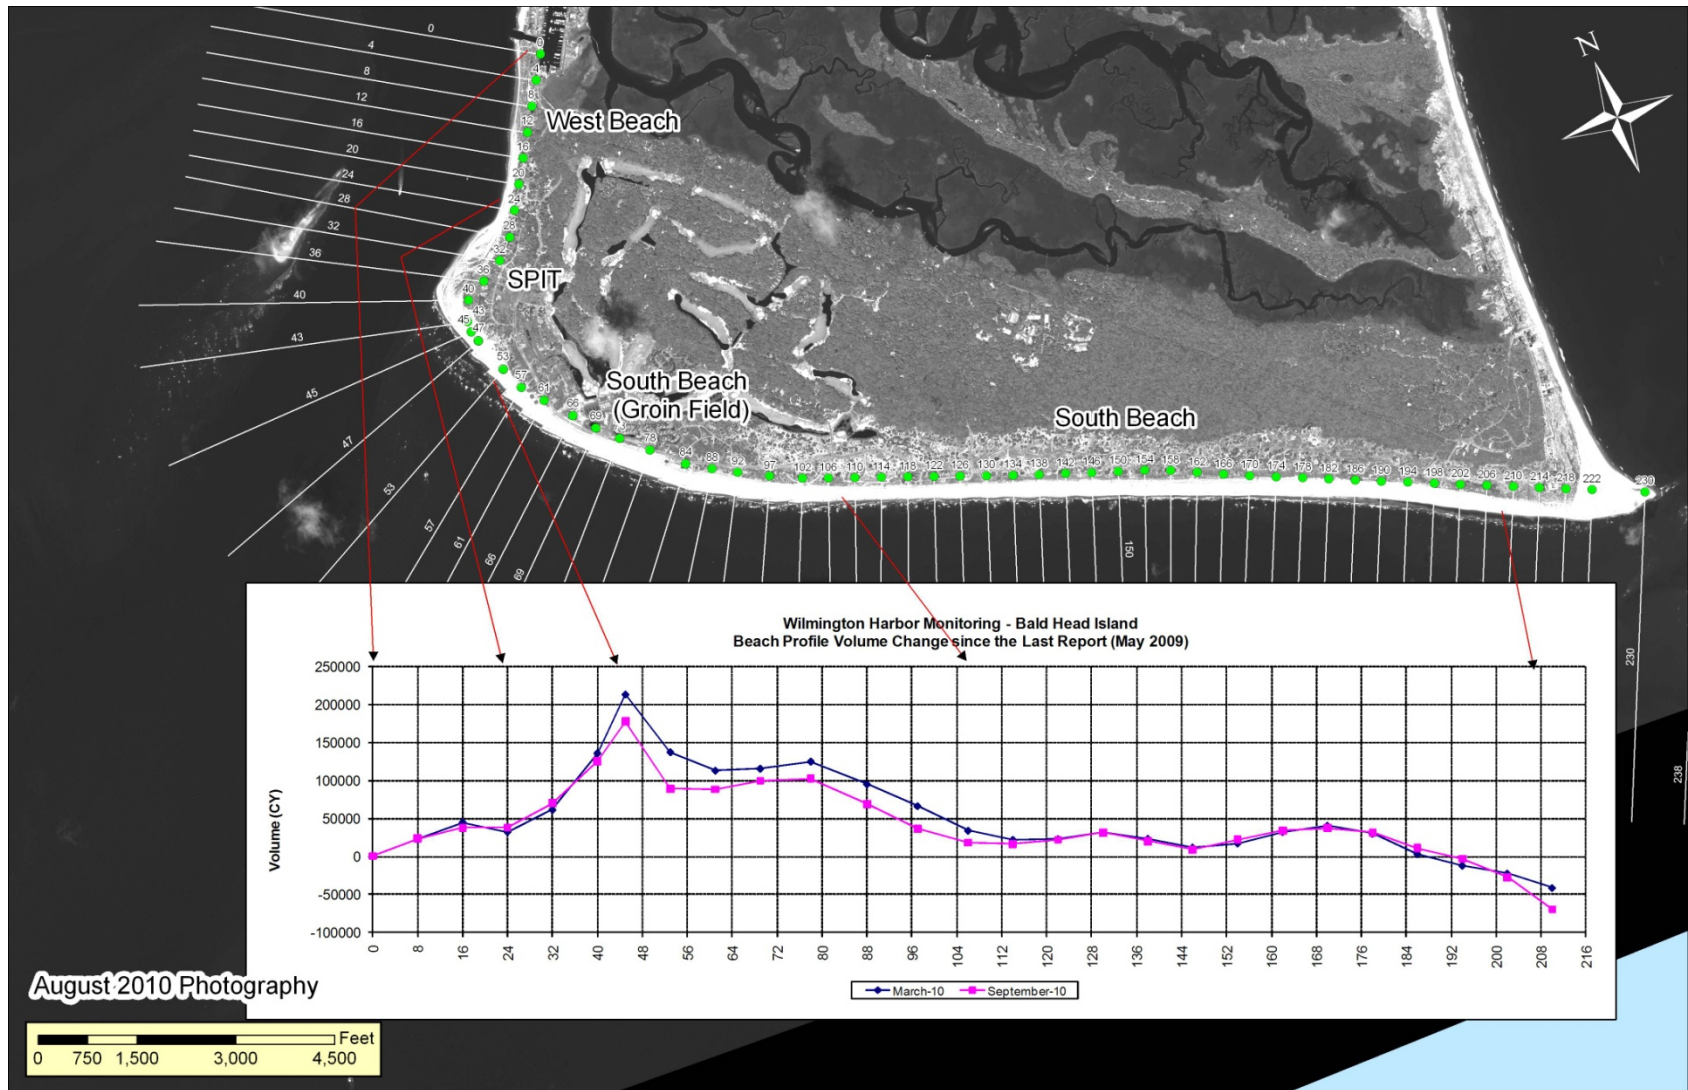
**Figure 3.14 Wilmington Harbor Monitoring – Bald Head Island Beach Profile Volume Changes Since Last Report (May 2009)**

Total volumetric changes computed over the entire active profile are given in Figures 3.14 and 3.15 for Bald Head Island. Figure 3.14 shows volume changes relative to the latest survey contained in Report 7 (May 2009); whereas, Figure 3.15 gives changes relative to the August 2000 survey at the beginning of the monitoring. For each profile comparison, volumes were computed from a common stable landward point to an observed closure depth offshore.

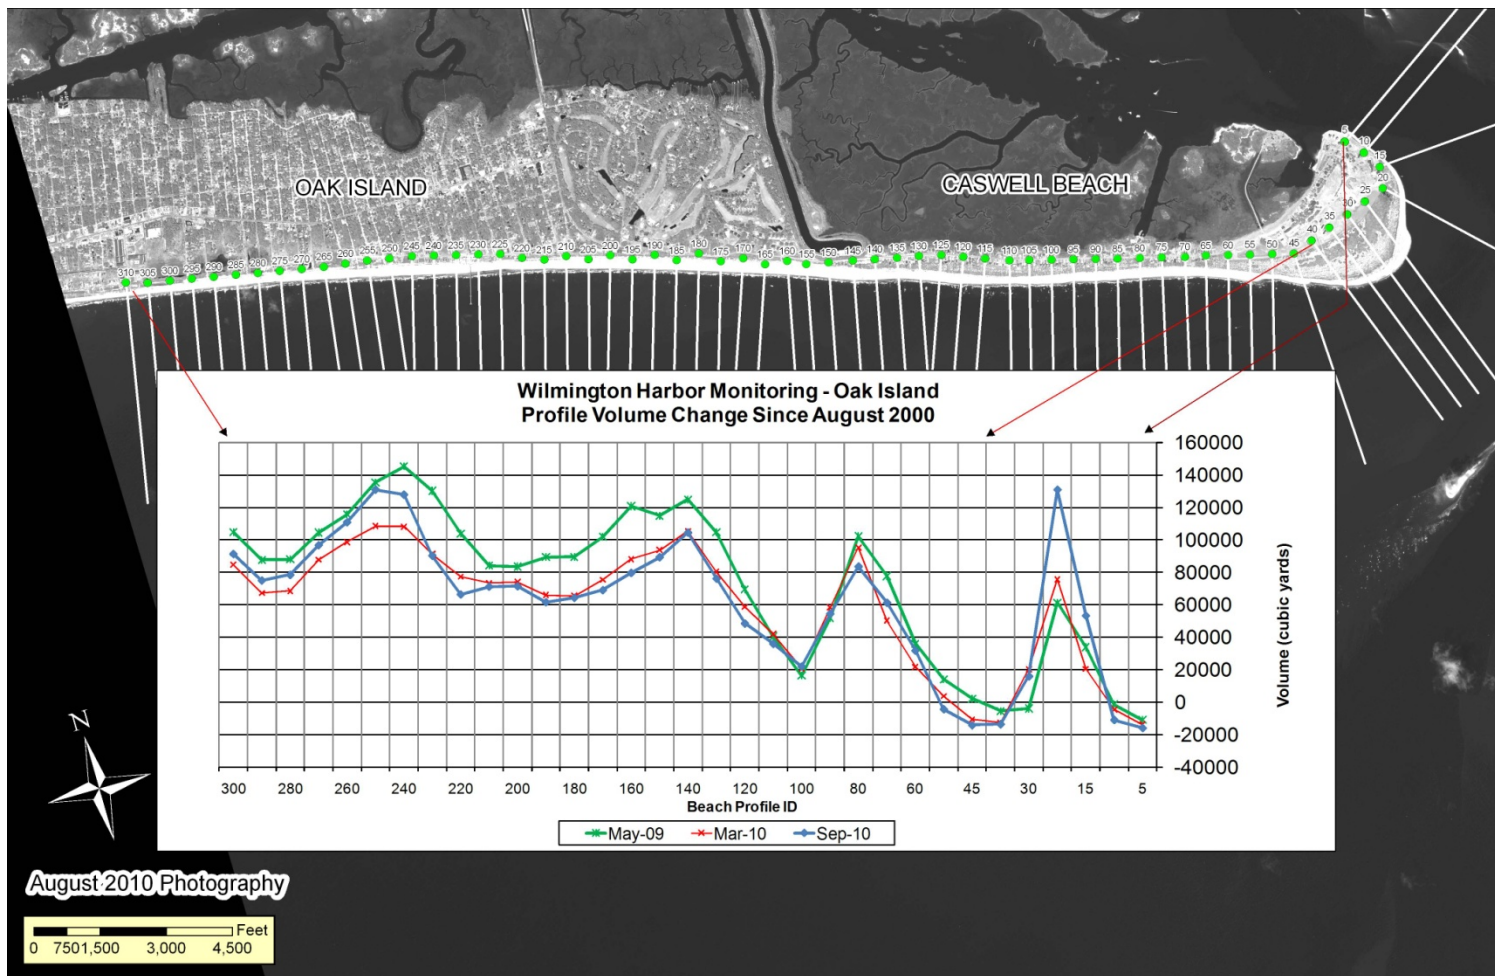
**Figure 3.20 Wilmington Harbor Monitoring - Oak Island Beach Profile Volume Change Since the Start of Monitoring (August 2000)**

As with the onshore volumes discussed previously, the total (onshore+offshore) profile volume changes have been generally positive. Figure 3.20 shows the volume changes for last three onshore/offshore surveys relative to the August 2000 pre-project survey. In this regard, all reported volume changes are positive with the exception of 5 profiles along the eastern end of the island which show relatively minor losses. Significant volumetric loss occurred in the areas that received beach disposal material in 2009 between the May 2009 and March 2010 survey. The pattern of volumetric change prior since March 2010 appears to be relatively similar indicating that the initial losses were predominately due to profile equilibration of the newly placed material. Measured volumes for the entire monitoring area with the September 2010 survey totaled nearly 2,035,000 cubic yards greater than what was measured in August 2000. This is only slightly less than the total volume placed along the island in both the 2001 and 2009 beach placement operations which totaled 2,246,200 cubic yards.
