**US Army Corps  
of Engineers®**  
Wilmington District

# PHYSICAL MONITORING WILMINGTON HARBOR NAVIGATION PROJECT REPORT 9: October 2010 – August 2012

December 2013

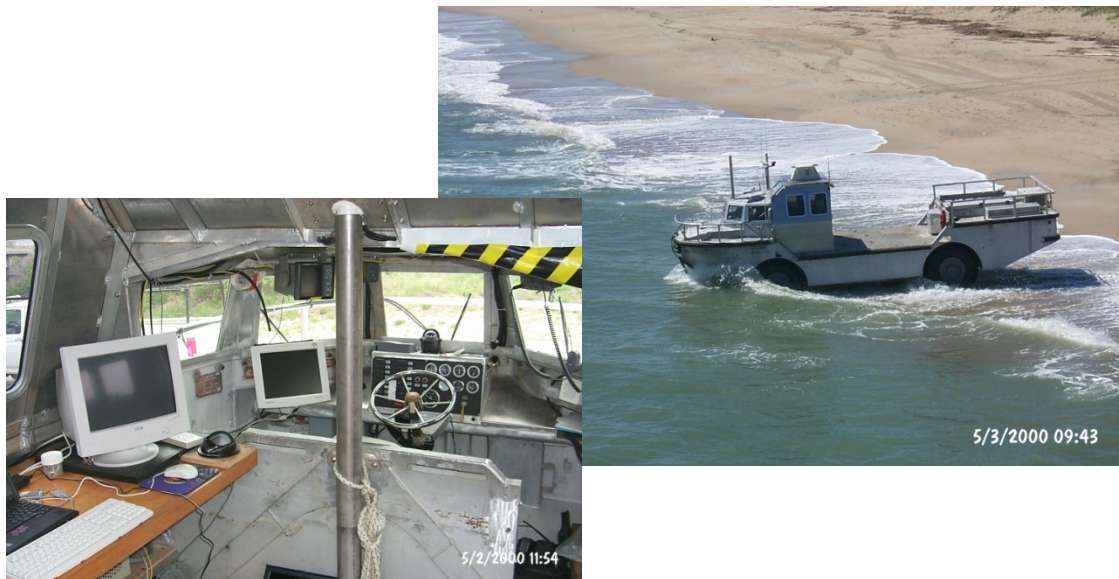
**Figure 1.5 FRF Hydro-LARC Survey System**

The most difficult areas to obtain accurate bathymetric surveys are through the surfzone and over the shoal areas that border each side of the Cape Fear entrance channel, and those near Frying Pan Shoals. Access to these locations is very difficult for conventional watercraft due to breaking waves and shallow depths. Under the present monitoring effort these access problems are largely eliminated through the use of the FRF's Lighter Amphibious Re-supply Cargo (LARC) survey system. The LARC vehicle, shown in Figure 1.5, is uniquely designed to transit through the water, across shoals, and through the surf zone up to the base of the beach dunes. The LARC is equipped with a Trimble Real-Time Kinematic Global Positioning Satellite (RTK-GPS) survey system for accurate horizontal and vertical positioning of the vehicle and a Knudsen Echosounder to measure depth while traversing the profile lines.

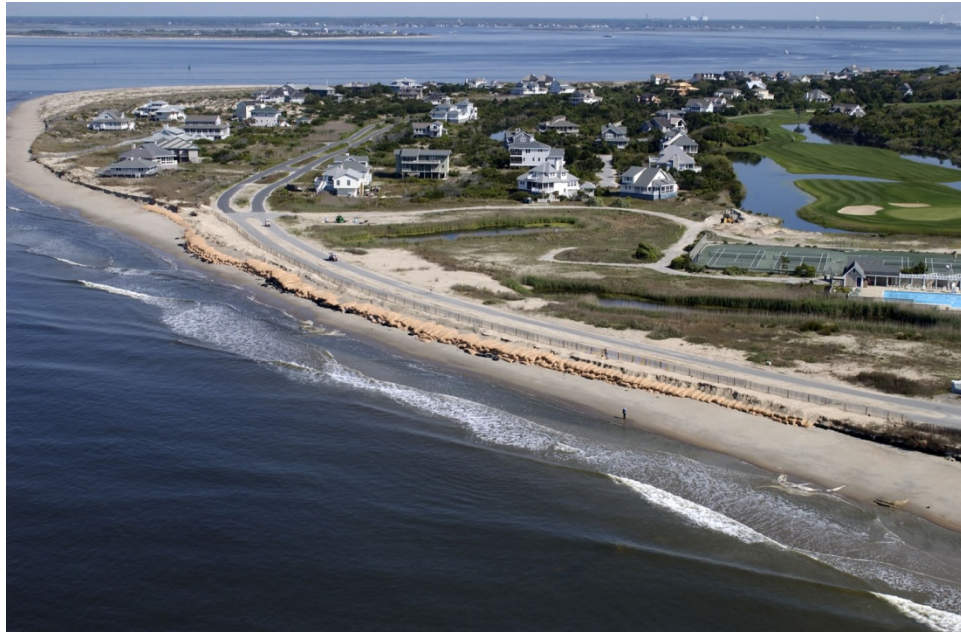
**Figure 2.3 Sand Bag Revetment along South Bald Head Wynd, April 2003.**

In 1994 a 645-foot-long sand bag revetment was placed along the badly eroding portion of western South Beach. In 2003-2004 the sand bag revetment was expanded by increasing the overall length by 200 feet, increasing the base width from 20 to 40 feet and increasing the crest elevation by 6 feet to +12 feet NGVD. A view of the expanded sand bags are shown in Figure 2.3, as it appeared in April 2003.

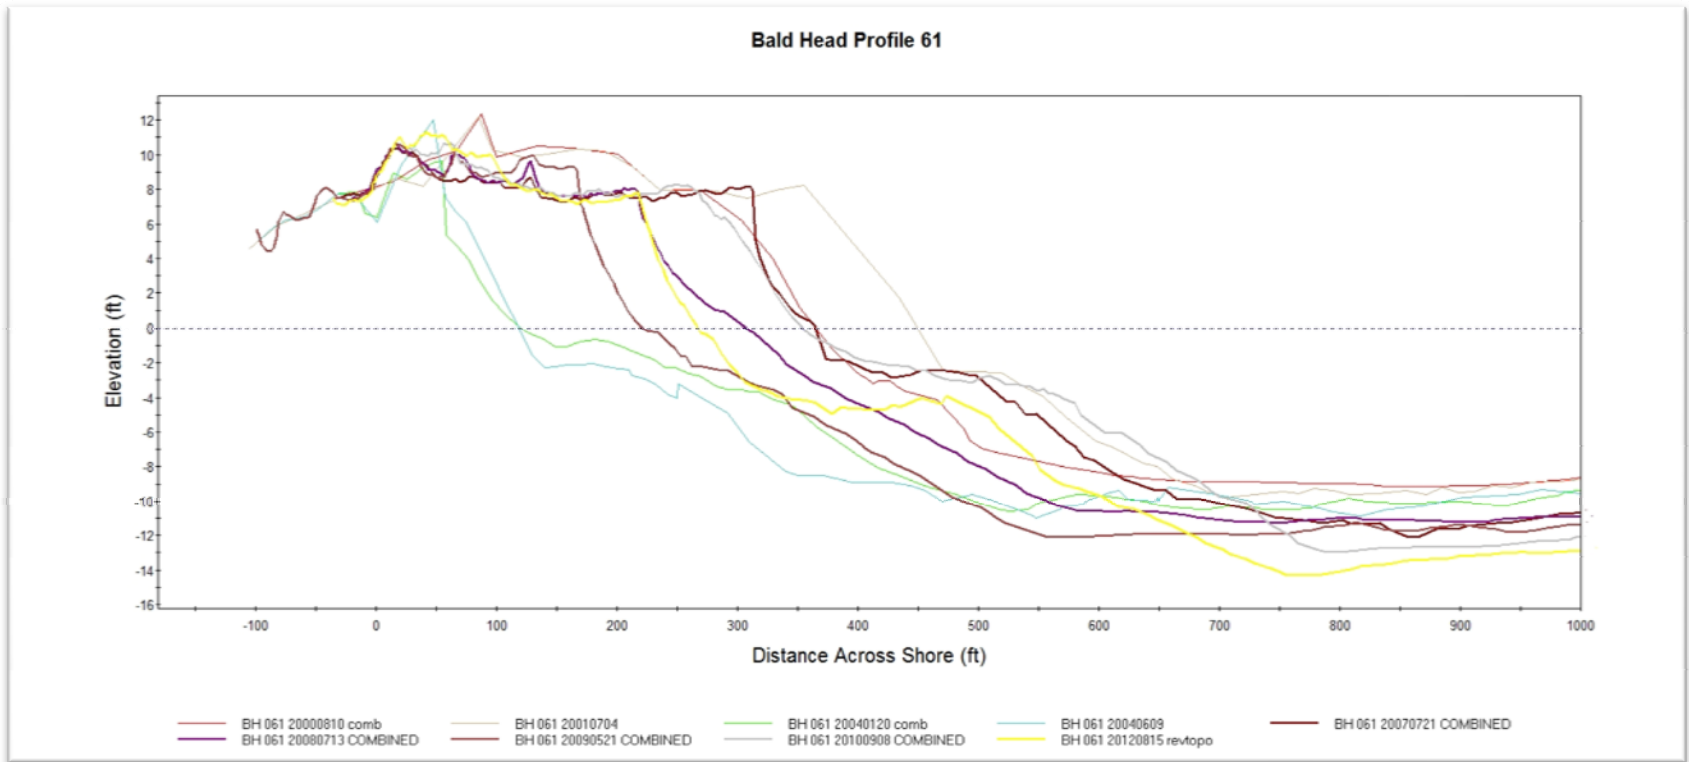
**Figure 3.3 Bald Head Island Profile 061**

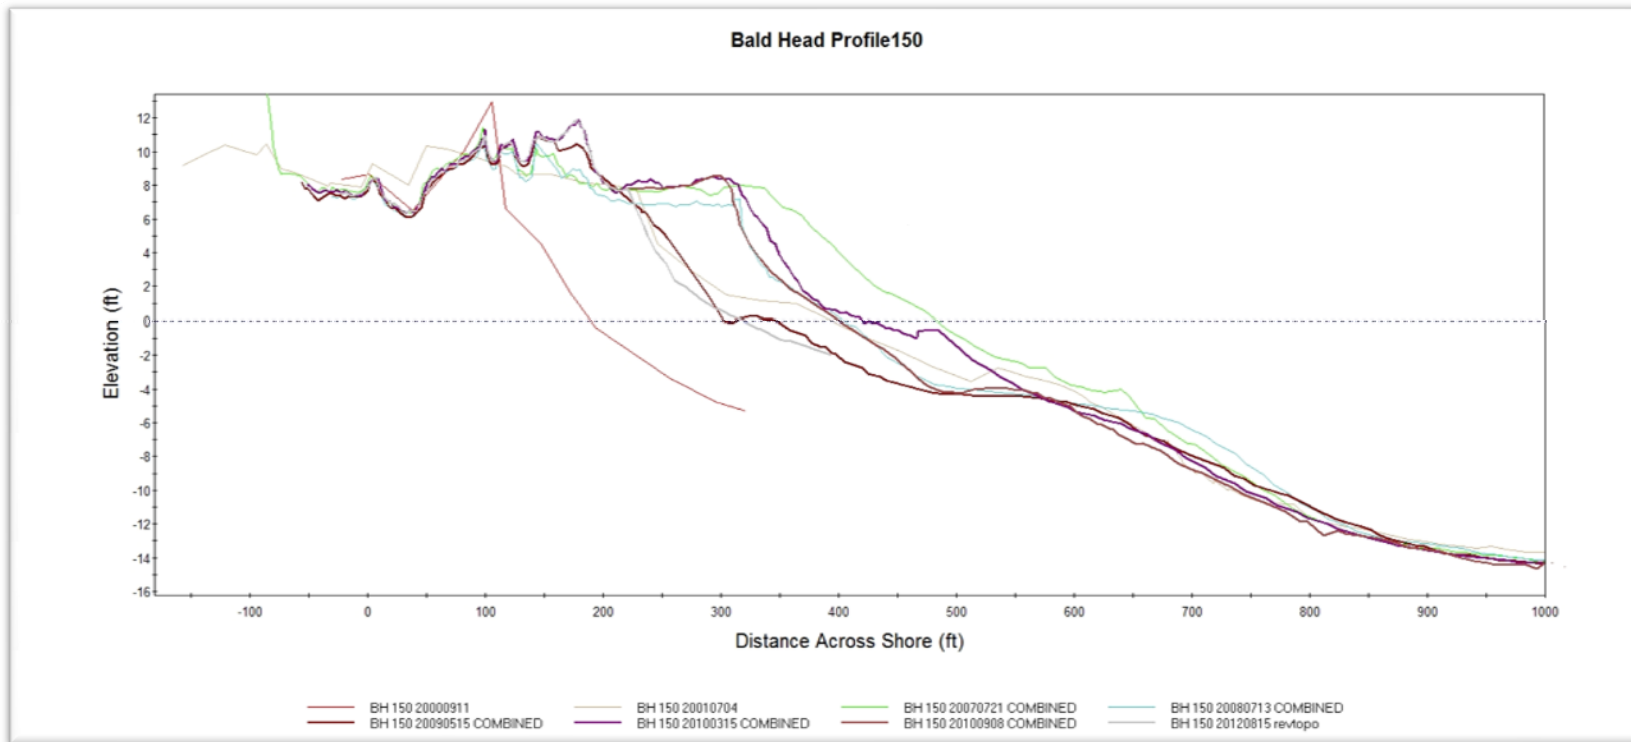
**Figure 3.4 Bald Head Island Profile 150**

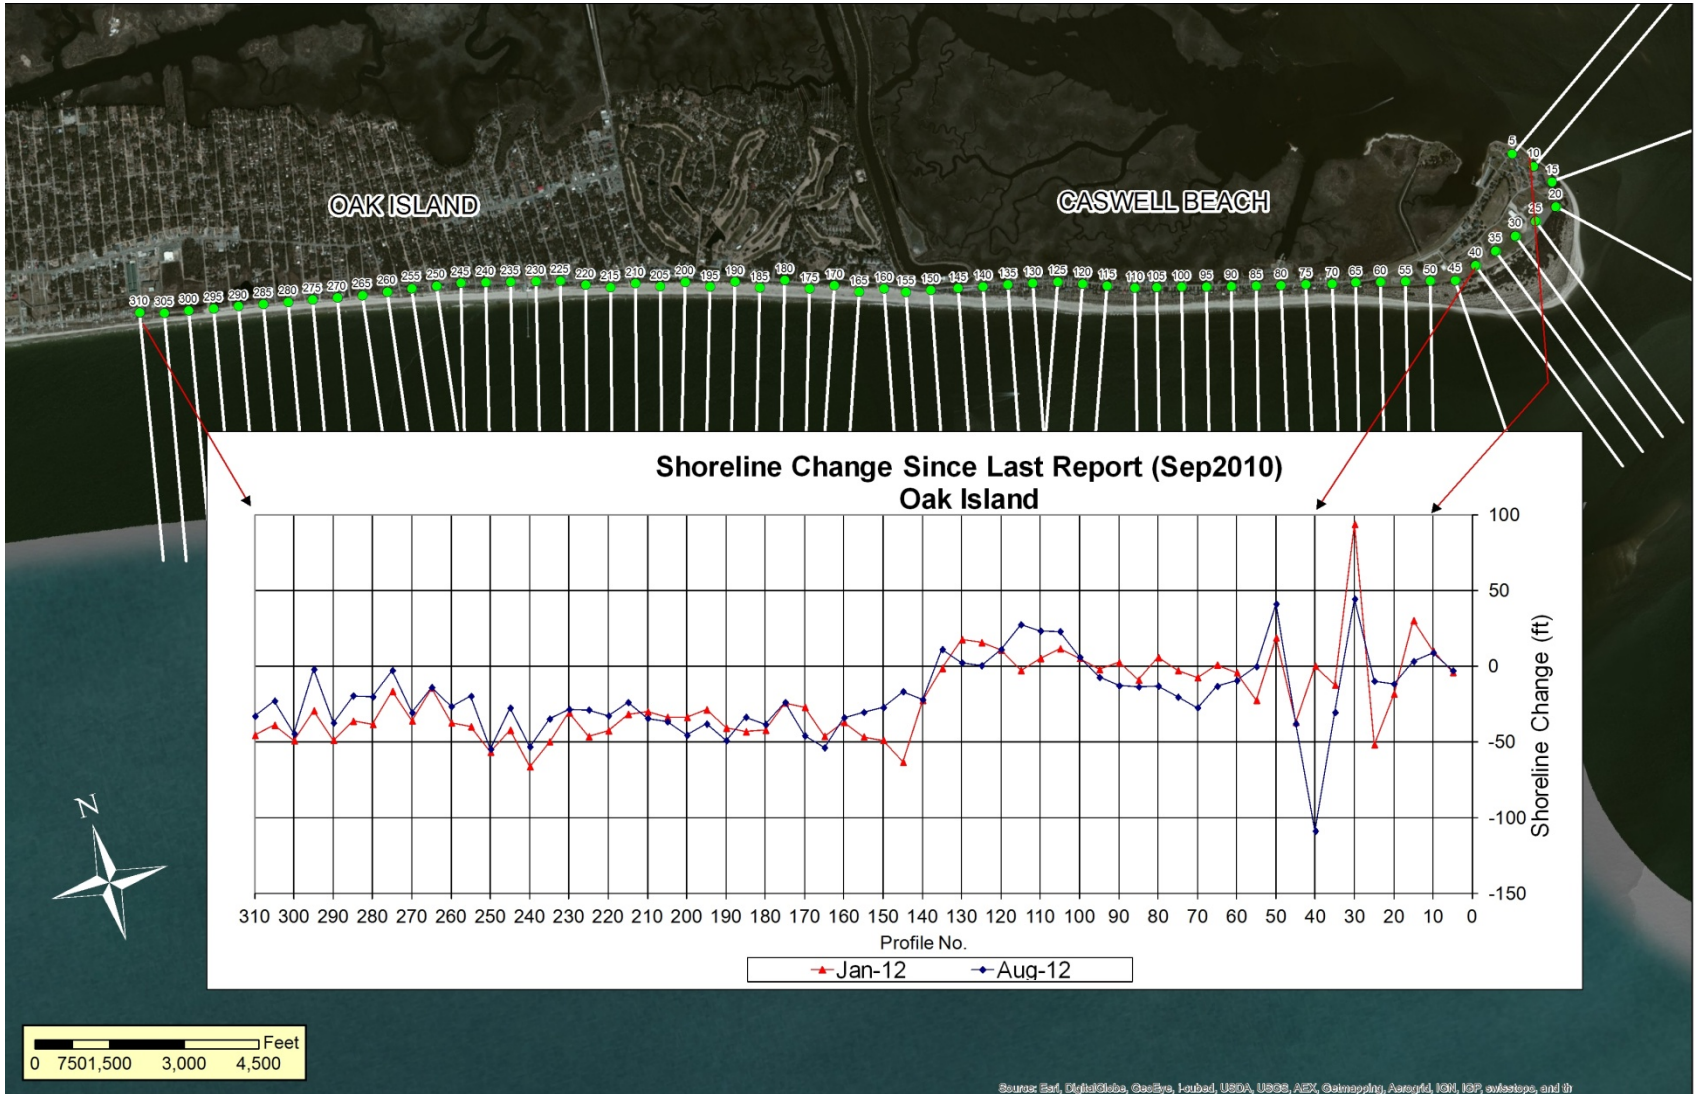
**Figure 3.6 Shoreline Change Since Last Report (September 2010) - Oak Island**

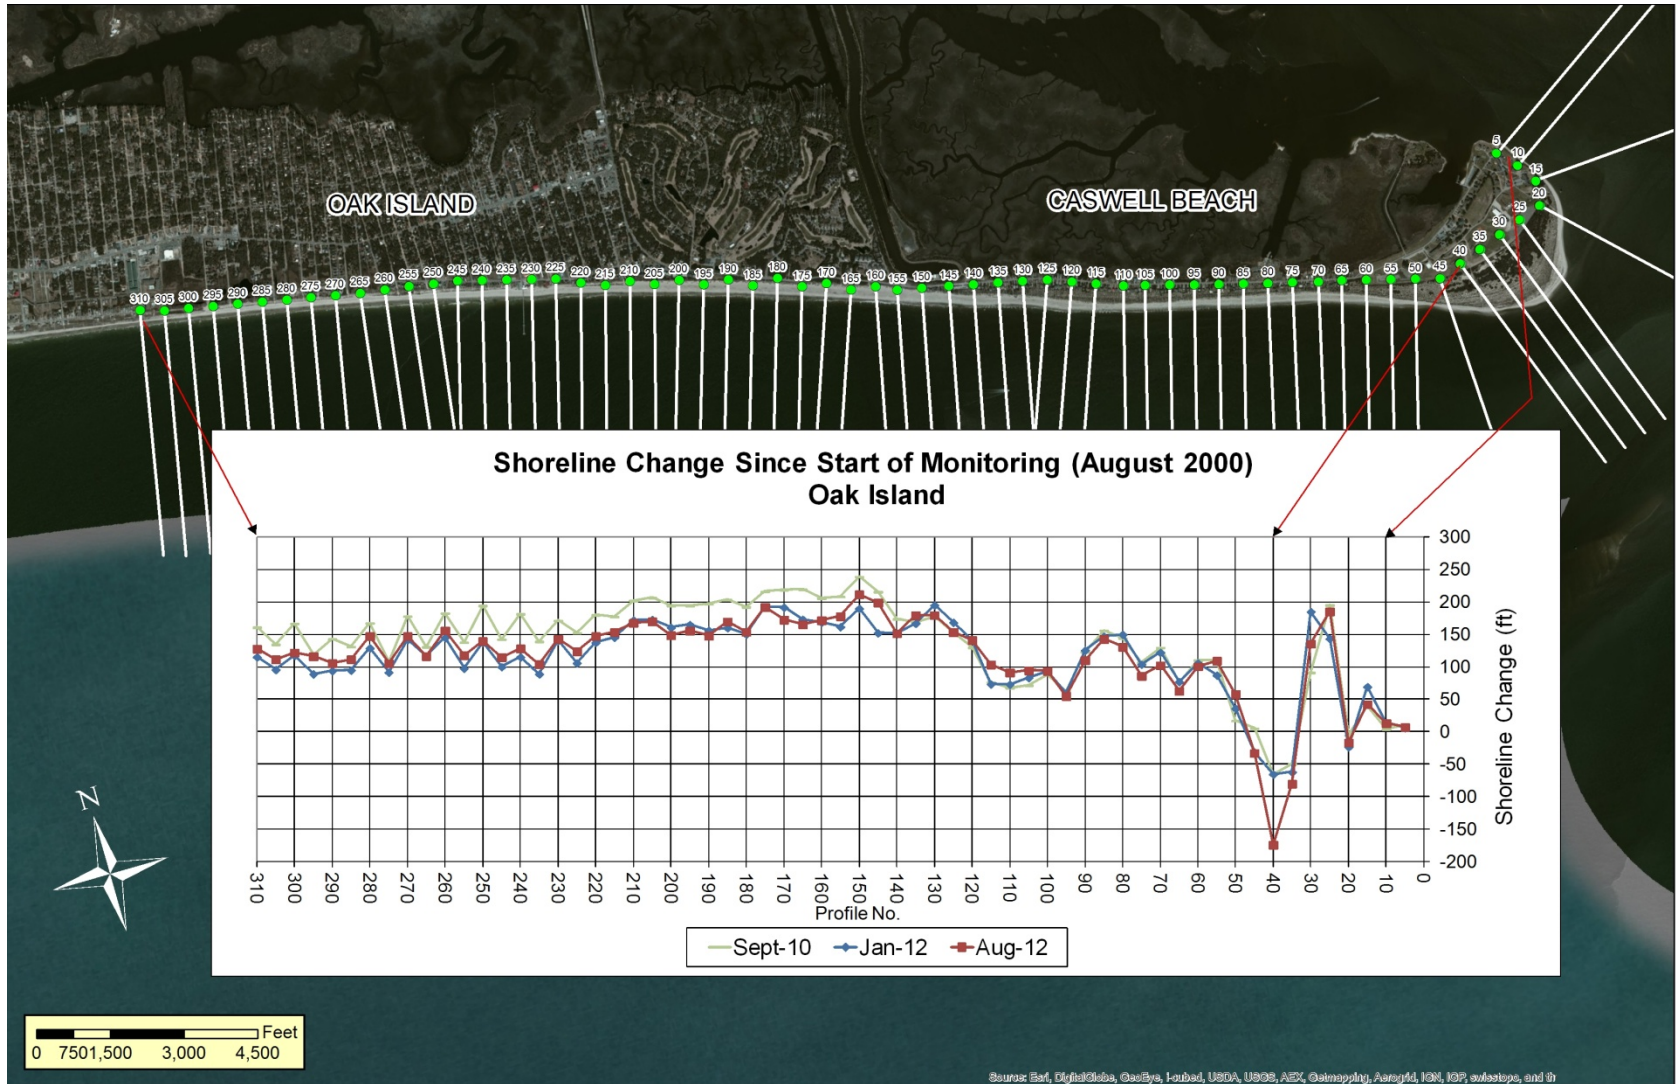
**Figure 3.7 Shoreline Change Since Start of Monitoring (August 2000) - Oak Island**

When comparing the shoreline changes back to August 2000 (i.e. the pre-project survey), Figure 3.7 shows a definite pattern of accretion at almost all locations. As shown by the August 2012 shoreline change plot, the beach has widened by as much as 212 feet (Profile 150). In fact, except for four profiles on the eastern tip of the island (Profiles 20, 35, 40 and 45) all other profile lines have shown some shoreline increase. The most extreme loss along the island was located at Profile 40 which has a measured shoreline loss of 174 feet when compared to the pre-project condition. This profile is in close proximity to Ft. Caswell and has drawn interest from the local residents of Ft Caswell. Some concerns as to whether this erosion is related to the 2009/2010 dredging of Jay Bird Shoals for the locally funded Bald Head Island nourishment project have been expressed, however, the USACE has not evaluated this claim to date. The overall beach stability has resulted not only from the recent beach disposal, but also from the positive effect of the initial placement of disposal material in 2001, as well as, the nearby Sea Turtle Habitat Project. This latter project (also completed in 2001) was placed just to the west of the monitoring limits, but sediment has dispersed eastward into the study area. Given the length of time since its initial construction, it is unlikely the project is continuing to provide significant sediment to the profiles within the monitoring area. In considering all the profile data, the alongshore average shoreline position was 115 feet more seaward in August 2012 than it was in September 2000. This is a decrease of nearly 20 feet when compared to the values measured in Report 8.

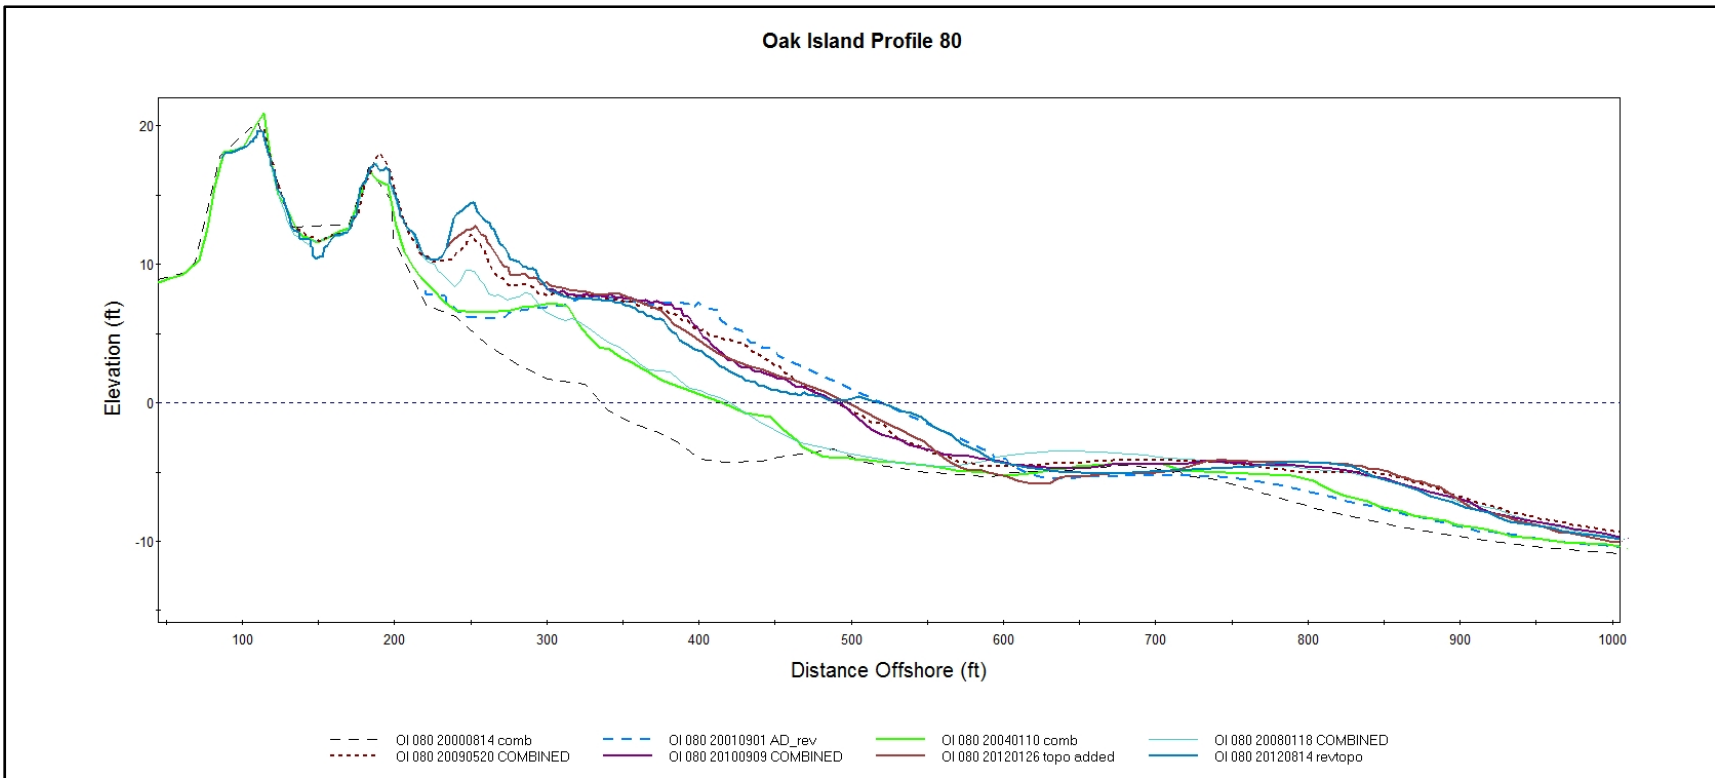
**Figure 3.8 Oak Island Profile 80**

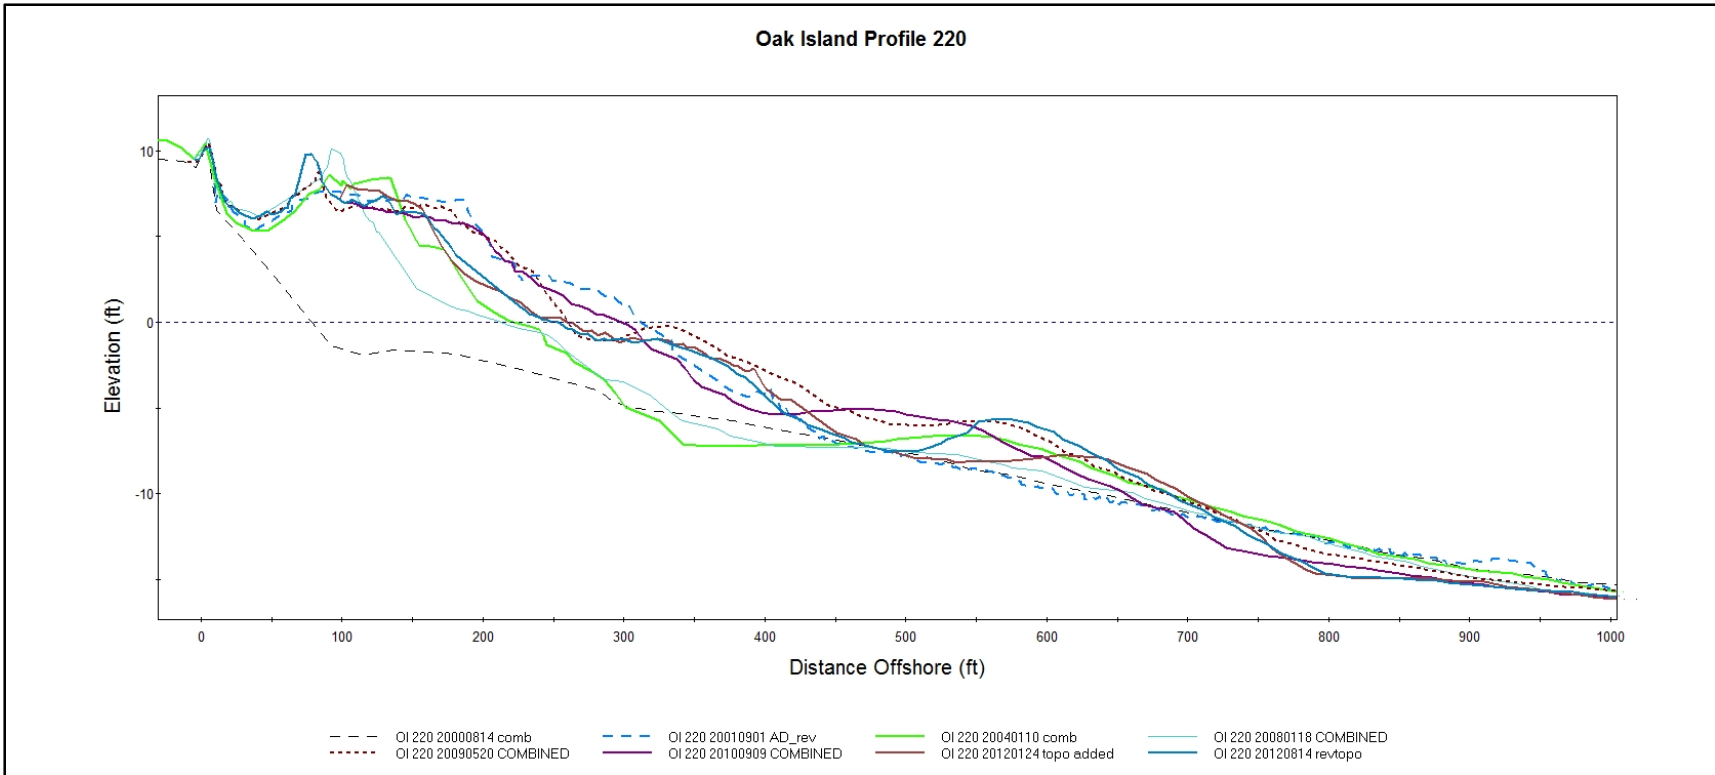
**Figure 3.9 Oak Island Profile 220**

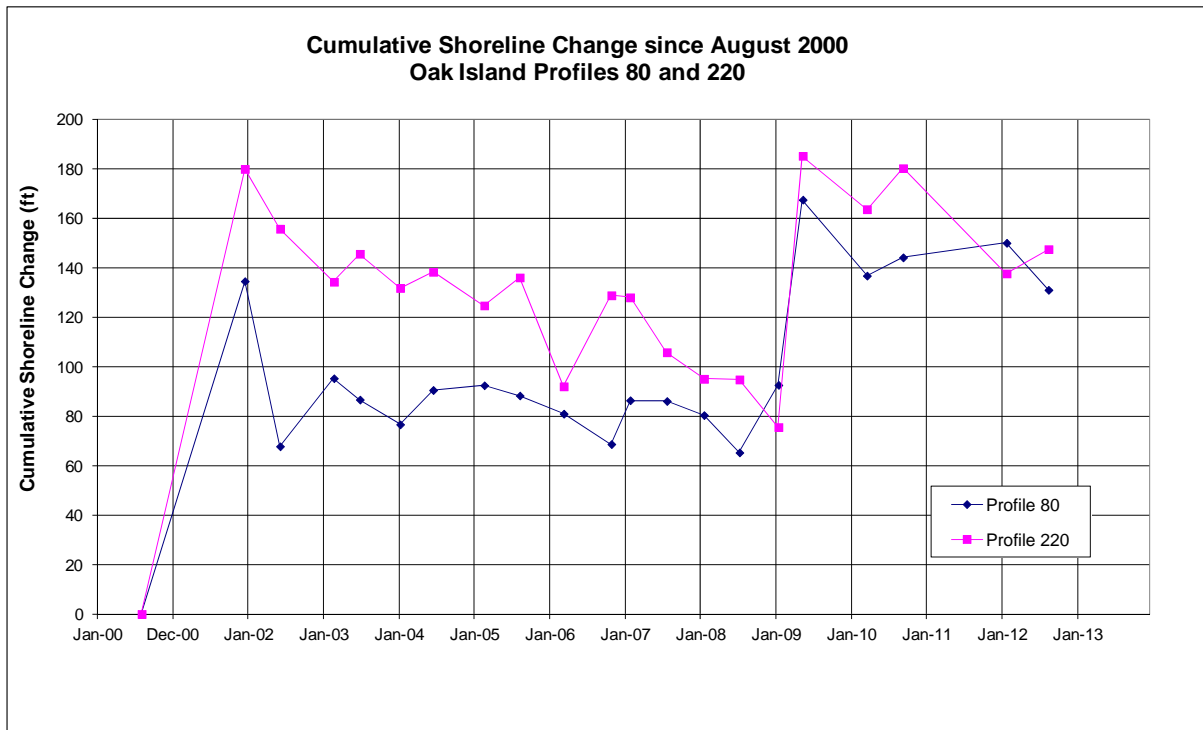
**Figure 3.10 Cumulative Shoreline Change Since August 2000  
Oak Island Profiles 80 and 220**

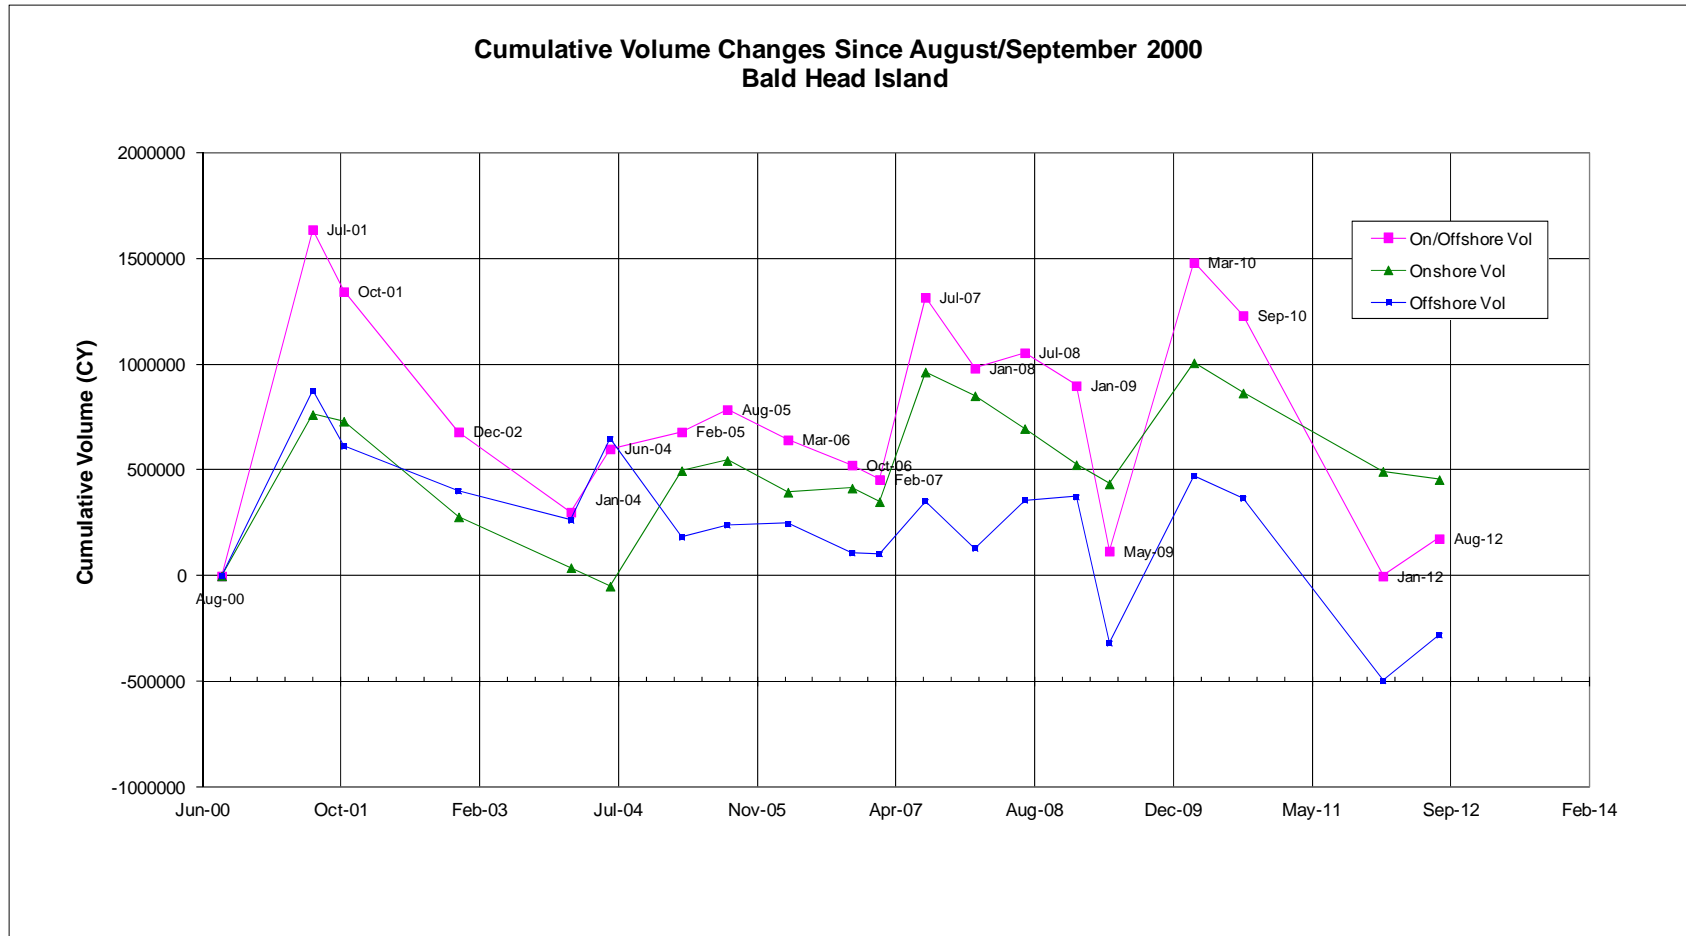
**Figure 3.13 Cumulative Volume Changes Since August/September 2000 for Bald Head Island**

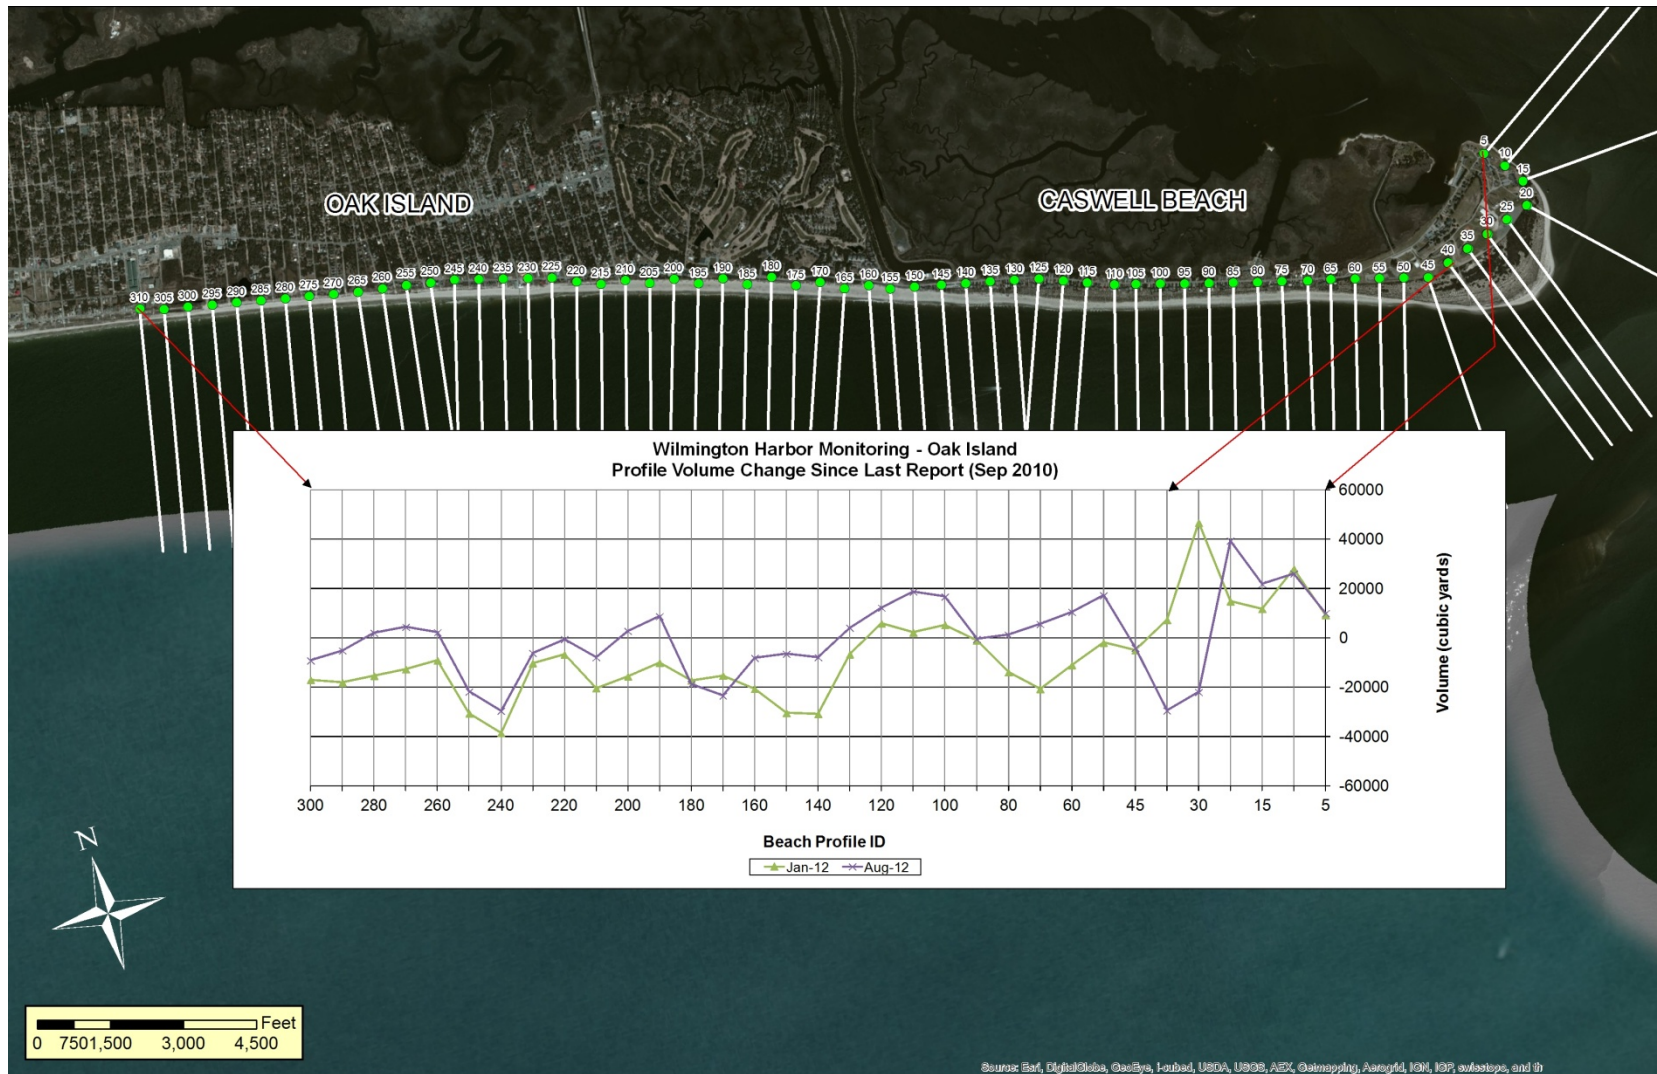
**Figure 3.19 Wilmington Harbor Monitoring - Oak Island Beach Profile Volume Change Since Last Report (September 2010)**

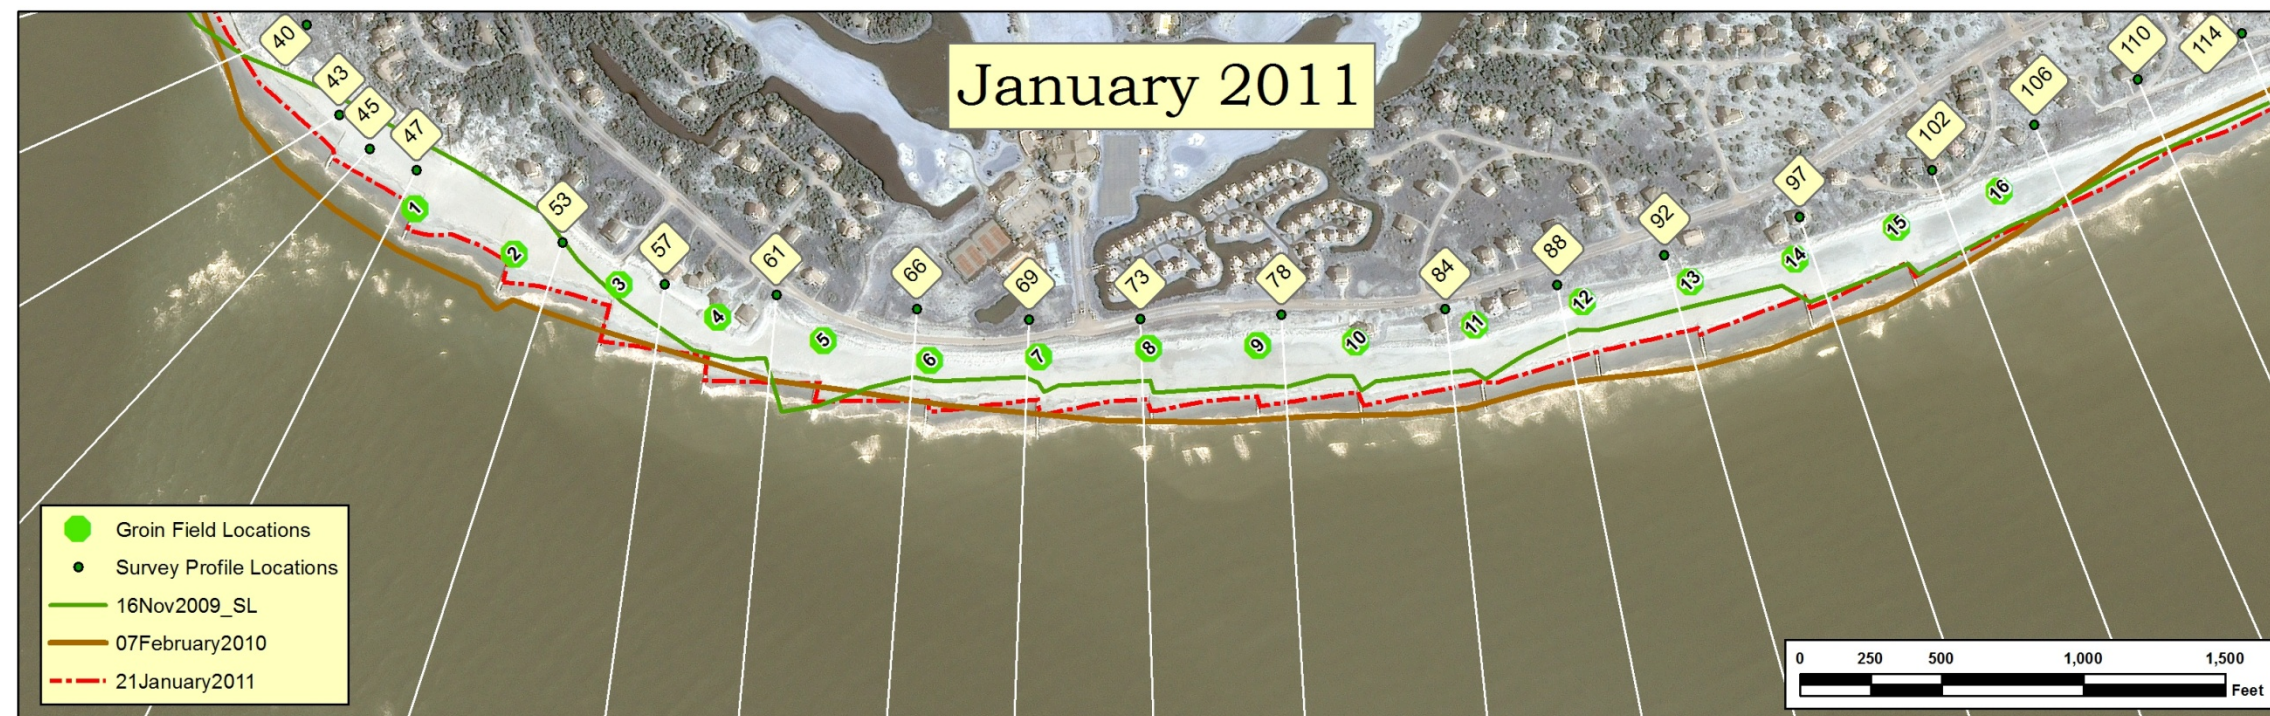
Figure 4.18 Evolution of Groin Field Shoreline (February 2010 and January 2011)

within this groin field combined with the westerly longshore transport within the area produced the saw tooth shoreline visible within the photograph. Figure 4.18(B) displays the shoreline conditions as of September 2011 and June 2012. Shoreline recession measured in September 2011 was observed throughout the groin field area with the majority of the shoreline having retreated back to the pre-project conditions of November 2009. The exception to this was in the area of groins 1 and 2 where the groins remained intact and prevented the extreme erosion measured in November 2009. Even with these groins remaining functional, peak losses were measured near groin 1 of nearly 220 feet. The second image in Figure 4.18(B) shows the June 2012 shoreline. This image shows that the shoreline had recovered some from the extreme conditions observed in September and also shows that the groin field is continuing to function. Peak losses measured during June 2012 were located at groin two and measured to be approximately 150 feet, however the majority of the shoreline continued to be seaward of the pre-project shoreline conditions.

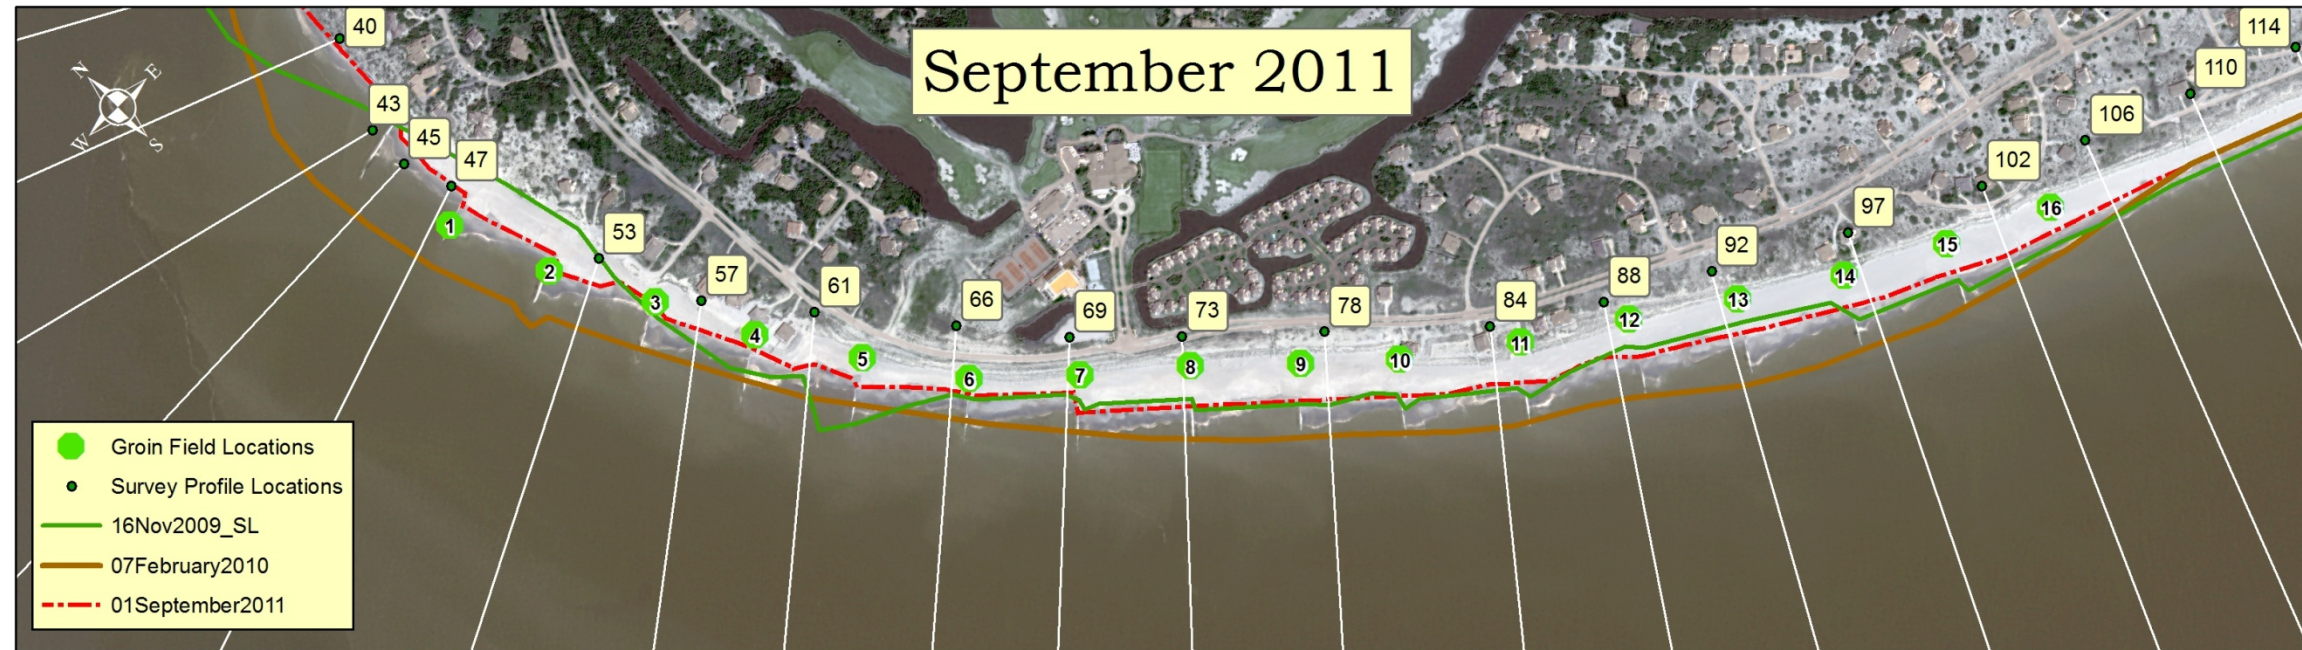
Figure 4.18(B) Evolution of Groin Field Shoreline (September 2011 and June 2012)
