**US Army Corps  
of Engineers®**  
Wilmington District

# PHYSICAL MONITORING WILMINGTON HARBOR NAVIGATION PROJECT REPORT 2: June 2003 – June 2004

**PHYSICAL MONITORING  
WILMINGTON HARBOR NAVIGATION PROJECT  
REPORT 2:  
June 2003 – June 2004**

FEBRUARY 2005

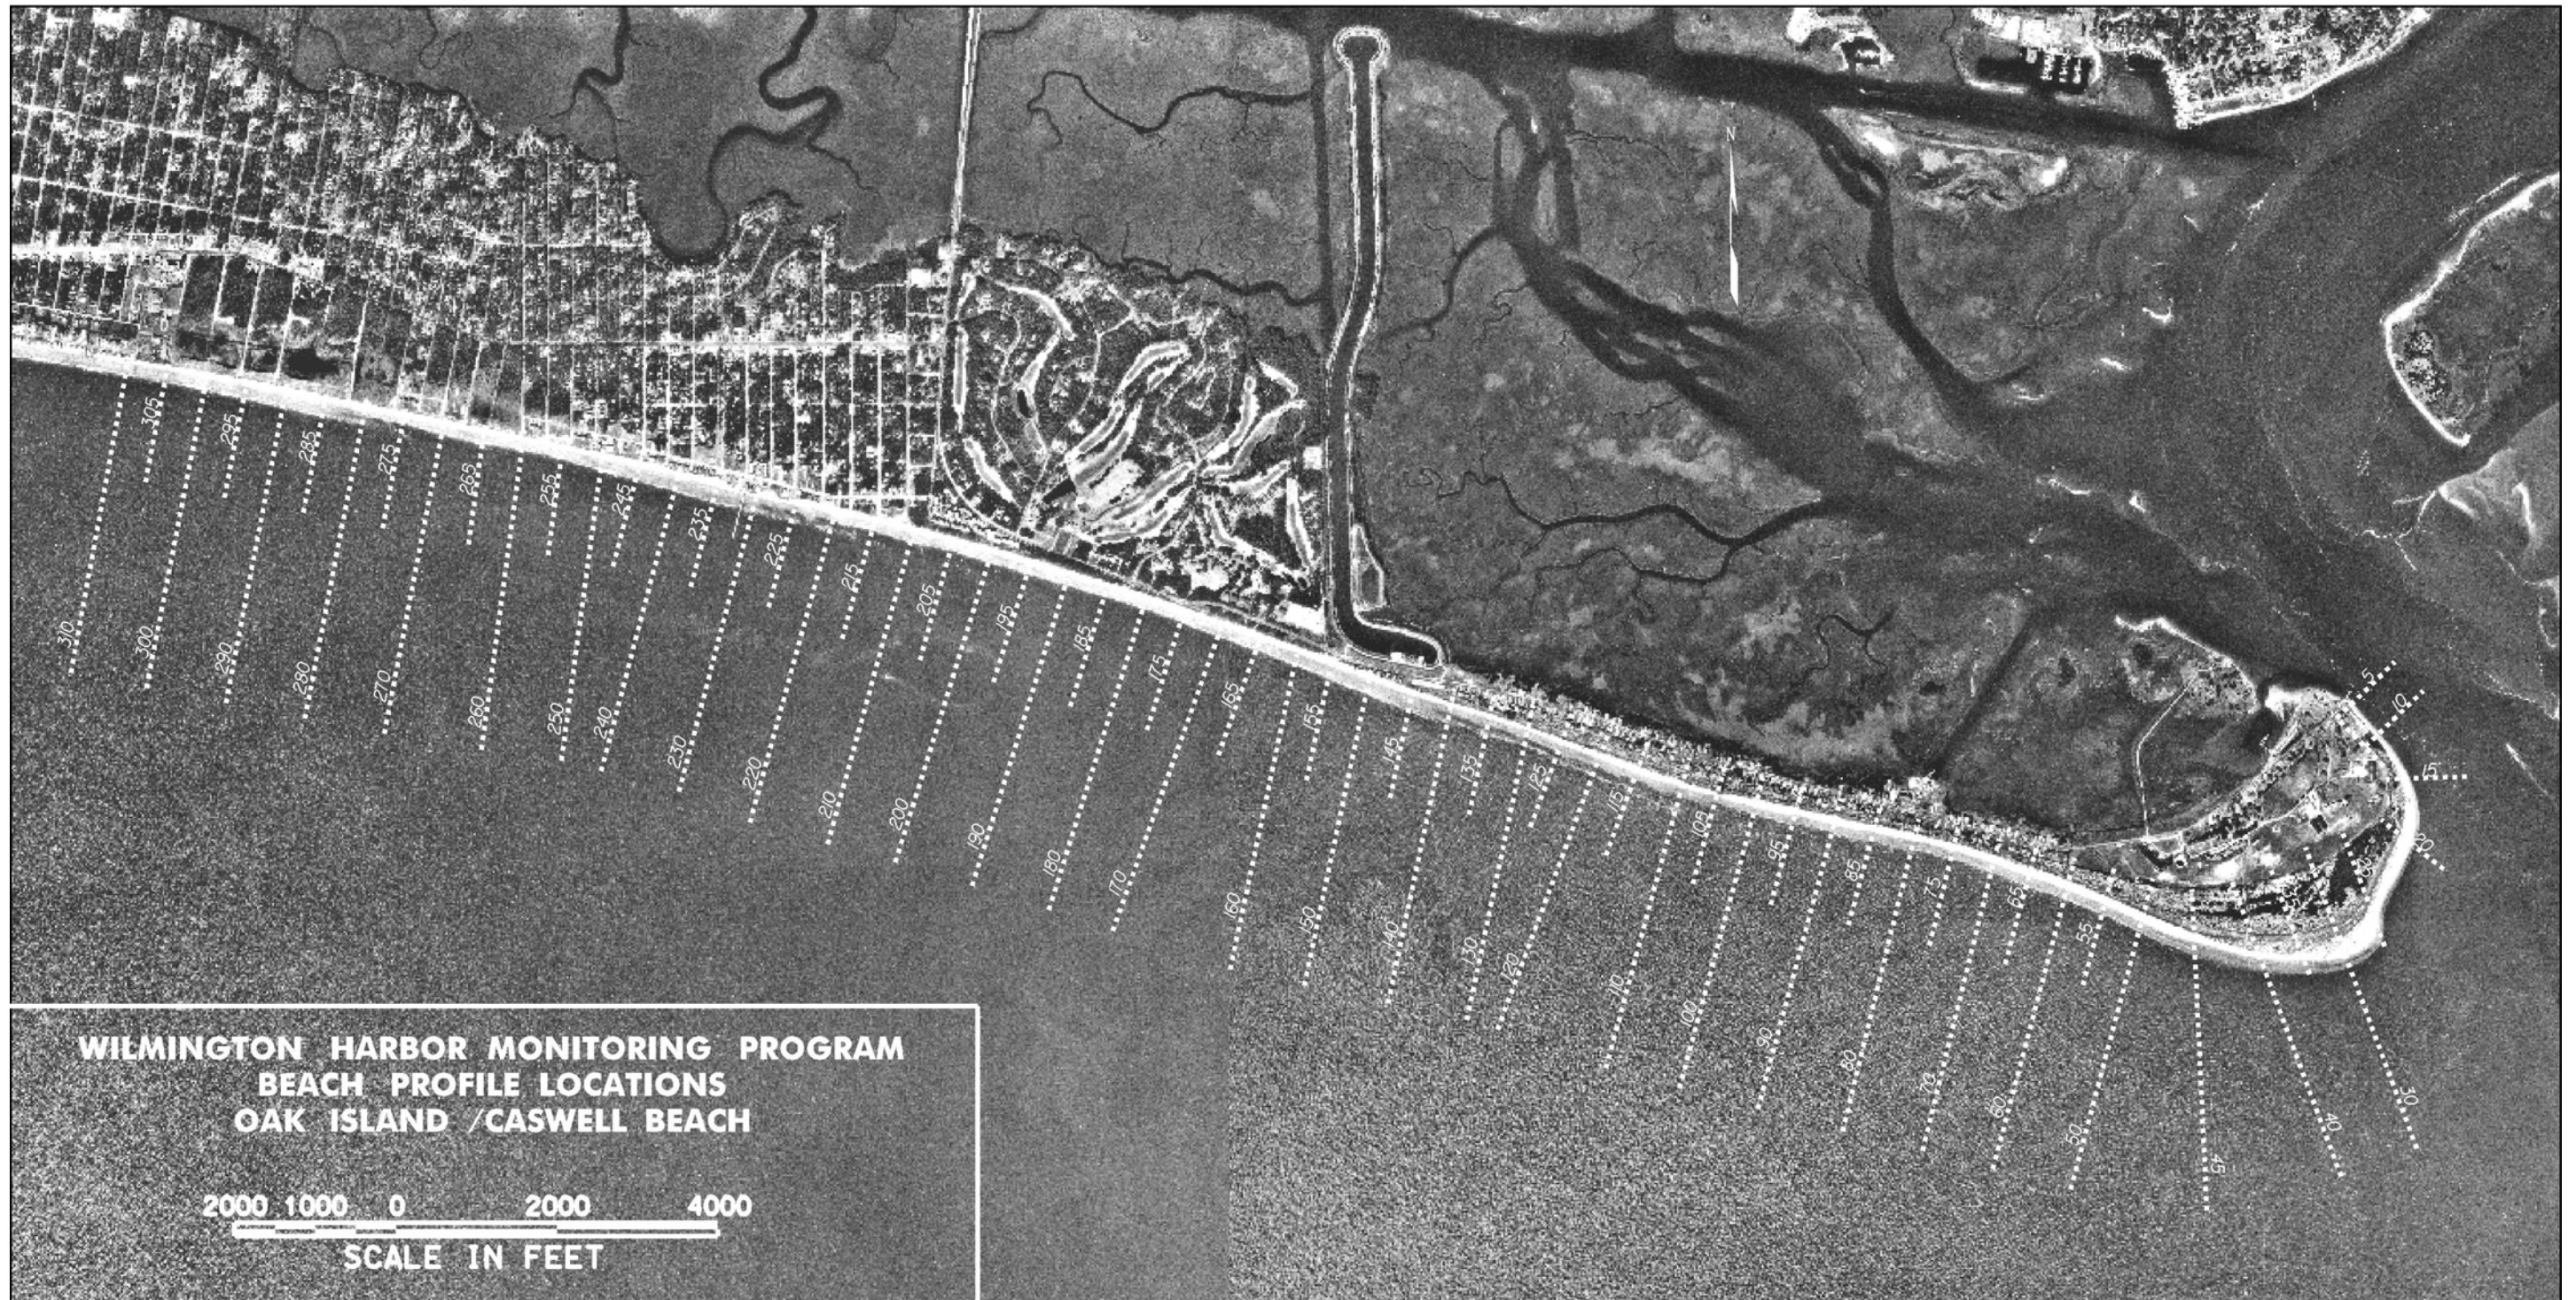
Figure 1.4 Oak Island/Caswell Beach Profile Locations

Beach Profile Surveys. The beach profile surveys serve as the backbone of the monitoring program and are taken along both Bald Head Island and Oak Island/ Caswell Beach. The beach surveys consist of specified transects, or profiles, taken generally perpendicular to the trend of the shoreline. For Bald Head Island, the beach profiles begin at the entrance to the Bald Head Island marina on West Beach, and extend all the way to Cape Point, located at the eastern end of South Beach as shown in Figure 1.3. The location of these profile stations were selected to coincide with existing beach profile stations currently being monitored by the Village of Bald Head Island, which are spaced at an interval of approximately 400 feet. The total shoreline distance covered along Bald Head Island is about 22,000 feet and includes a total of 58 beach profile stations. For the Oak Island/Caswell Beach portion, beach profile stations were established at approximately 500-foot intervals, beginning near the Cape Fear River Entrance and extending west along Caswell Beach/Oak Island, as shown in Figure 1.4. This coverage includes approximately 5,000 feet of shoreline fronting the North Carolina Baptist Assembly grounds at Fort Caswell (2,500 ft along the inlet shoulder and 2,500 ft along the ocean-front) plus 26,000 ft along Oak Island extending west of the Baptist Assembly property. The beach profile stations extend 1000 feet westward of the designated disposal limit on Oak Island and encompass a total shoreline length of 31,000 feet. A total of 62 profile lines comprise this shoreline reach. The profile locations follow along an existing baseline established by the Corps of Engineers that had designated profile stations at 1,000 foot intervals. The monitoring plan added intermediate lines at 500-feet and utilized the pre-existing 1,000 foot stations so that prior surveys could be incorporated into the program as necessary.

The beach profile surveys were analyzed using BMAP (Beach Morphology Analysis Program) to determine both shoreline and unit volume changes over time for each profile of interest. The beach profile locations were given previously in Figure 1.3 for Bald Head Island and Figure 1.4 for Oak Island. It is noted that the beach profile numbers are reflective of their location on the baseline. For example, the origin of beach profile 43 is located near station 43+00 on the Bald Head Island baseline. The shoreline is represented by the mean high water line which is 2.71 feet above the National Geodetic Vertical Datum (NGVD29) for the monitoring area.

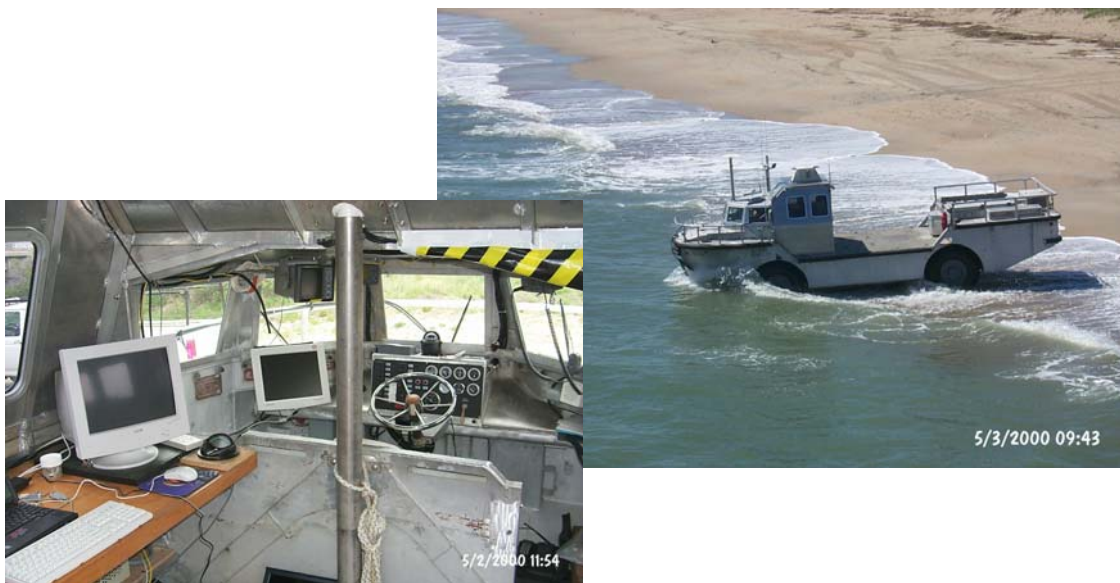
Figure 1.5 FRF Hydro-LARC Survey System

The most difficult areas to obtain accurate bathymetric surveys are through the surfzone and over the shoal areas that border each side of the Cape Fear entrance channel, and those near Frying Pan Shoals. Access to these locations is very difficult for conventional watercraft due to breaking waves and shallow depths. Under the present monitoring effort these access problems are largely eliminated through the use of the FRF's LARC survey system. The LARC (Lighter Amphibious Re-supply Cargo) vehicle, shown in Figure 1.5, is uniquely designed to transit through the water, across shoals, through the surf zone up to the base of the beach dunes. The LARC is equipped with a Trimble Real-Time Kinematic Global Positioning Satellite (RTK-GPS) survey system for accurate horizontal and vertical positioning of the vehicle and a Knudsen Echosounder to measure depth while traversing the profile lines.

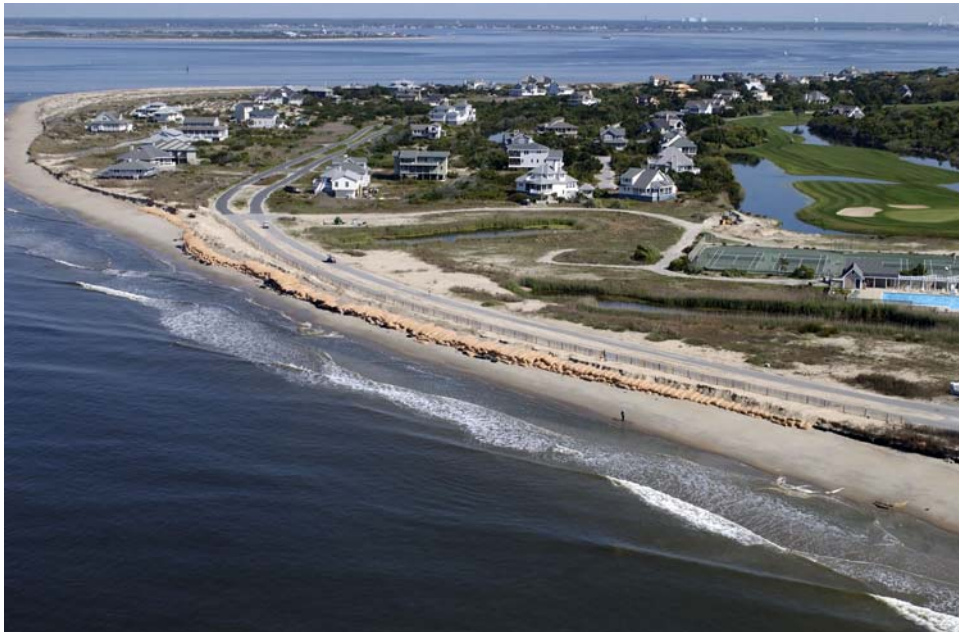
**Figure 2.3 Sand Bag Revetment along South Bald Head Wynd, April 2003.**

A permit to repair a 641-foot-long existing sand bag revetment was applied for in January 2003. The sand bag revetment, shown in Figure 2.3, is located along South Bald Head Wynd between stations 62+00 and 69+00. The existing structure was authorized under permits issued in 1994 and 1995.

The high-sustained erosion has prompted the Village of Bald Head to install sand bags to protect the beachfront road throughout the critically eroding reach. This installation is a rehabilitation of an earlier sand bag structure placed in the mid-1990's in response to erosion problems that have been prevalent over the last several decades in this area. Further, a geotextile groin field that was placed by the village in conjunction with the 1996 beach fill, but deteriorated within about four years, is also being replaced in an attempt to more effectively retain the beach within this problem area. The groin field is being rebuilt in conjunction with the present (2004-05) beach disposal/dredging operation. The combination of beach fill and geo-tube groins is expected to moderate the relatively high erosion experienced along the western portion of South Beach.

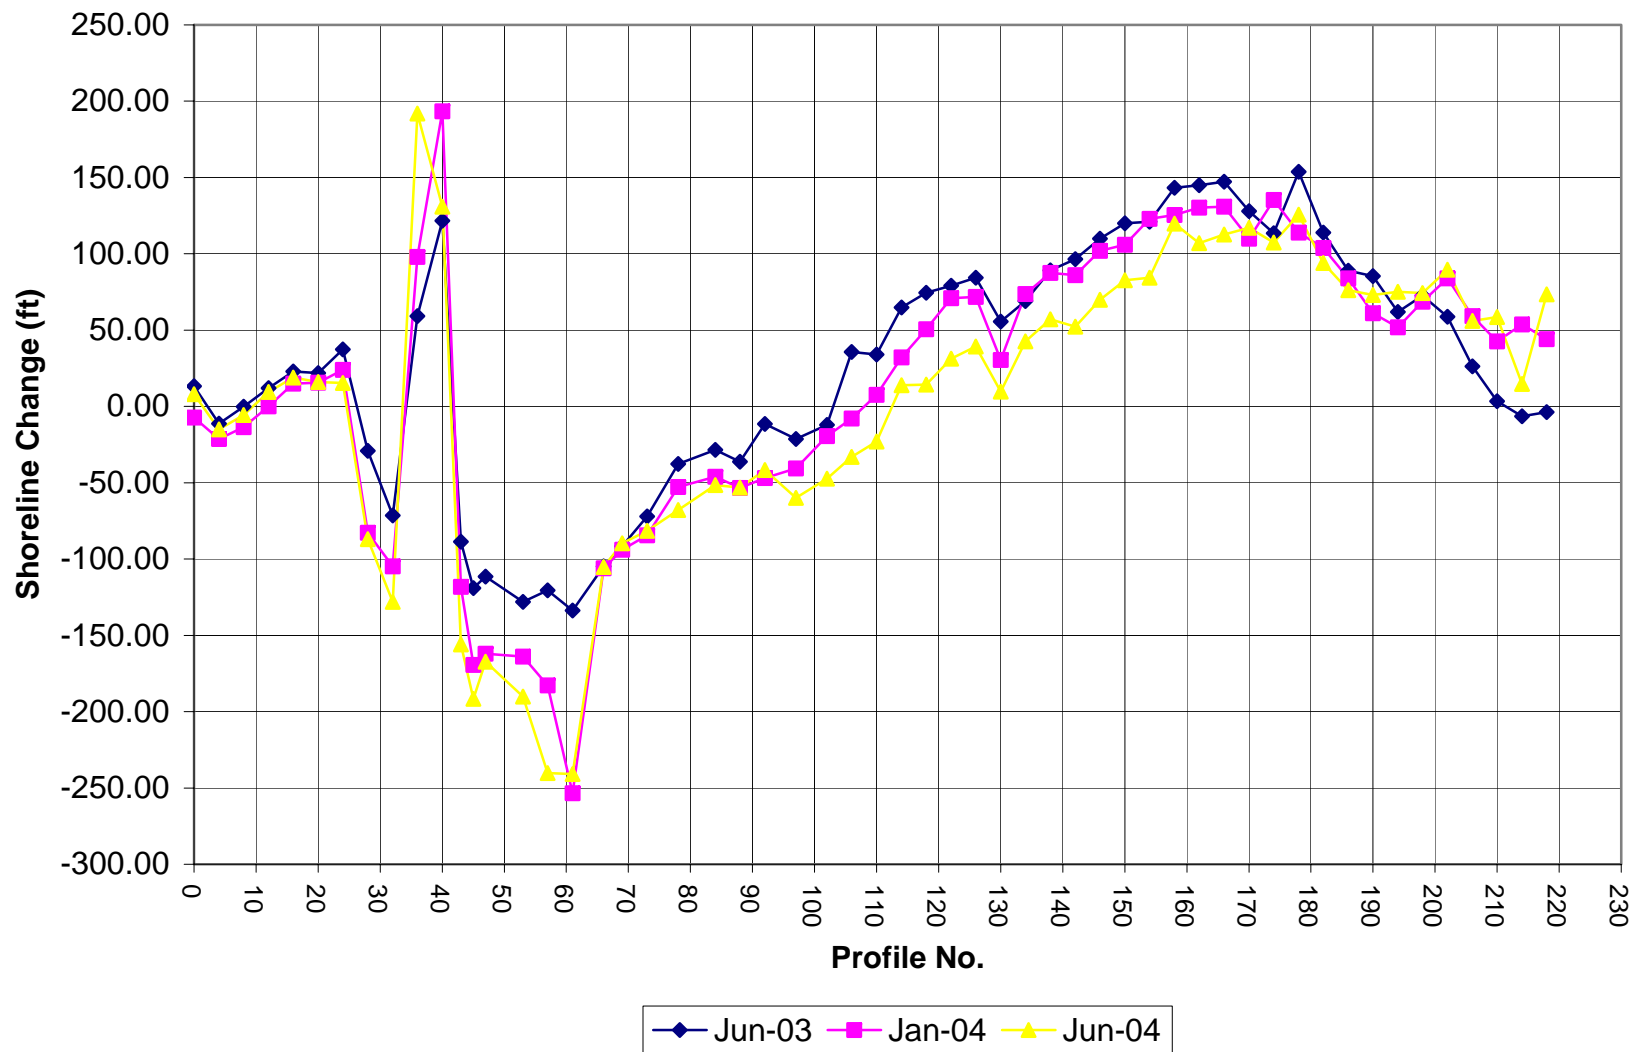
Figure 3.2 Shoreline Change Since Start of Monitoring (Sep 2000) Bald Head Island

A similar pattern of shoreline change is shown in Figure 3.2 as measured over the last 4-year period since the monitoring was initiated. This figure likewise reveals a spit growth area with an adjacent erosion zone to its east, plus an extended area of accretion along the eastern portions of the island. Although the pattern is similar, the relative magnitudes of the shoreline changes are greater when considering the entire monitoring period. For example, the spit growth area is found to extend nearly 200 feet beyond its September 2000 position. Similarly, the shoreline recessions along the eroding portions of western South Beach reach a maximum of -250 feet and this eroded reach extends for about 7,000 linear feet (Profile 43 to Profile 110). These values of shoreline change indicate that the erosion has been severe in this area where the shoreline position is on the average 108 feet landward on its pre-project location. In contrast, beginning at about Profile 110, the shoreline response has been positive with accretion prevalent over the remaining eastern 11,000-feet of South Beach. The average alongshore position of the present shoreline is 69 feet seaward of its September 2000 location. With respect to the entire monitoring area (Profiles 00 to Profile 218), the shoreline is presently on the average 3.4 feet more seaward than it was in 2000.

A similar pattern of shoreline change was measured along Bald Head Island over last 4-year period since the monitoring was initiated. This pattern includes the spit growth area with an adjacent erosion zone to its east, plus an extended area of accretion along the eastern portions of the island. Although the pattern is similar, the relative magnitudes of the shoreline changes are greater when considering the entire monitoring period. Specifically, the spit growth area is found to extend nearly 200 feet beyond its September 2000 position. Similarly, the shoreline recessions along the eroding portions of western South Beach reach a maximum of -250 feet and this eroded reach extends for about 7,000 linear feet (Profile 43 to Profile 110). These values of shoreline change indicate that the erosion has been severe in this area where the shoreline position is on the average 108 feet landward of its pre-project location. In contrast, beginning at about Profile 110, the shoreline response has been positive with accretion prevalent over the remaining eastern 11,000-feet of South Beach. Along this stable area, the average alongshore position of the present shoreline is 69 feet seaward of its

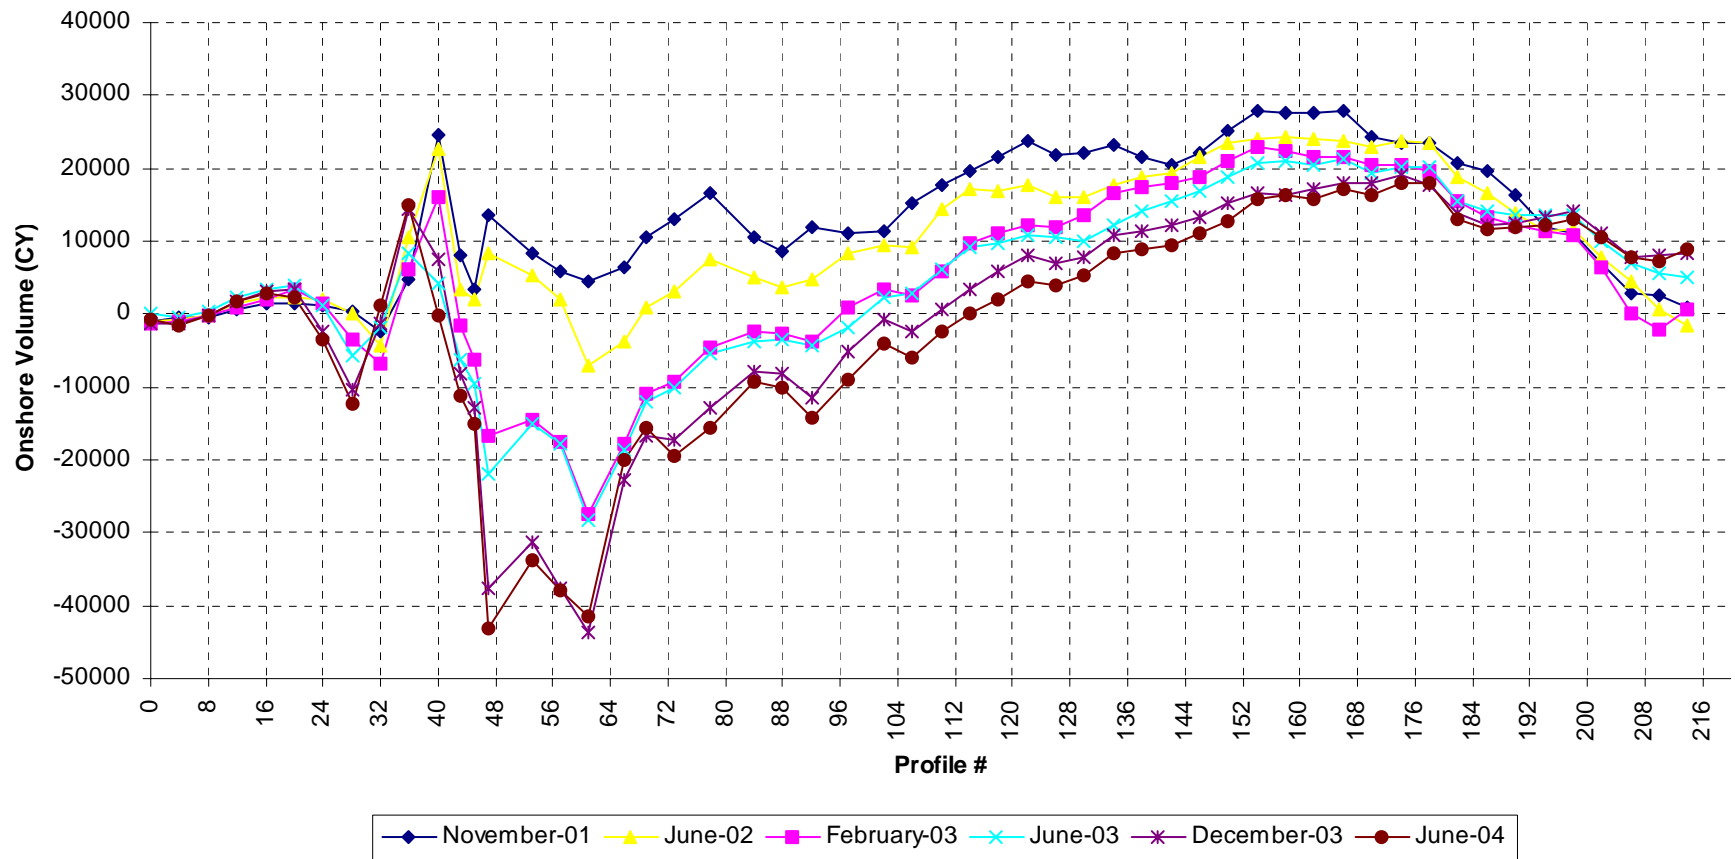
**Figure 3.12 Wilmington Harbor Monitoring – Bald Head Island Beach Profile Volume Change since Start of Monitoring (August/September 2000)**  
**Onshore Volumes above –2 ft NGVD**

The results of all onshore beach profiles surveys taken to date since the start of the monitoring in August/September 2000 are given in Figure 3.12. As noted above, this graph shows the volume changes relative to the start of the program in 2000. As with the prior

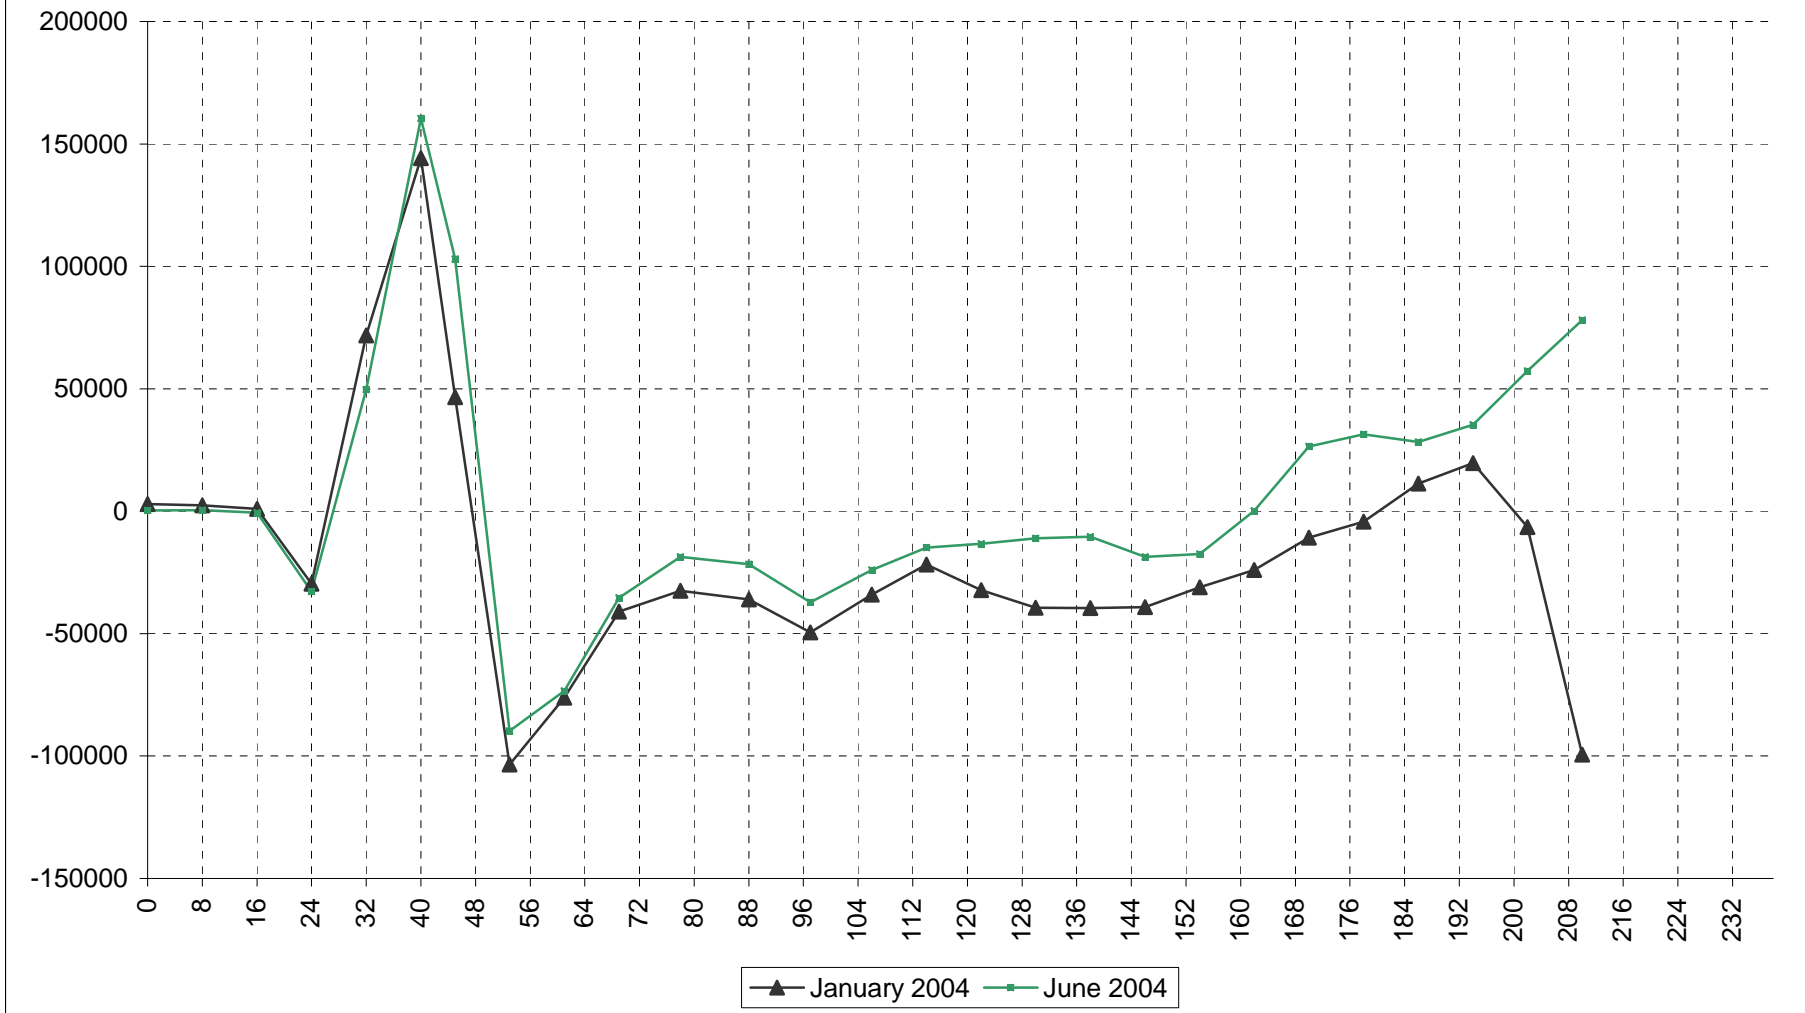
**Figure 3.14 Wilmington Harbor Monitoring – Bald Head Island Beach Profile Volume Changes Since Last Report (Dec 2002 )**

Figure 3.14 shows that between December 2002 and January 2004 most of Bald Head Island experienced a volume loss. The exceptions to the general loss were the continued growth of the spit between Profiles 32 and 45 and some volumetric gain near the eastern end of the island (Profiles 186 & 194). The volume loss was greatest in the previously noted erosion zone just east of the spit. Some relatively large losses were also measured at the last two profiles nearest to Cape Fear. With the most recent survey of June 2004, most of the profiles experienced some recovery. The gain in volume is most evident beginning at Profile 78 and progressing eastward. With this survey, profiles east of 162 and those of the spit area all show positive volume changes with respect to the December 2002 survey.

In terms of volumetric change from the last survey (December 2002) of Report 1 to June 2004, most of Bald Head Island experienced a loss. The exceptions to the general loss were the continued growth of the spit between Profiles 32 and 45 and some volumetric gain near the eastern end of the island (east of Profile 162). The volume loss was greatest in the previously noted erosion zone just east of the spit.

Total volumetric changes computed over the entire active profile are given in Figures 3.14 and 3.15 for Bald Head Island. Figure 3.14 shows volume changes relative to the latest survey contained in Report 1 (December 2002); whereas, Figure 3.15 gives changes relative to the August 2000 survey at the beginning of the monitoring. For each profile comparison, volumes were computed from a common stable landward point to an observed closure depth offshore.

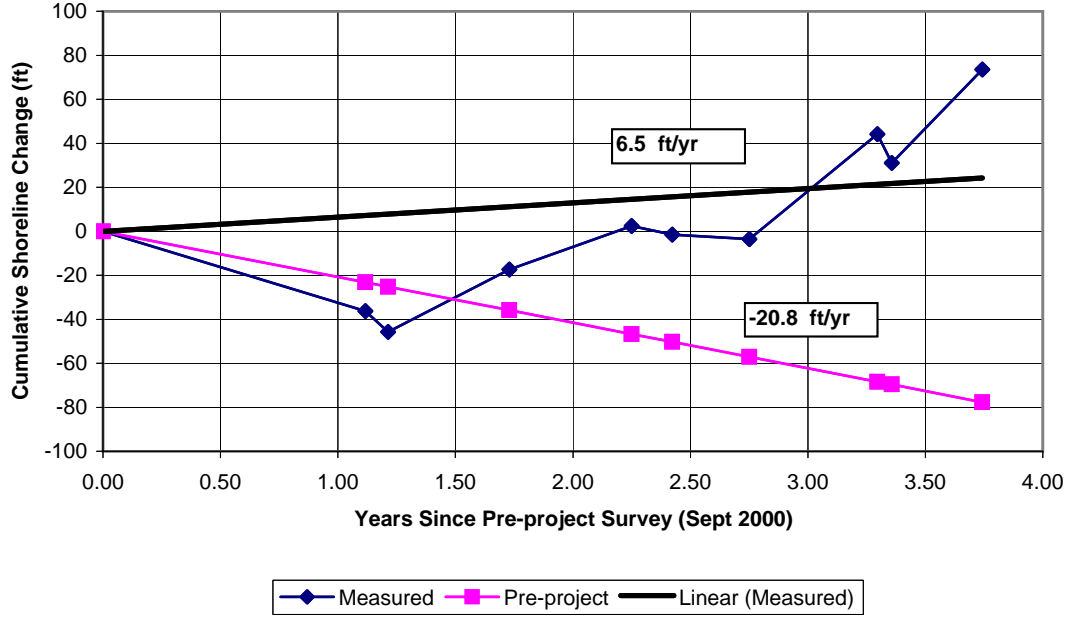
Wilmington Harbor Monitoring - Bald Head Island  
Measured vs. Pre-Project Shoreline Change Rates  
Profile 218
