**US Army Corps  
of Engineers®**  
Wilmington District

# PHYSICAL MONITORING WILMINGTON HARBOR NAVIGATION PROJECT REPORT 3: June 2004 – August 2005

**PHYSICAL MONITORING  
WILMINGTON HARBOR NAVIGATION PROJECT  
REPORT 3:  
June 2004 – August 2005**

## EXECUTIVE SUMMARY

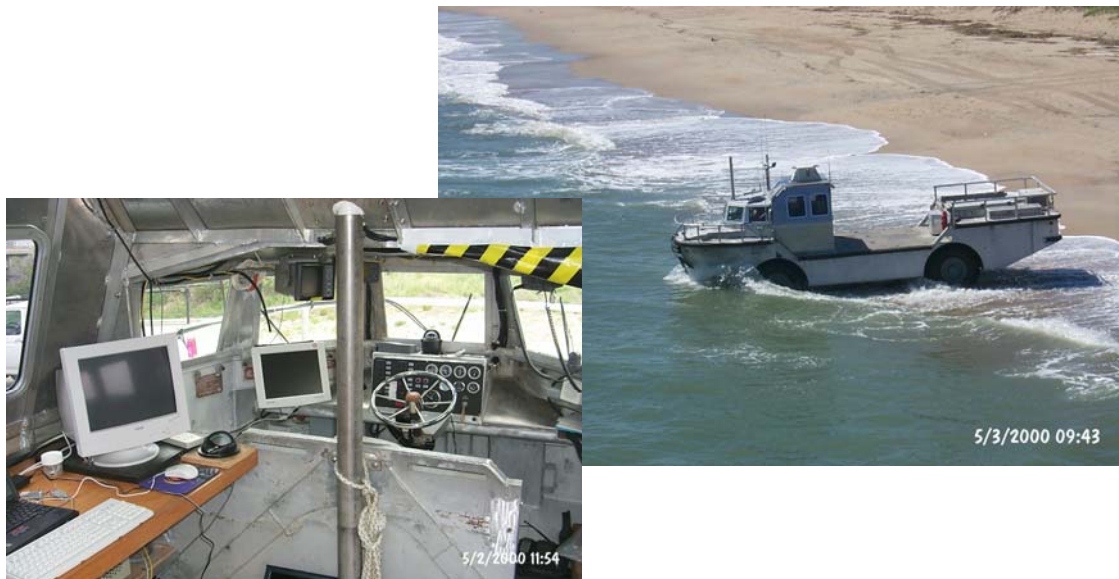
Figure 1.5 FRF Hydro-LARC Survey System

The most difficult areas to obtain accurate bathymetric surveys are through the surfzone and over the shoal areas that border each side of the Cape Fear entrance channel, and those near Frying Pan Shoals. Access to these locations is very difficult for conventional watercraft due to breaking waves and shallow depths. Under the present monitoring effort these access problems are largely eliminated through the use of the FRF's LARC survey system. The LARC (Lighter Amphibious Re-supply Cargo) vehicle, shown in Figure 1.5, is uniquely designed to transit through the water, across shoals, through the surf zone up to the base of the beach dunes. The LARC is equipped with a Trimble Real-Time Kinematic Global Positioning Satellite (RTK-GPS) survey system for accurate horizontal and vertical positioning of the vehicle and a Knudsen Echosounder to measure depth while traversing the profile lines.

Beach profile surveys are the primary data source and are collected along both Bald Head Island and Oak Island/Caswell Beach. The beach surveys consist of specified transects, or profiles, taken generally perpendicular to the trend of the shoreline. Bald Head Island profiles include 58 stations along about 22,000 feet of shoreline. Oak Island/Caswell Beach profiles include 62 stations along about 31,000 feet of shoreline. Beach profile surveys are taken semi-annually and are scheduled to coincide with the spring (April-May) and fall (October-November) seasons. Bathymetric surveys of these profiles from offshore through the surf zone and over the shoal areas that border each side of the Cape Fear entrance channel, and those near Frying Pan Shoals are collected annually with the Engineering Research and Development Center's LARC (Lighter Amphibious Re-supply Cargo) survey

system. The LARC vehicle transits through the water, across shoals, through the surf zone up to the base of the beach dunes.

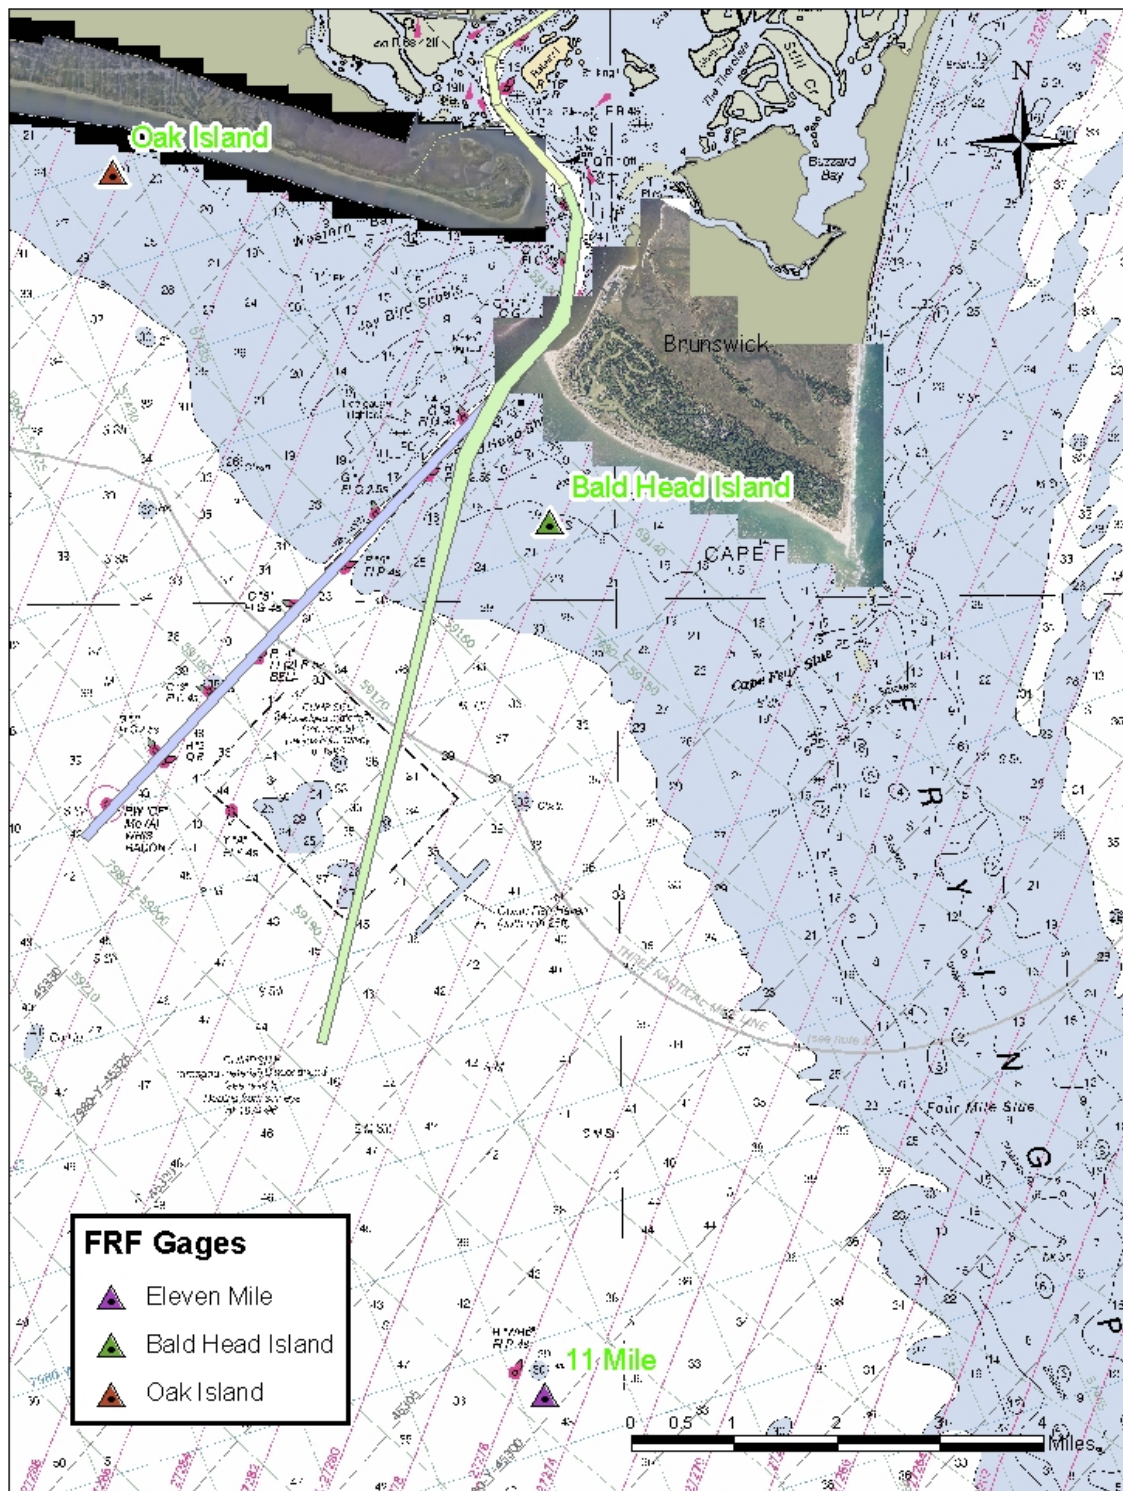
**Figure 1.7 Wave and Current Gauge Locations**

Wave data are collected by three bottom-mounted wave gauges consisting of an Acoustic Doppler Current Profiler (ADCP) meter and a pressure gauge. The gauges are located just offshore of Oak and Bald Head Islands plus in the offshore waters about 11 miles from the coast.

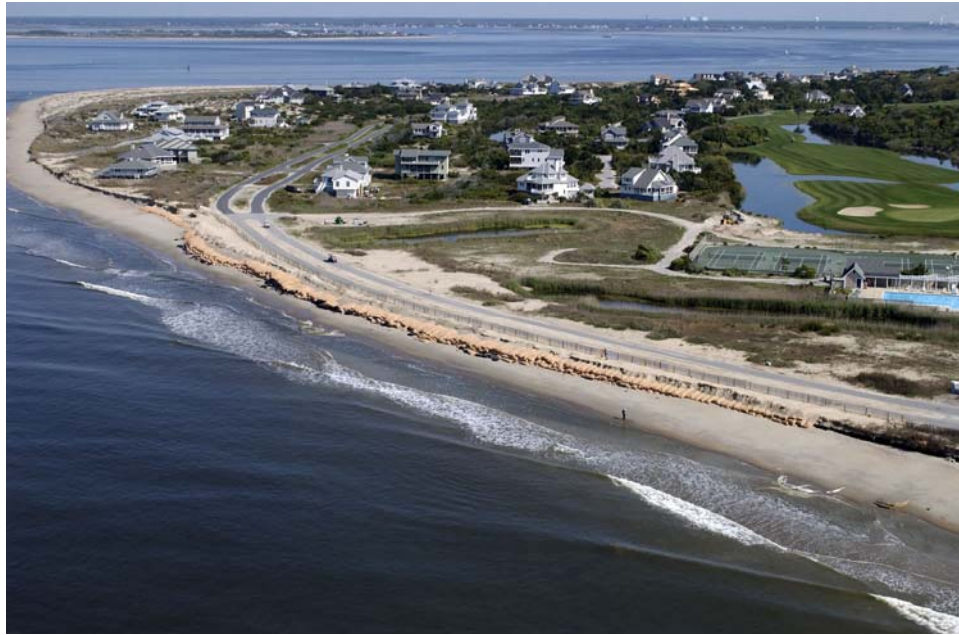
In 1994 a 645-foot-long sand bag revetment was placed along the badly eroding portion of western South Beach. In 2003-2004 the sand bag revetment was expanded by increasing the overall length by 200 feet, increasing the base width from 20 to 40 feet and increasing the crest elevation by 6 feet to +12 feet NGVD. A view of the expanded sand bags are shown in Figure 2.3, as it appeared in April 2003. With the latest beach disposal, this structure is for the most part covered by the new sediment.

**Figure 2.3 Sand Bag Revetment along South Bald Head Wynd, April 2003.**

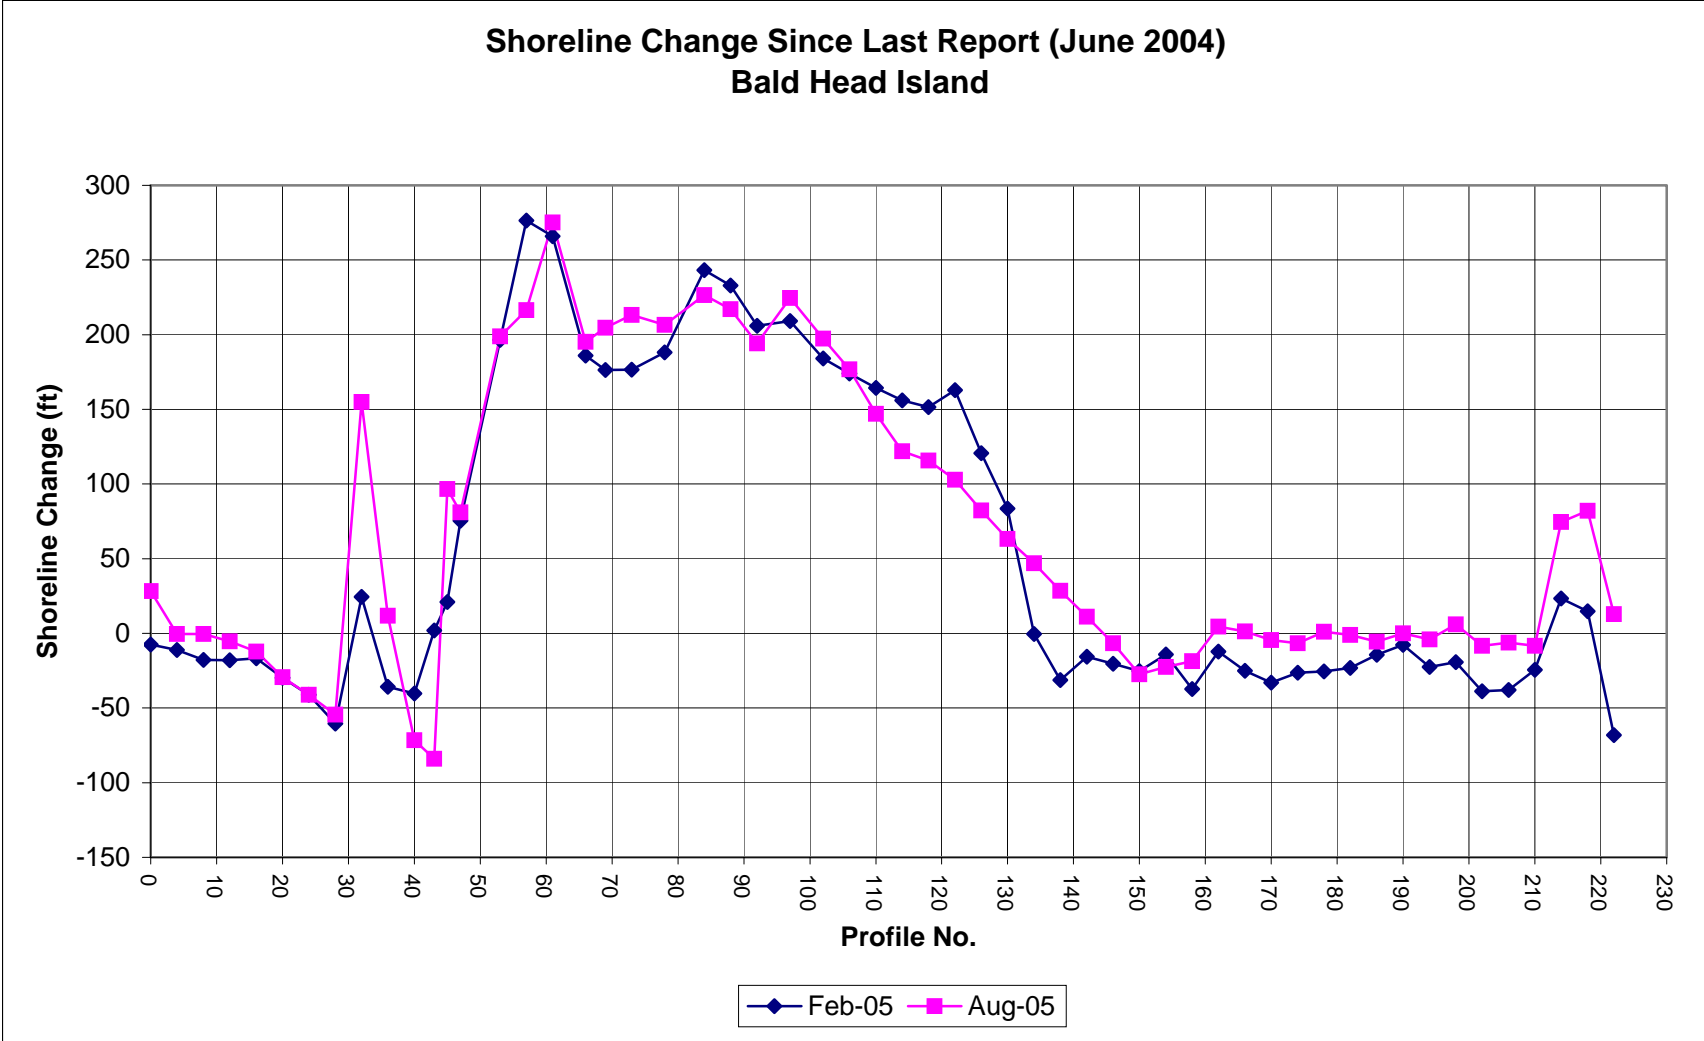
Figure 3.1 Shoreline Change Since Last Report (Jun 2004) Bald Head Island

As indicted in Figure 3.1, most of the profile locations along Bald Head Island have been accretionary or stable over the last year. The largest zone of accretion occurred between Profiles 46 and 142, reflecting the positive impact of the January 2005 beach fill. Over this 9,600 foot reach, the beach is up to 275 feet wider, with an alongshore average increase of 152 feet. Extending east of this fill area (between Profiles 146 and 220), the beach is found to be generally stable, with the shoreline being slightly seaward of its position a year ago, an average of 3 feet. In contrast to the stable nature found along South Beach, the area along West Beach and in the vicinity of the spit near the southwest corner of the island display eroded shorelines. For West Beach (Profiles 0 thru 28), the shoreline has receded an average of 14 feet since June 2004. For the vicinity of the spit (between Profiles 32 & 43), the shoreline has shown a large degree of variability, gaining as much as 155 feet and losing more than 80 feet. Overall, the alongshore average shoreline changes measured over the

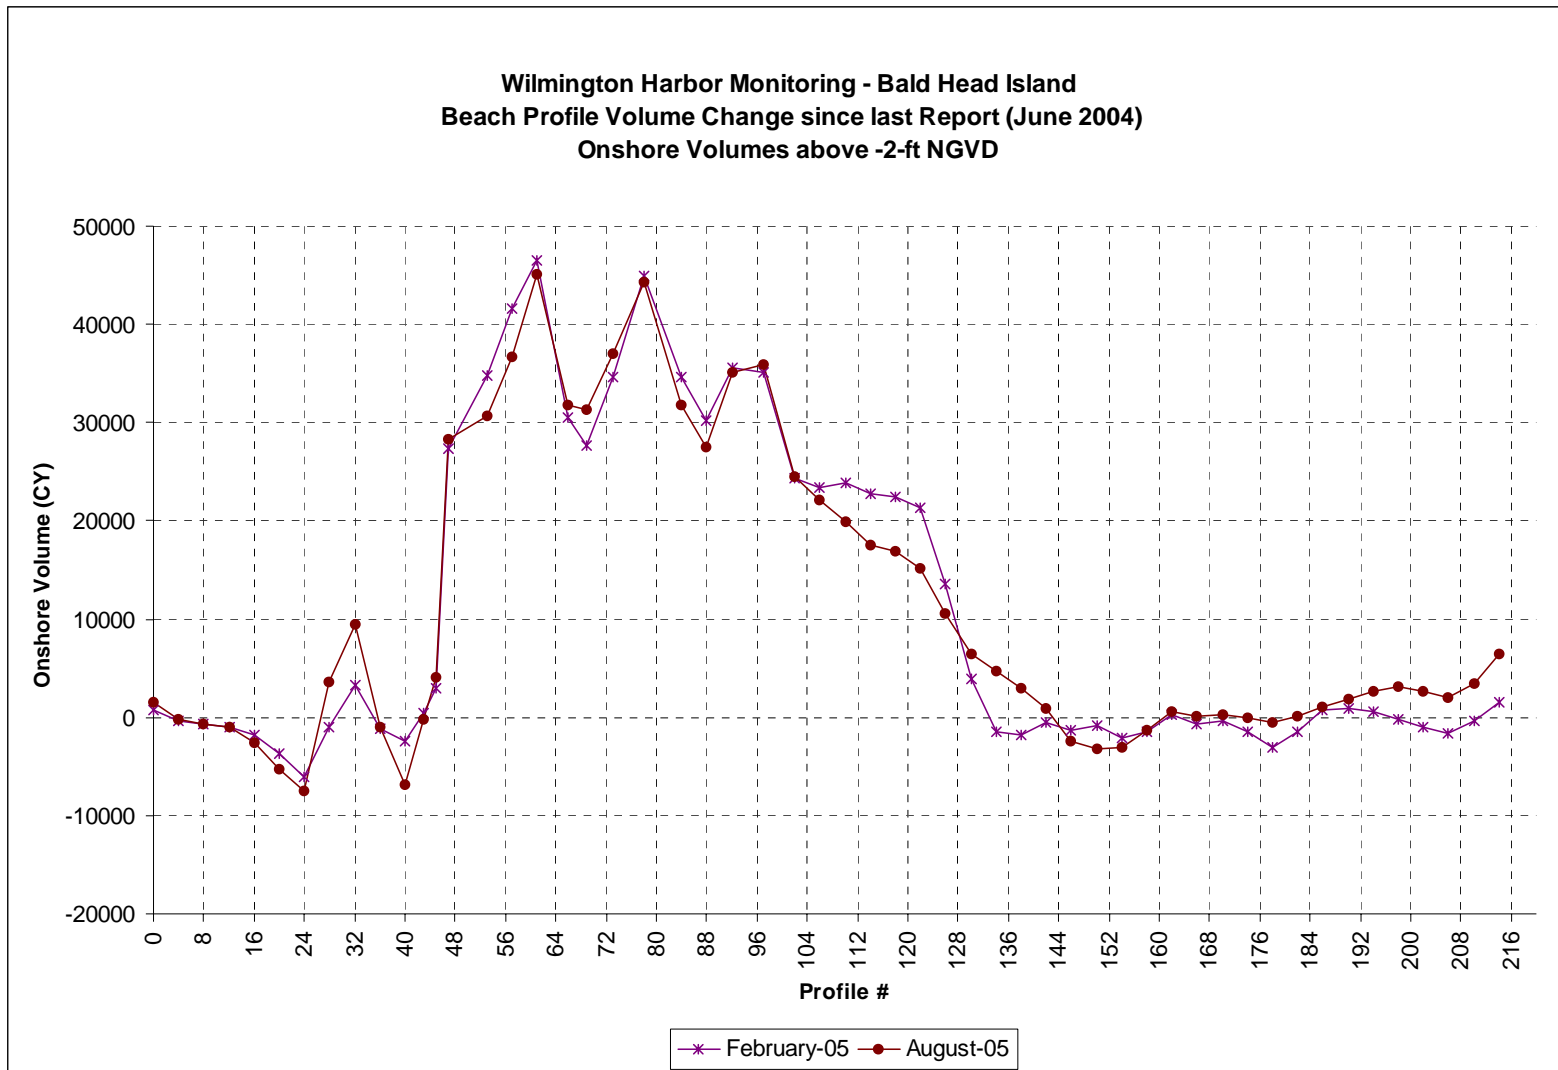
**Figure 3.11 Wilmington Harbor Monitoring – Bald Head Island Beach Profile Volume Change Since last Report (June 2004) Onshore Volumes above –2 ft NGVD**

The pattern of onshore volume changes shown in Figure 3.11 for Bald Head Island (since the last report) generally mimic those of the reported changes in the mean high water shoreline. In this regard, the volume changes show that most profile locations have either gained sediment or have been stable over the present reporting period. The largest increases are found between Profiles 47 and 130 resulting from the direct placement of the January 2005 fill. Within these limits about 549,000 cubic yards of material are present within the onshore portions of the beach. East of the fill area, extending to the end of south beach, relatively small changes are evident reflecting the overall stability of the upper portions of the beach over the current period. In contrast some minor volume losses are present along west beach and in the vicinity of the spit area. For west beach (Profiles 0-28), there is a trend of increased volume loss proceeding towards the spit, although these are relatively small compared to the other measured changes. Collectively, west beach onshore volume changes amount to loss of about 12,000 cubic yards by the end of the current period. Within the adjacent spit area (Profiles 32 thru 45) both volumetric increases and losses are found which is typical of this dynamic area. Overall, a slight net increase in onshore volume of 5,500 cubic yards is present over this area. In considering the total volume changes for all profiles over the current monitoring cycle, approximately 564,000 cubic yards were gained between June 2004 and August 2005.

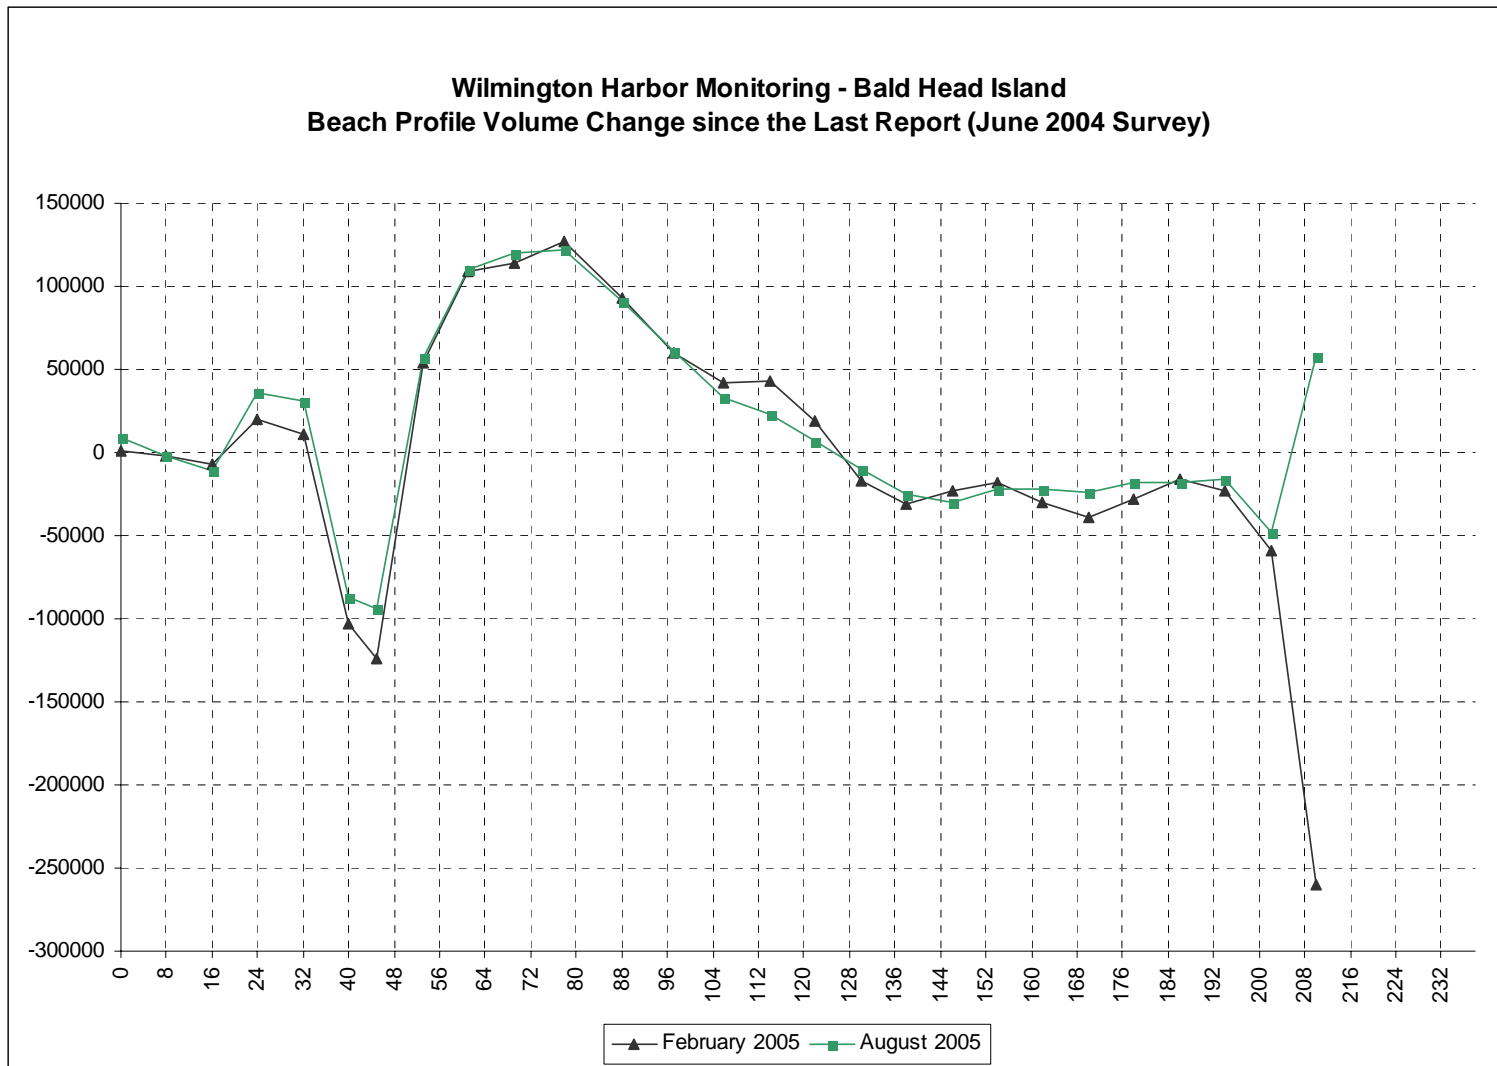
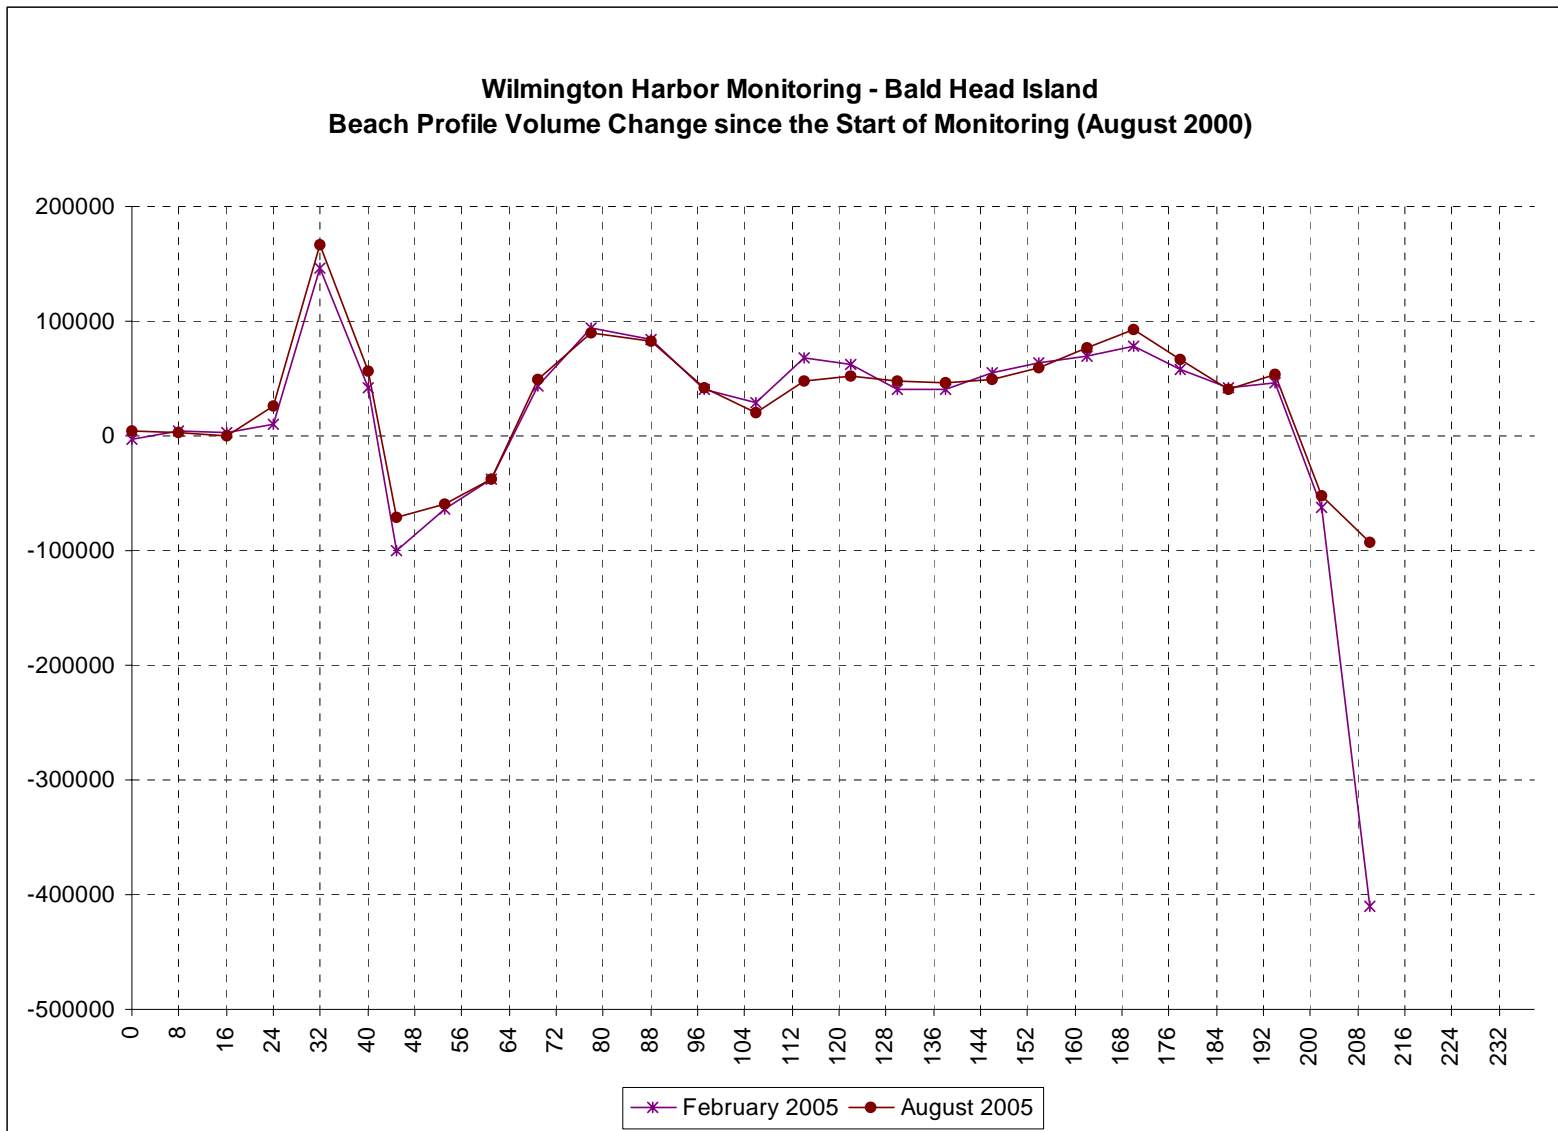
Total volumetric changes computed over the entire active profile are given in Figures 3.14 and 3.15 for Bald Head Island. Figure 3.14 shows volume changes relative to the latest survey contained in Report 2 (June 2004); whereas, Figure 3.15 gives changes relative to the August 2000 survey at the beginning of the monitoring. For each profile comparison, volumes were computed from a common stable landward point to an observed closure depth offshore.

Figure 3.14 Wilmington Harbor Monitoring – Bald Head Island Beach Profile Volume Changes Since Last Report (June 2004 Survey)

Figure 3.15 Wilmington Harbor Monitoring – Bald Head Island Beach Profile Volume Changes Since the Start of Monitoring (August 2000)

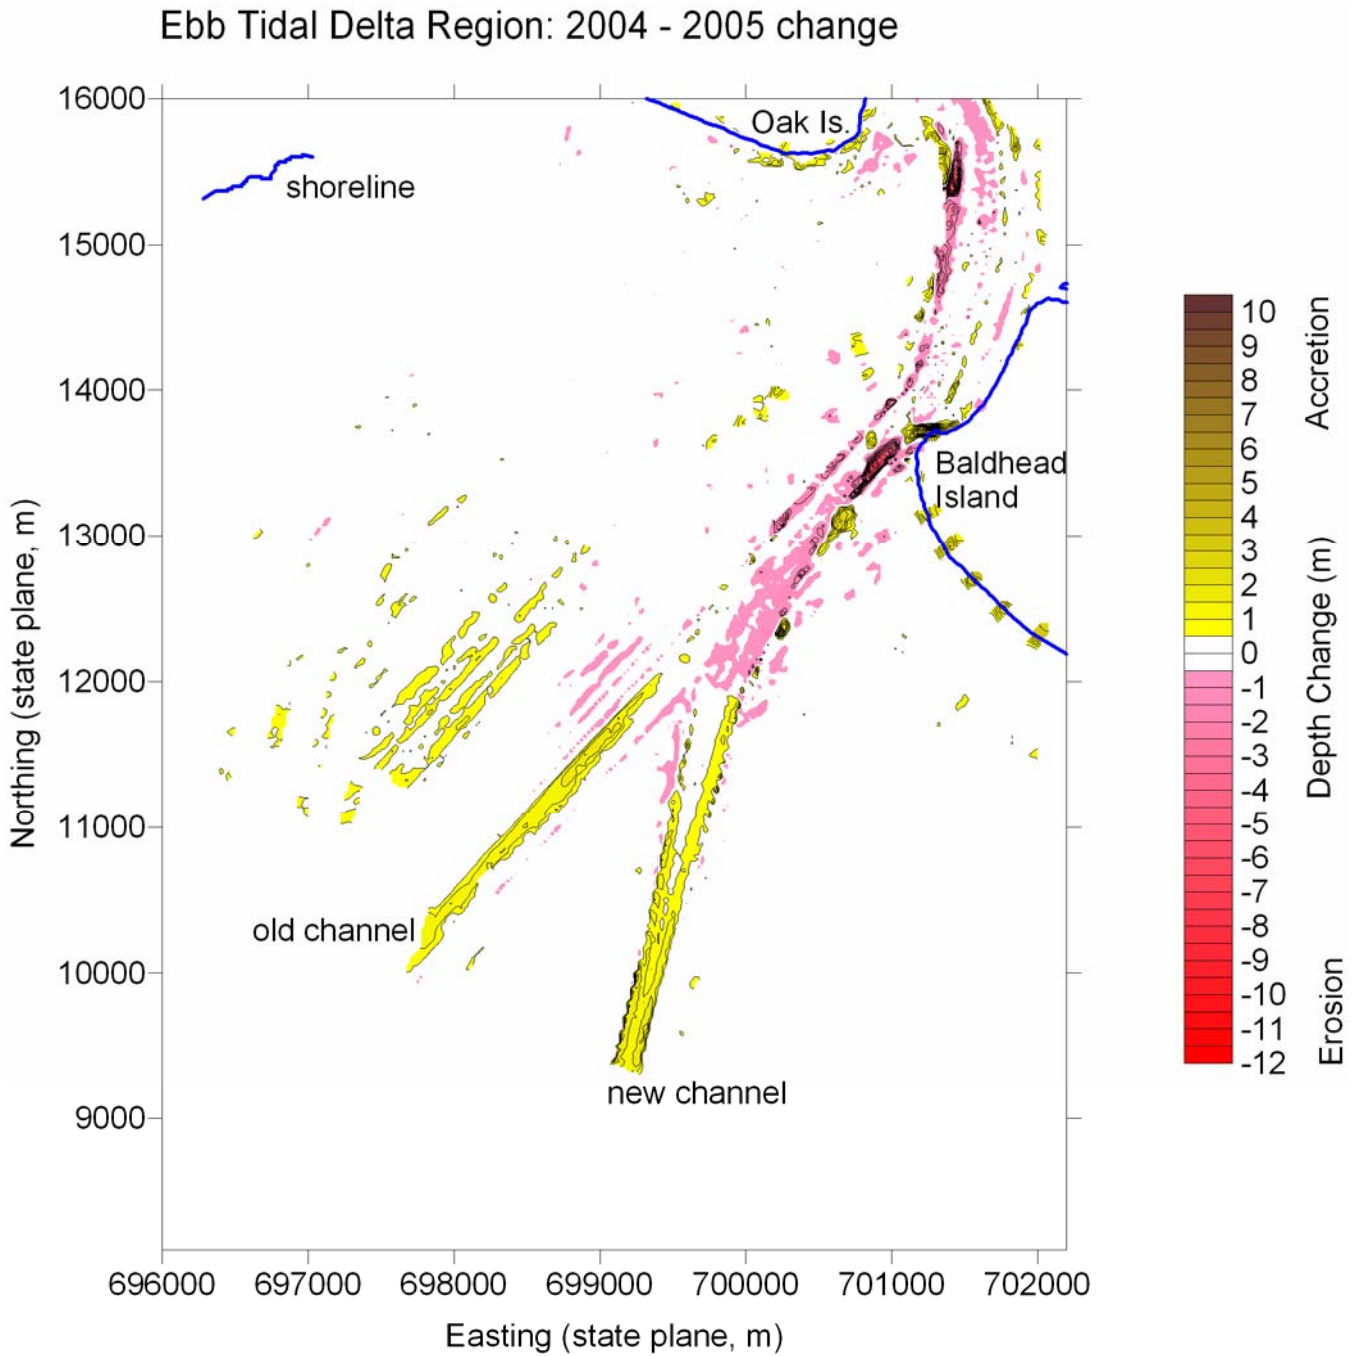
Figure 3.24 Bathymetric Changes of the Ebb Tidal Delta (January 2004 to March 2005)

Along the edge of Oak Island, shown in the upper portion of the figures, accretion is evident along the immediate shoreline. However an area of erosion is found just offshore within the developing flood margin channel fronting the tip of the island.

The major excavation of the realigned new channel is very prominent in the figure that was cut through relatively shallow portion of the ebb tidal to project depths of 42 feet (12.8 meters). The channel deepening is evident as well from the outer bar channel through the inlet between the two islands. The final most noteworthy change is the ribbon of accretion present along the west edge of Bald Head Shoal and along the immediate southwest tip of Bald Head Island. This ribbon of infilling also extends northward within in the inlet paralleling the eastern edge of the channel.

Further comparisons between surveys are made by generating maps showing changes in the bathymetry over time. Difference plots were made comparing the most recent survey of March 2005 with the prior survey of January 2004 as well as with the initial pre-project survey of August 2000. Figure 3.24 shows the bathymetric changes for the most recent period between January 2004 and March 2005. Detailed insets of these

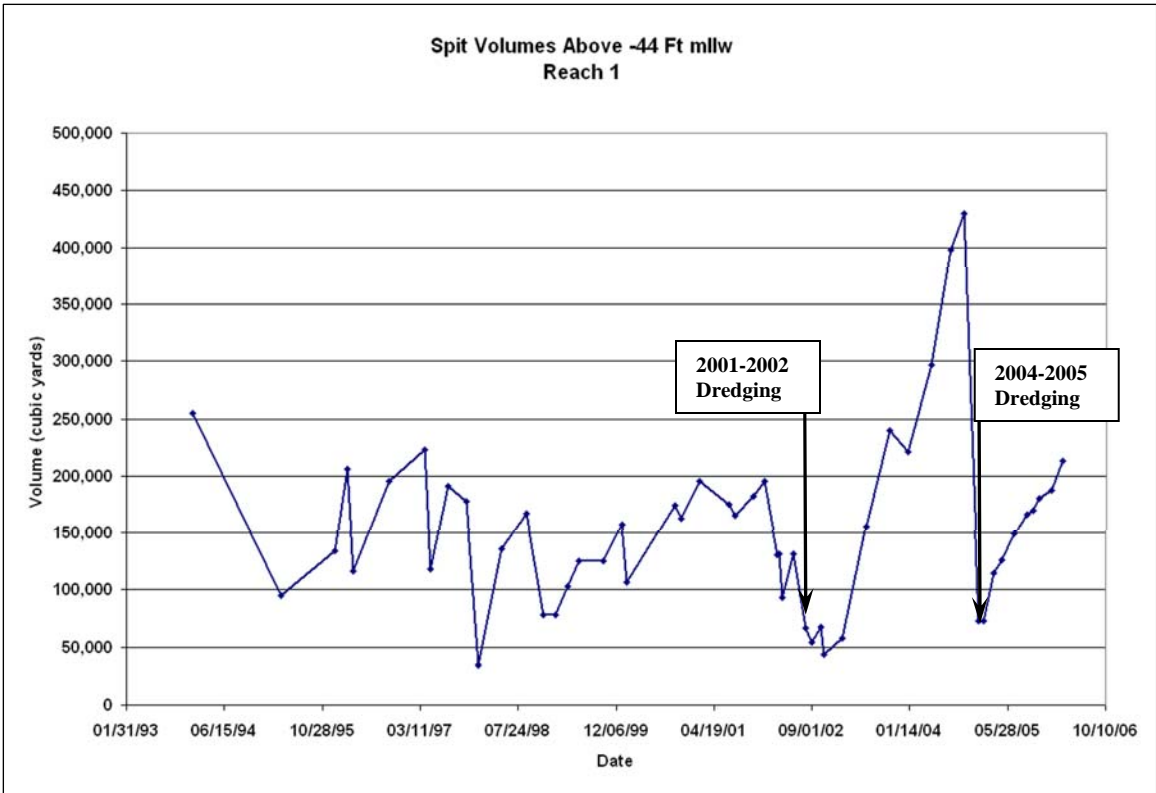
Figure 4.12. Baldhead Shoal Channel 1 spit volumes

The navigation channel surveys have shown the area of the spit to have enlarged volumetrically to at least twice as large as previously observed following the 1.8 million cubic yard fill placement in 2001-02. The same area of growth was monitored following the dredging and placement of 1.2 million cubic yards in 2004-05. The comparison showed that to date the rate of growth was slower following the second event. Specifically, the initial rate was about 16,000 cubic yards per month versus the second rate of about 10,000 cubic yards per month, i.e., a 38 % reduction. Among the possible explanations for this slower spit growth rate are: (1) sand tube groin field constructed immediately after the 2004/2005 placement has been effective in retaining the fill, (2) smaller volume of material placed in the 2004/2005 placement dispersed from the island at a slower rate, (3) different location of placement with the second fill being farther away from the channel, and/or (4) possible dissimilar wave and current conditions for each period of record.

Spit volumes were calculated within the bounding polygons shown in Figure 4.11. The change in spit volumes above -44 ft MLLW for Baldhead Shoal Reach 1 is shown in Figure 4.12 with the two dredging/placement events noted. Figure 4.13 shows a comparison of the two post-placement responses from Figure 4.12. Note the difference in slope between the two post-placements. These slope differences indicate a different rate of spit volume growth, with a slower growth rate after the 2004/2005 placement identified by the flatter slope. Specifically, the initial rate was about 16,000 cubic yards per month versus the second rate of about 10,000 cubic yards per month, i.e., a 38 % reduction in the shoaling rate. Among the possible explanations for this slower spit growth rate are: (1) sand tube groin field constructed immediately after the 2004/2005 placement has been effective in retaining the fill, (2) smaller volume of material placed in the 2004/2005 placement dispersed from the island at a slower rate, (3) different location of placement with the second fill being farther away from the channel, and/or (4) possible dissimilar wave and current conditions for each period of record.

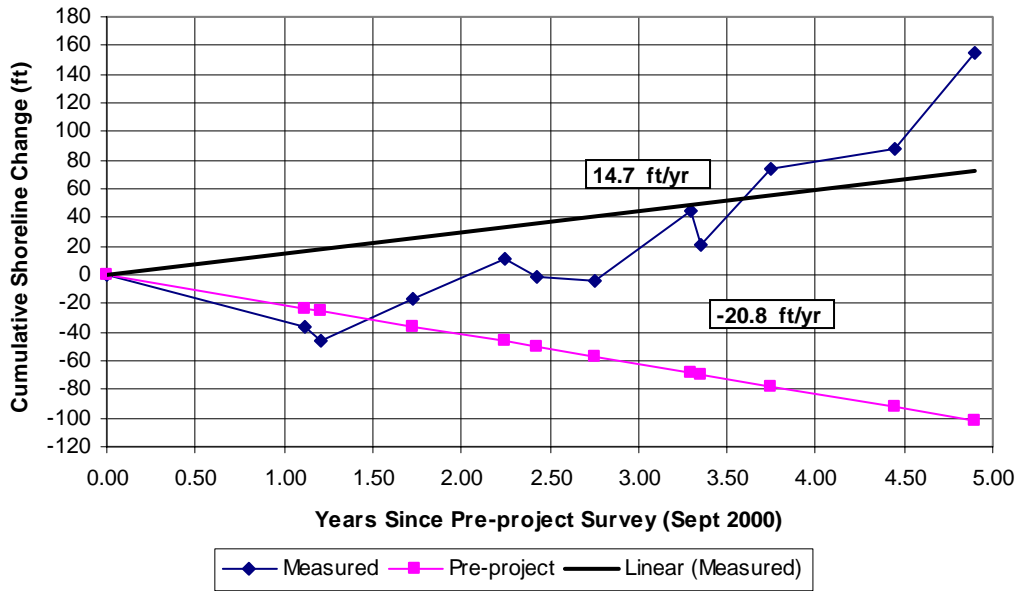
**Wilmington Harbor Monitoring - Bald Head Island  
 Measured vs. Pre-Project Shoreline Change Rates  
 Profile 218**
