**US Army Corps  
of Engineers®**  
Wilmington District

**PHYSICAL MONITORING  
WILMINGTON HARBOR NAVIGATION  
PROJECT  
REPORT 4:  
September 2005 – October 2006**

MAY 2007

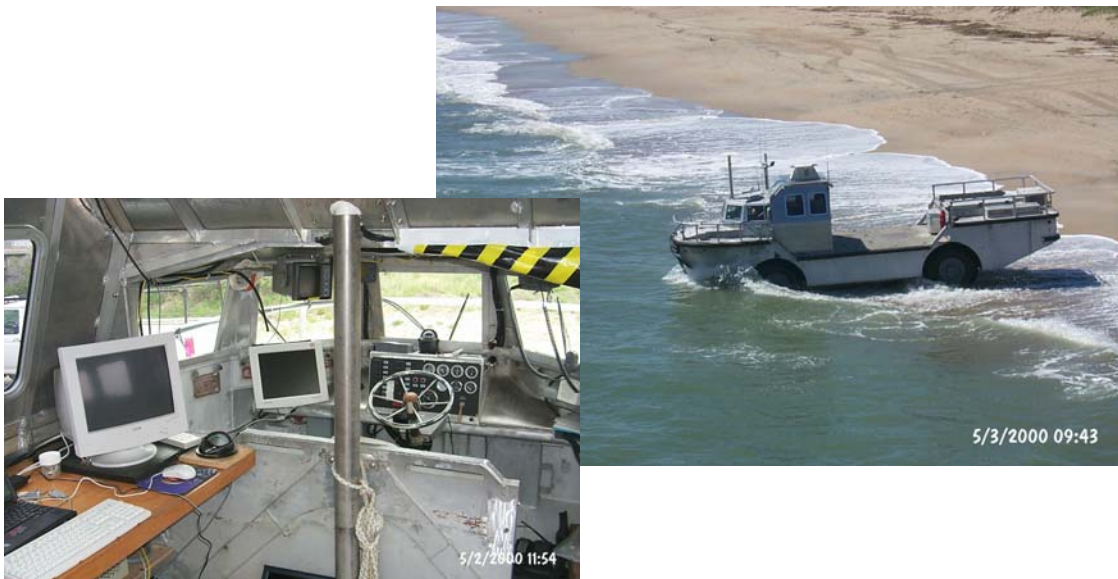
**Figure 1.5 FRF Hydro-LARC Survey System**

The most difficult areas to obtain accurate bathymetric surveys are through the surfzone and over the shoal areas that border each side of the Cape Fear entrance channel, and those near Frying Pan Shoals. Access to these locations is very difficult for conventional watercraft due to breaking waves and shallow depths. Under the present monitoring effort these access problems are largely eliminated through the use of the FRF's Lighter Amphibious Re-supply Cargo (LARC) survey system. The LARC vehicle, shown in Figure 1.5, is uniquely designed to transit through the water, across shoals, and through the surf zone up to the base of the beach dunes. The LARC is equipped with a Trimble Real-Time Kinematic Global Positioning Satellite (RTK-GPS) survey system for accurate horizontal and vertical positioning of the vehicle and a Knudsen Echosounder to measure depth while traversing the profile lines.

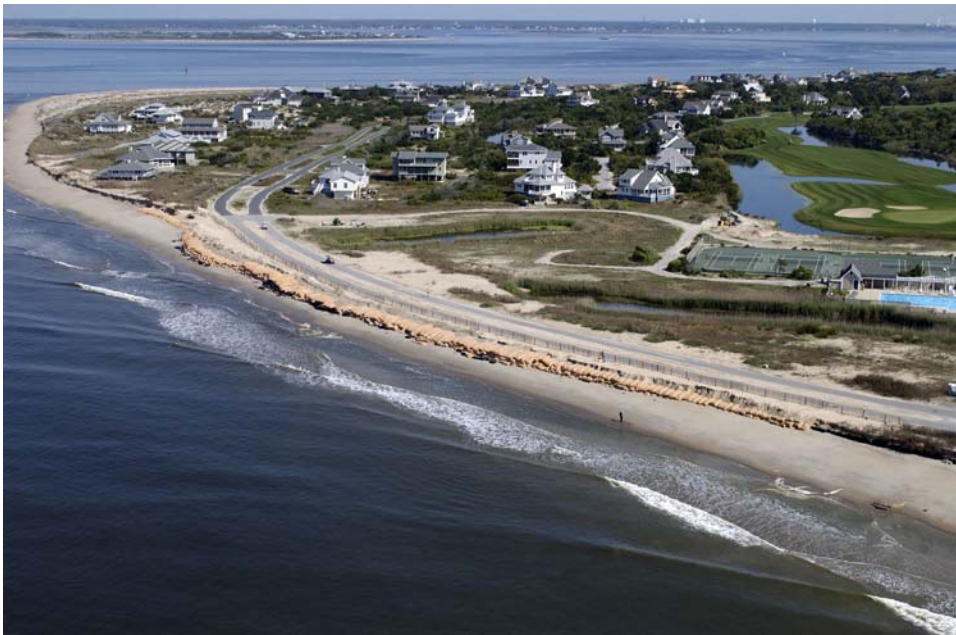
**Figure 2.3 Sand Bag Revetment along South Bald Head Wynd, April 2003.**

In 1994 a 645-foot-long sand bag revetment was placed along the badly eroding portion of western South Beach. In 2003-2004 the sand bag revetment was expanded by increasing the overall length by 200 feet, increasing the base width from 20 to 40 feet and increasing the crest elevation by 6 feet to +12 feet NGVD. A view of the expanded sand bags are shown in Figure 2.3, as it appeared in April 2003. With the latest beach disposal, this structure is for the most part covered by the new sediment.

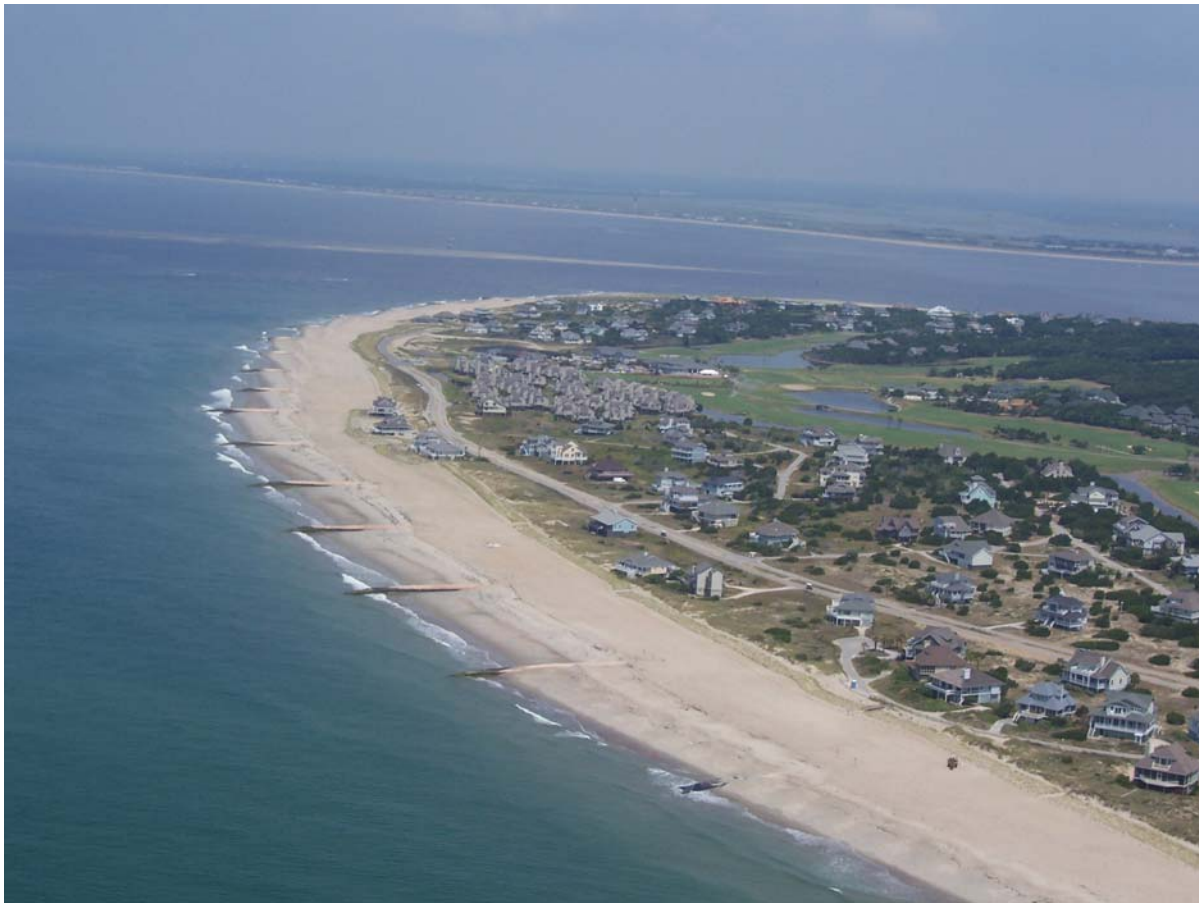
**Figure 2.4 Reconstructed Groinfield along Bald Head Island, July 2006 (Courtesy of Village of Bald Head Island)**

In 1996, the Village constructed sixteen geo-textile groins from station 49+00 to Station 114+00. The groins were 9 feet in diameter and 325 feet long. The spacing between the groins was about 450 feet. The groin field slowed the erosion for several years before they began to fail and ceased to function in 2000. Due to apparent effectiveness of the geo-textile groins, the Village of Bald Head Island decided to rebuild the groin field following the beach fill placement in 2005. As such a sixteen structure sand tube groinfield was reconstructed along South Beach between stations 47+00 and 105+00. The replacement geo-tubes were constructed between January and March 2005. Some modifications were made to the original 1996 plan. These modifications included: (1) the spacing was reduced from 450 feet to 385 feet thereby reducing the overall extent for the groinfield, (2) the tube lengths were 300 feet for 14 of the structures and 250 feet for the remaining two, (3) the individual tubes were tapered with a landward maximum diameter of 10 feet to 6 feet at the seaward end, and (4) the entire groin field was shifted westward to be more aligned with the problem area. Figure 2.4 shows an aerial view of the completed groins taken in July 2006.

about 200 feet with adjacent portions losing 200 feet. The greatest losses are found at Profiles 45 and 47. These lines are located immediately west of the new groin field. Photographic evidence (see Figure 2.4) along with measurements taken by the Village of Bald Head along the groins (Olsen, 2006) confirms that the western sides of the groins are on the downdrift sides of the structures. The remaining area along West Beach (Profiles 0 thru 28) has shown an overall gain, with the shoreline advancing an average of 10 feet since August 2005. This gain reflects the positive impact associated with the Bald Head Creek disposal project in January 2006. However, from Figure 3.1, it is seen that the shoreline in this area has receded between March and October 2006, following this disposal. Overall, the alongshore average shoreline changes measured over the entire monitoring area were losses of 9 feet and 8 feet for the March 2006 and October 2006 surveys, respectively.

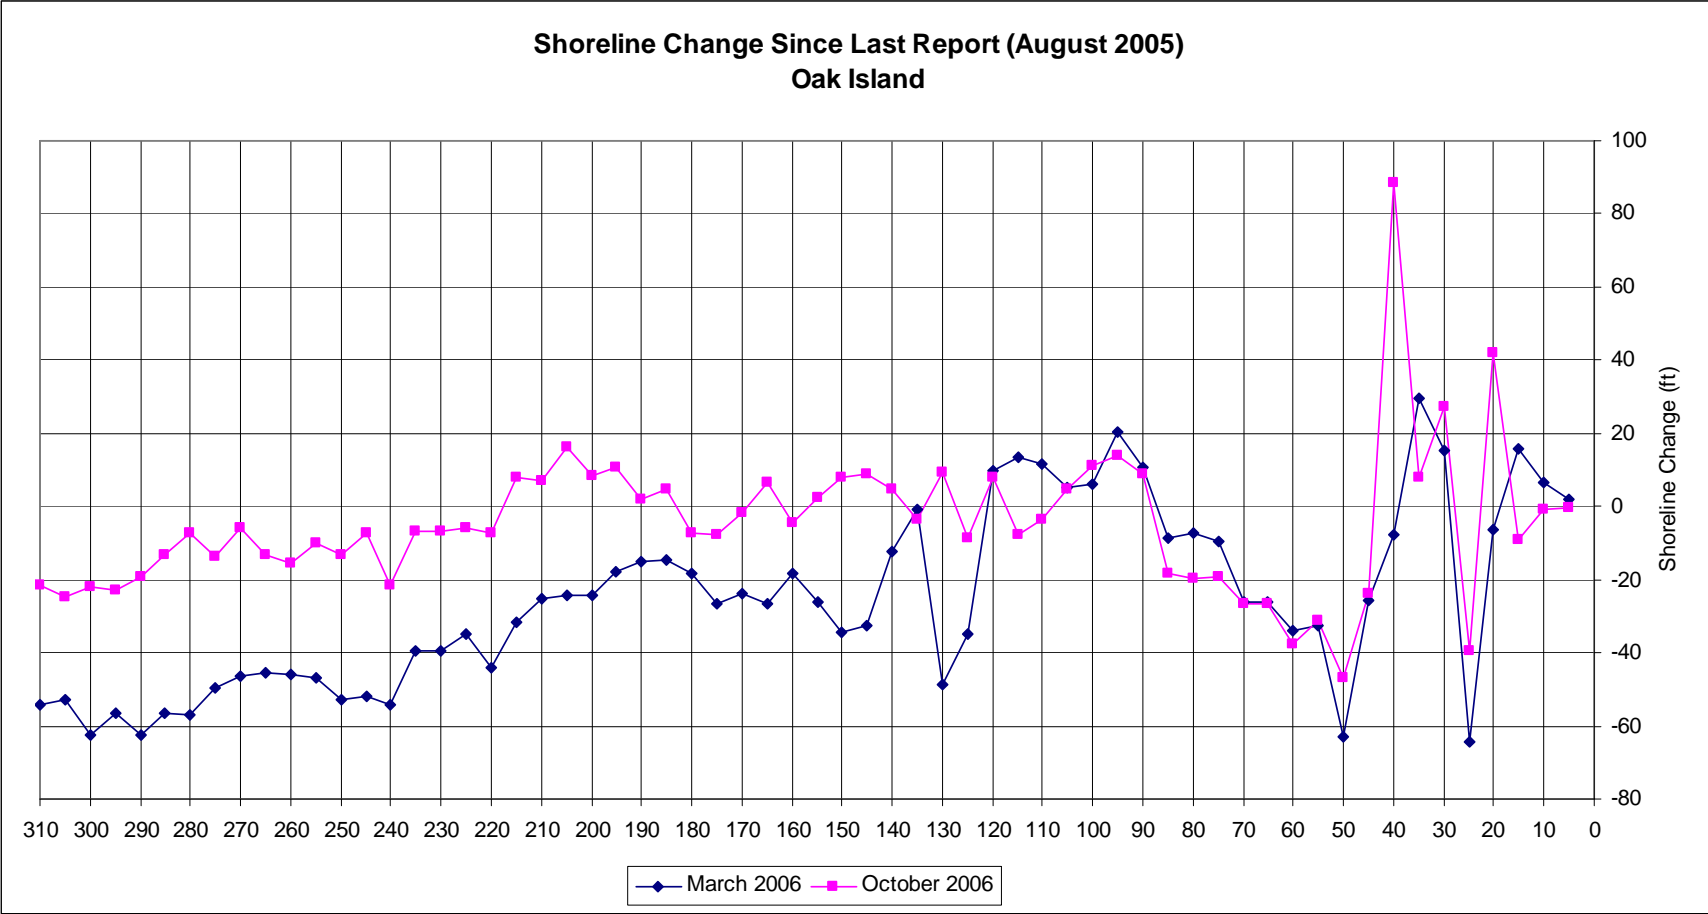
**Figure 3.6 Shoreline Change Since Last Report (August 2005) Oak Island**

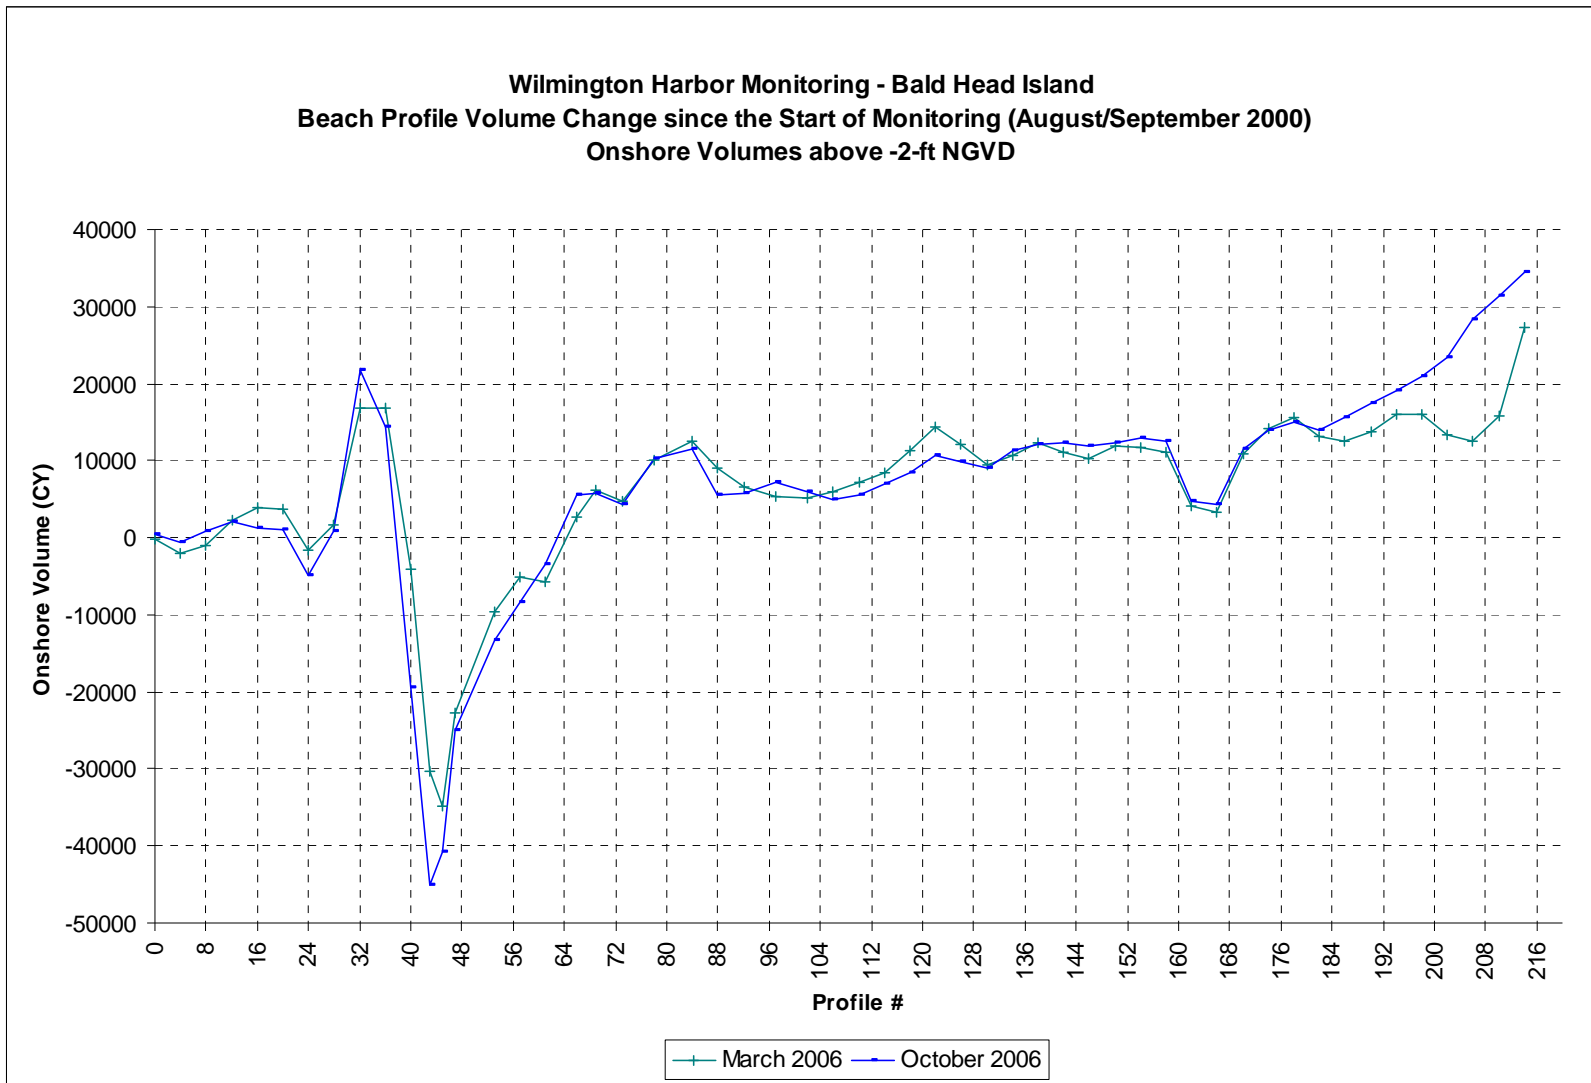
The results of the onshore beach profile analysis surveys since the start of the monitoring in August/September 2000 are given in Figure 3.12. This graph shows that with the exception of one area, all profile locations have experienced net gains in the onshore over the last six years. The area that experienced onshore losses since the beginning of the project are along western end of South Beach and adjoining spit area. The greatest losses are found near Profile 47, which is just downdrift of the reconstructed groins. Within this erosion zone, approximately 130,000 cubic yards have been lost since 2000. This area of South Beach has

**Figure 3.12 Wilmington Harbor Monitoring – Bald Head Island Beach Profile Volume Change since Start of Monitoring (August/September 2000) Onshore Volumes above –2 ft NGVD**

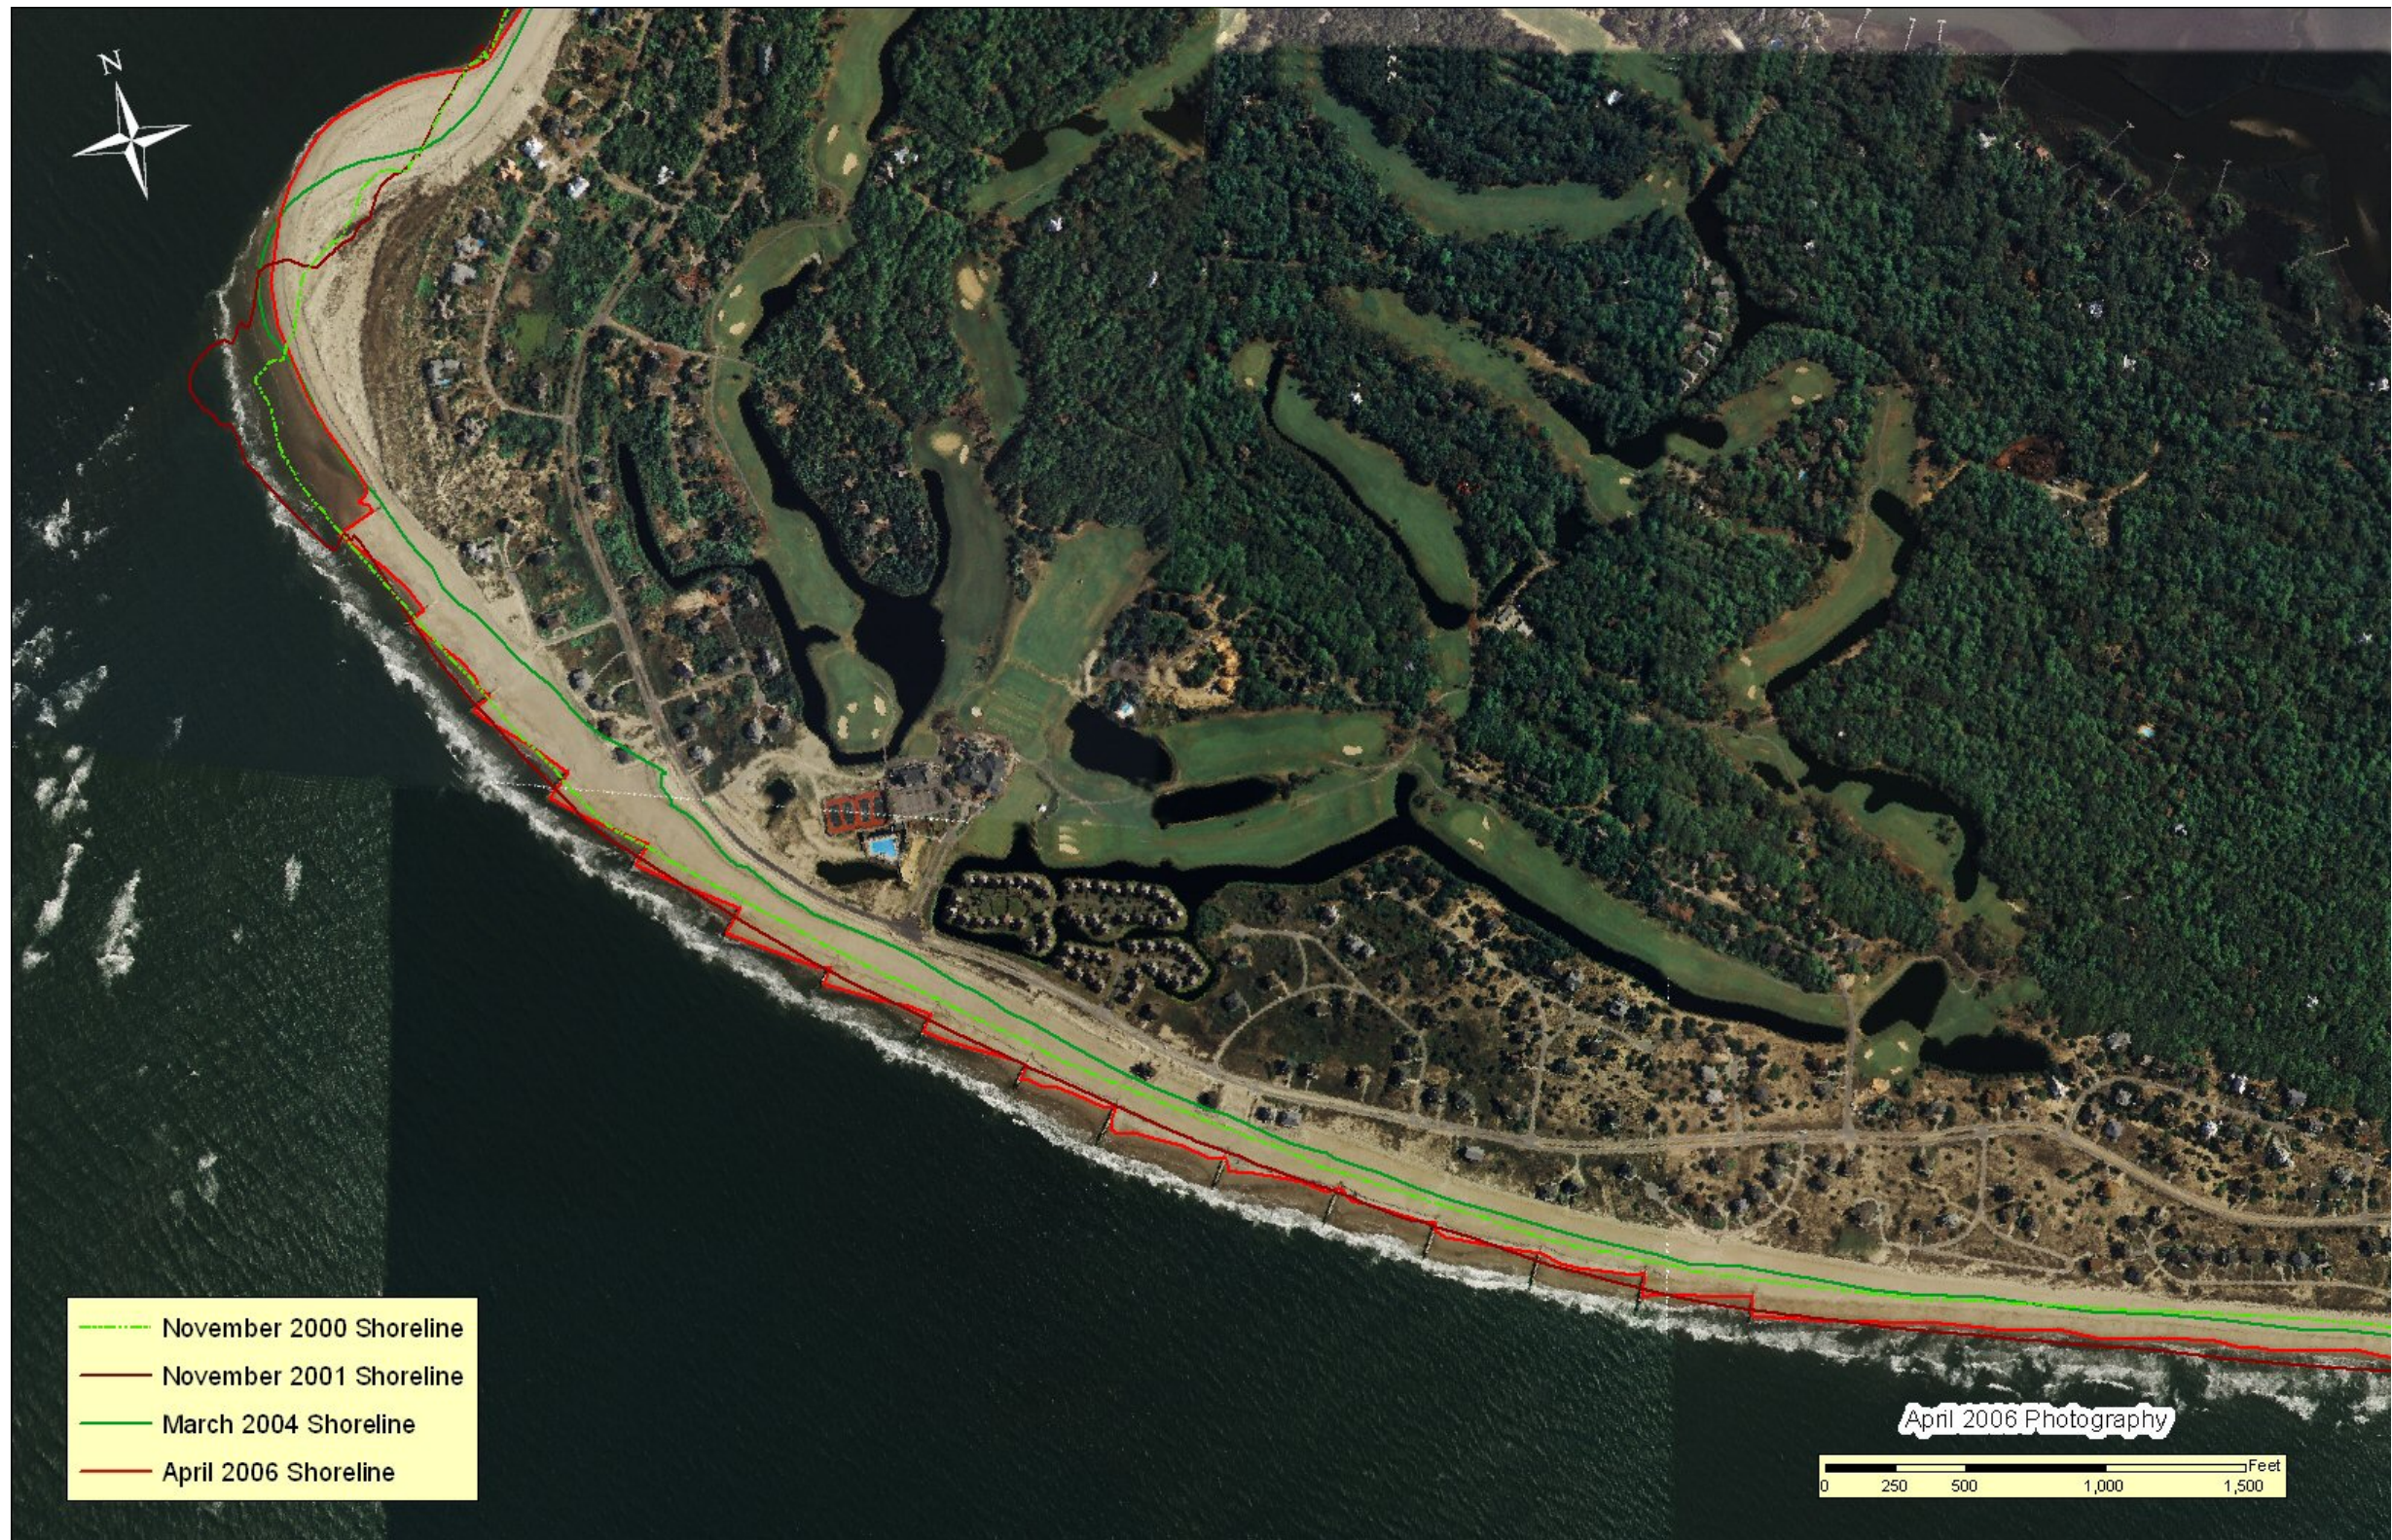
Figure 4.13. Shoreline Comparison: Pre and Post groin field reconstruction and 2005 beach disposal
