**US Army Corps  
of Engineers®**  
Wilmington District

**PHYSICAL MONITORING  
WILMINGTON HARBOR NAVIGATION  
PROJECT  
REPORT 5:  
October 2006 – September 2007**

APRIL 2008

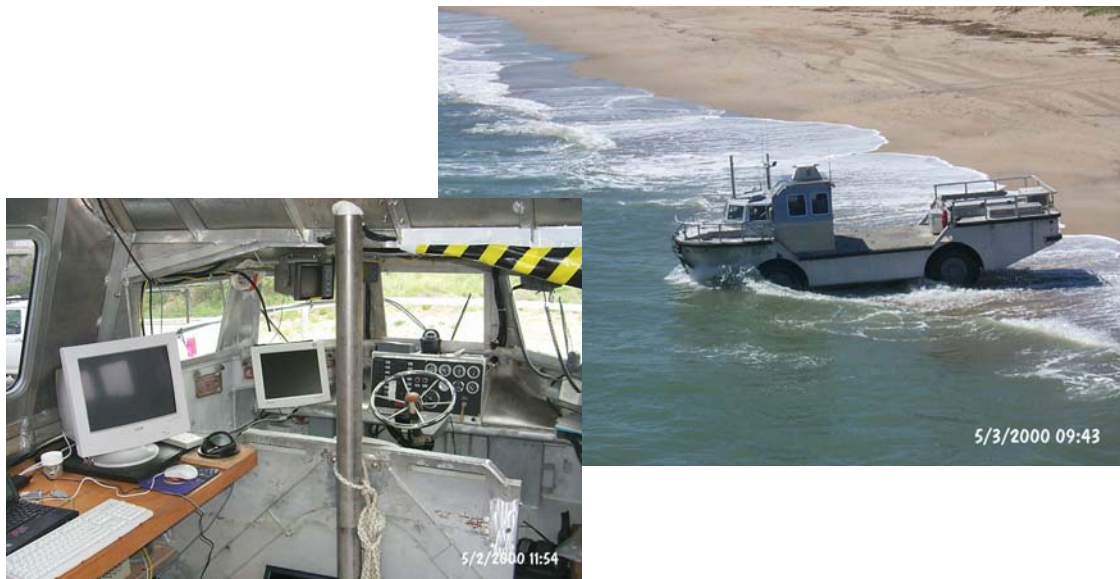
**Figure 1.5 FRF Hydro-LARC Survey System**

The most difficult areas to obtain accurate bathymetric surveys are through the surfzone and over the shoal areas that border each side of the Cape Fear entrance channel, and those near Frying Pan Shoals. Access to these locations is very difficult for conventional watercraft due to breaking waves and shallow depths. Under the present monitoring effort these access problems are largely eliminated through the use of the FRF's Lighter Amphibious Re-supply Cargo (LARC) survey system. The LARC vehicle, shown in Figure 1.5, is uniquely designed to transit through the water, across shoals, and through the surf zone up to the base of the beach dunes. The LARC is equipped with a Trimble Real-Time Kinematic Global Positioning Satellite (RTK-GPS) survey system for accurate horizontal and vertical positioning of the vehicle and a Knudsen Echosounder to measure depth while traversing the profile lines.

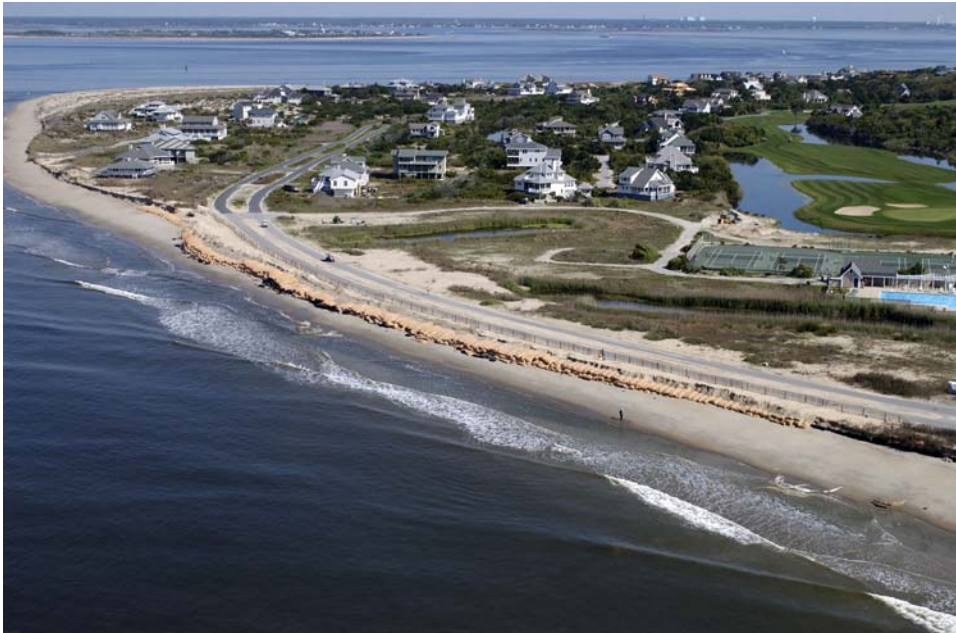
**Figure 2.3 Sand Bag Revetment along South Bald Head Wynd, April 2003.**

In 1994 a 645-foot-long sand bag revetment was placed along the badly eroding portion of western South Beach. In 2003-2004 the sand bag revetment was expanded by increasing the overall length by 200 feet, increasing the base width from 20 to 40 feet and increasing the crest elevation by 6 feet to +12 feet NGVD. A view of the expanded sand bags are shown in Figure 2.3, as it appeared in April 2003. This structure is now, for the most part, covered by the new sediment with the subsequent beach disposal operations.

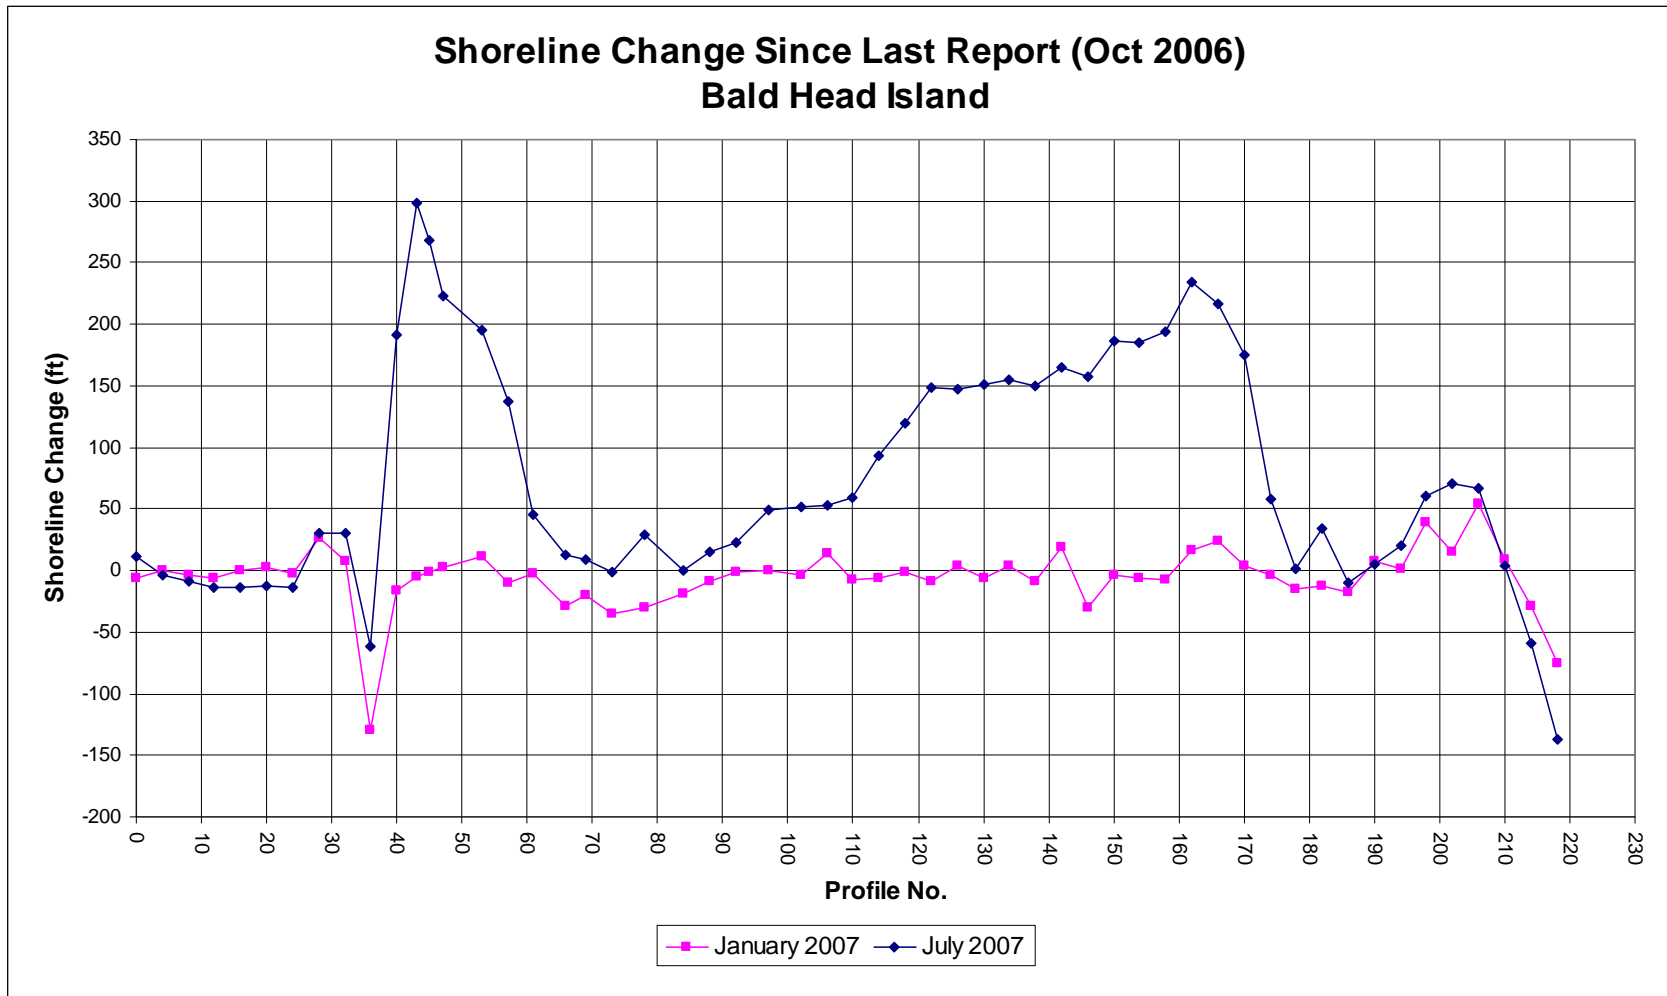
**Figure 3.1 Shoreline Change Since Last Report (October 2006) Bald Head Island**

As indicated in prior reports, the area in the vicinity of the spit (Profiles 32 to 47) is found to be highly variable. Over the last year, a portion of this area has shown gains of about 300 feet with adjacent portions losing 60 feet. The greatest gains are found at Profiles 40 thru 47 under the direct influence of the recent beach fill. In contrast the greatest loss is found at Profile 36 just inside the advancing spit. The remaining area along West Beach (Profiles 0 thru 28) has shown a general loss over the period, with the shoreline retreating about 5 to 10 feet over much of this area. Overall, the alongshore average shoreline changes measured over the entire monitoring area were losses of 7 feet with the January 2007 survey and a gain of 70 feet as of July 2007, since the last reporting.

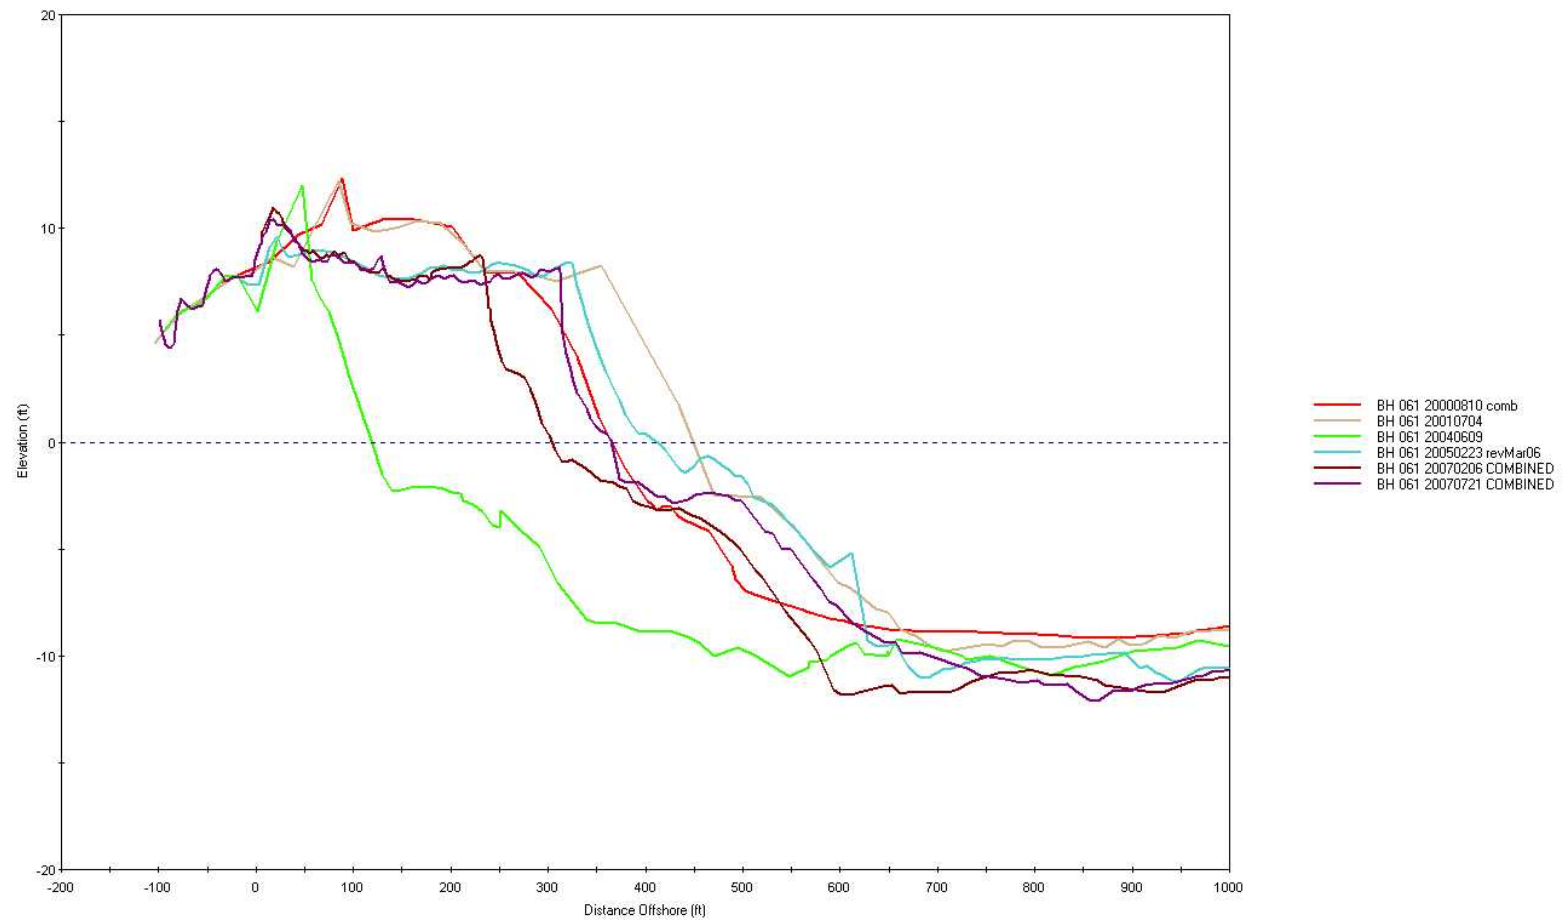
Figure 3.3 Bald Head Island Profile 061

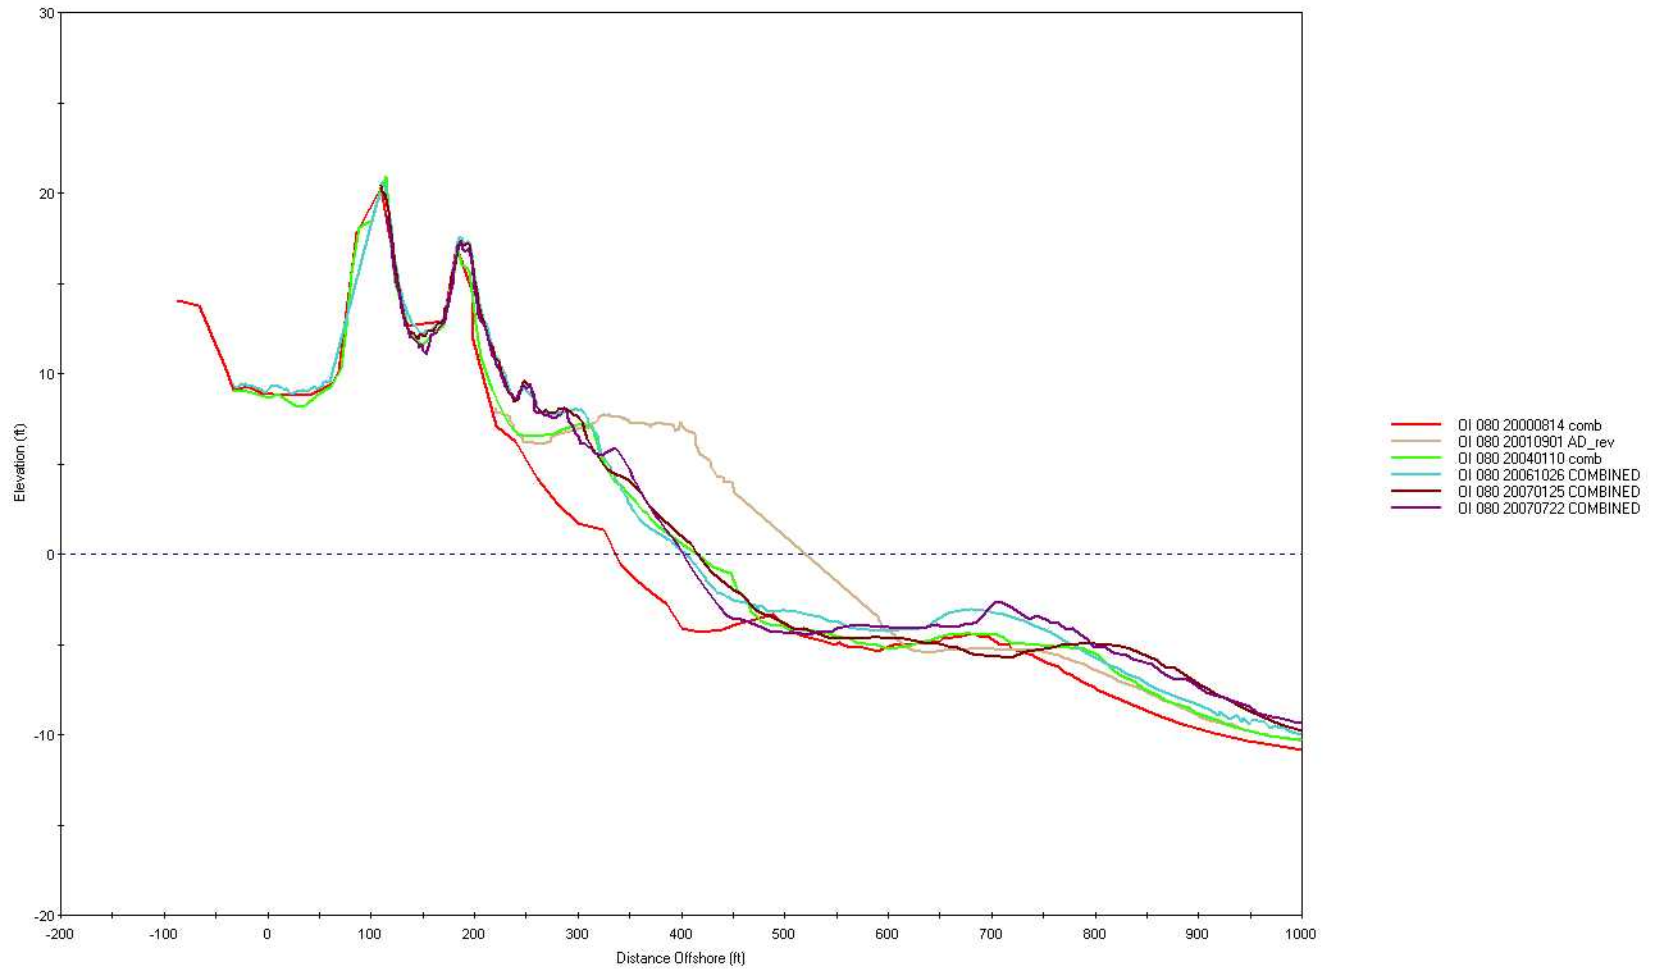
Figure 3.8 Oak Island Profile 80

shoreline at Profile 80 has varied between about 70 and 95 seaward of its August 2000 position. For Profile 220, the shoreline has also remained relatively stable following the initial fill adjustment; however a slight erosional trend is noticeable over the last five years.

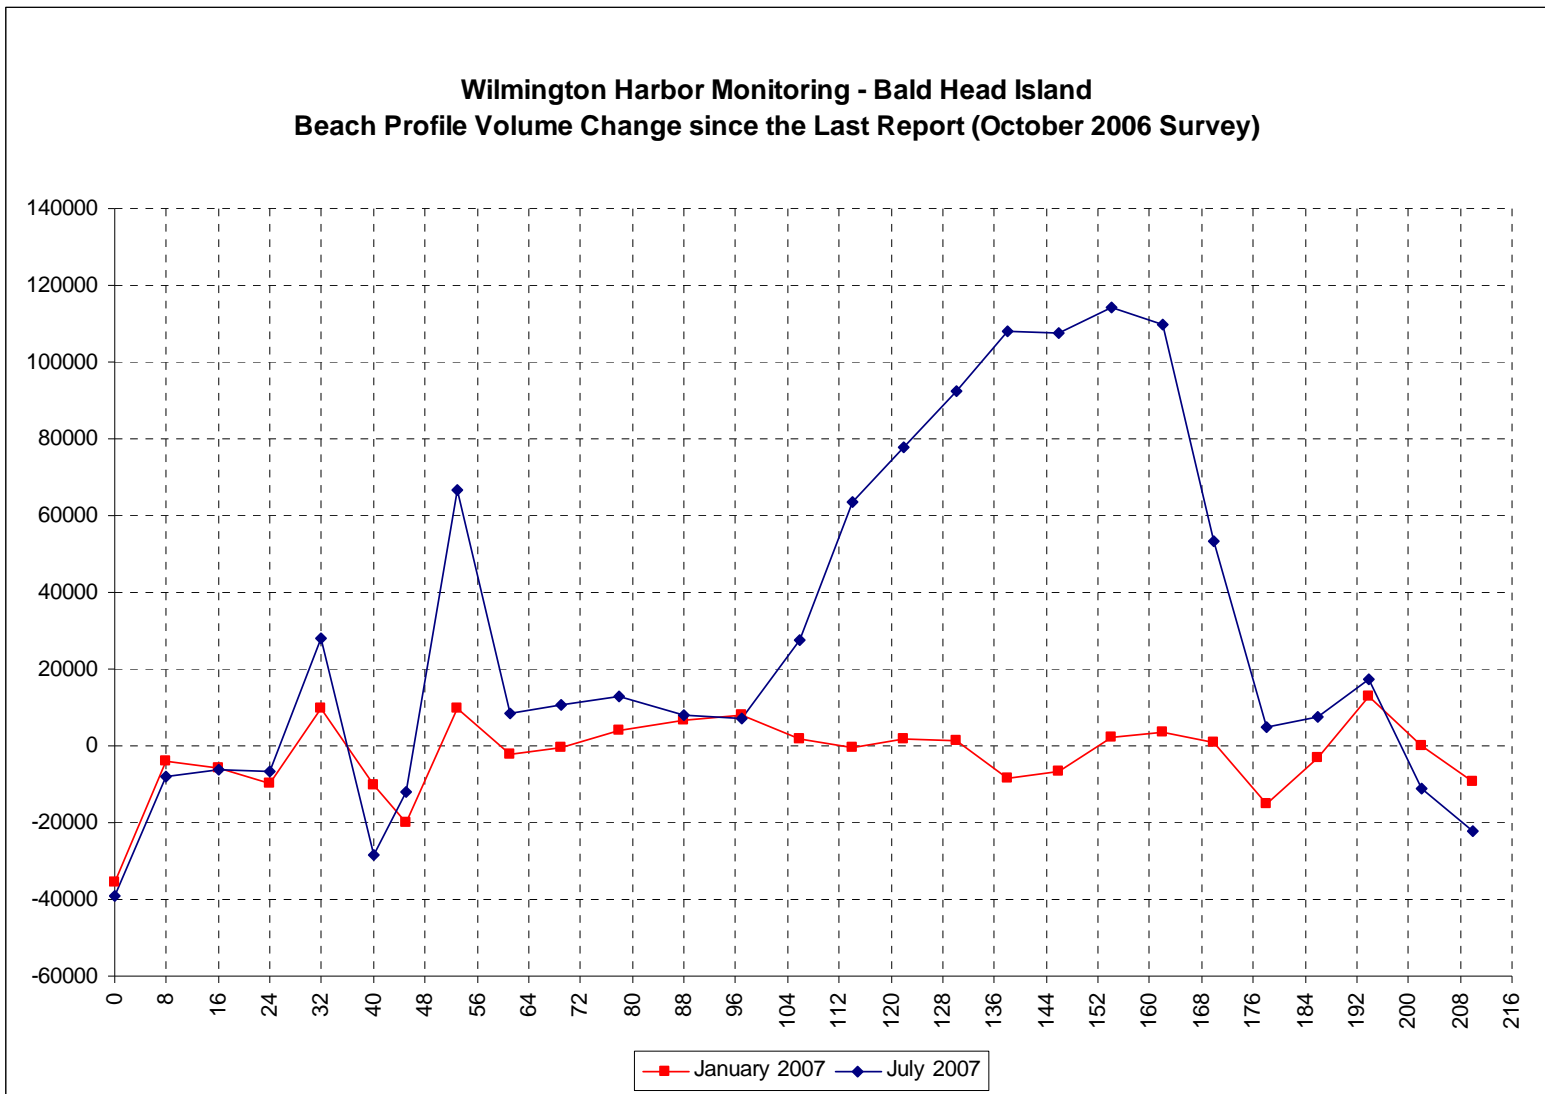
**Figure 3.14 Wilmington Harbor Monitoring – Bald Head Island Beach Profile Volume Changes Since Last Report (October 2006 Survey)**

Total volumetric changes computed over the entire active profile are given in Figures 3.14 and 3.15 for Bald Head Island. Figure 3.14 shows volume changes relative to the latest survey contained in Report 4 (October 2006); whereas, Figure 3.15 gives changes relative to the August 2000 survey at the beginning of the monitoring. For each profile comparison, volumes were computed from a common stable landward point to an observed closure depth offshore.

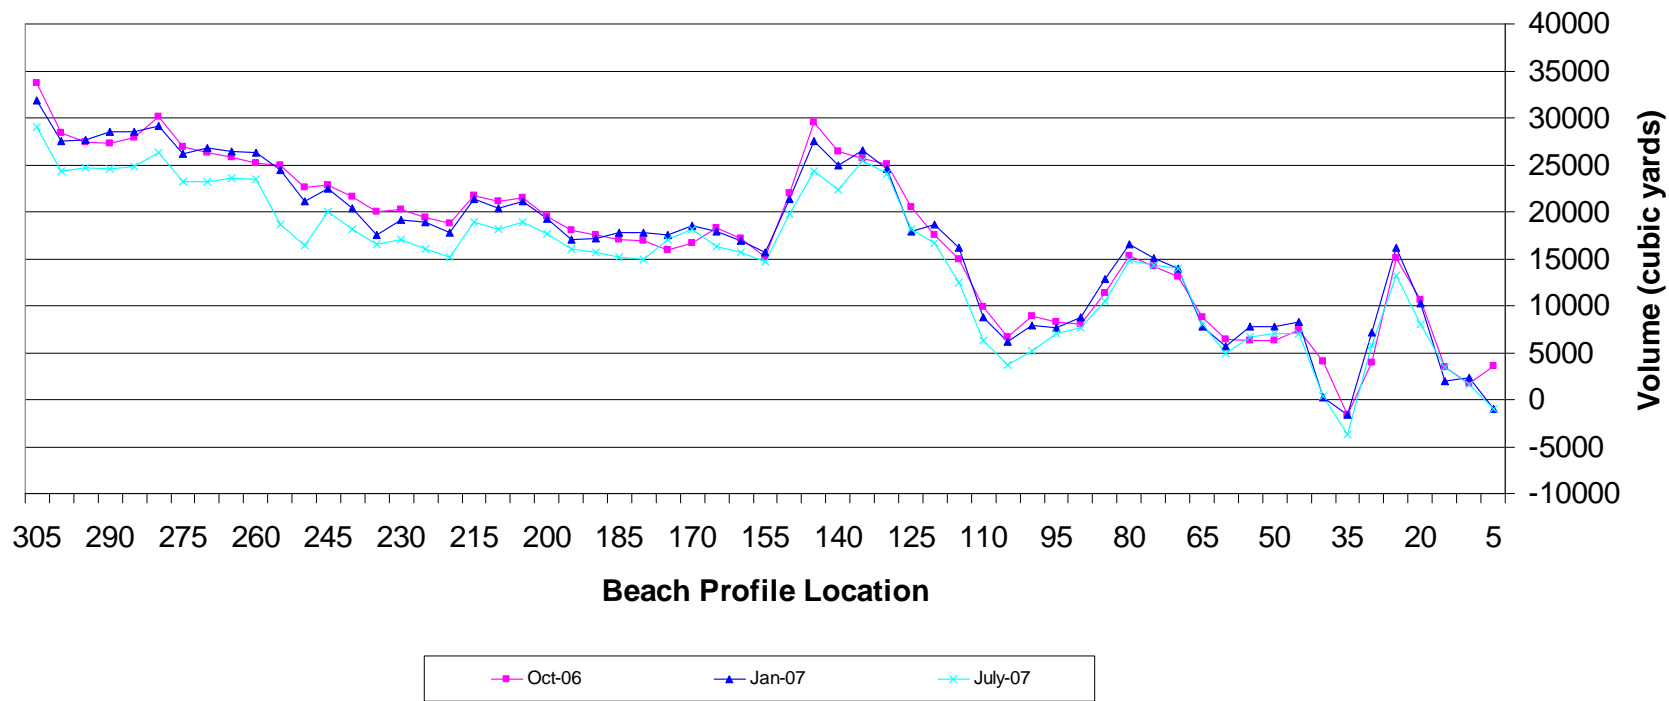
**Figure 3.17 Wilmington Harbor Monitoring – Oak Island Beach Profile Volume Change since Start of Monitoring (August 2000) Onshore Volumes above –2 ft NGVD**

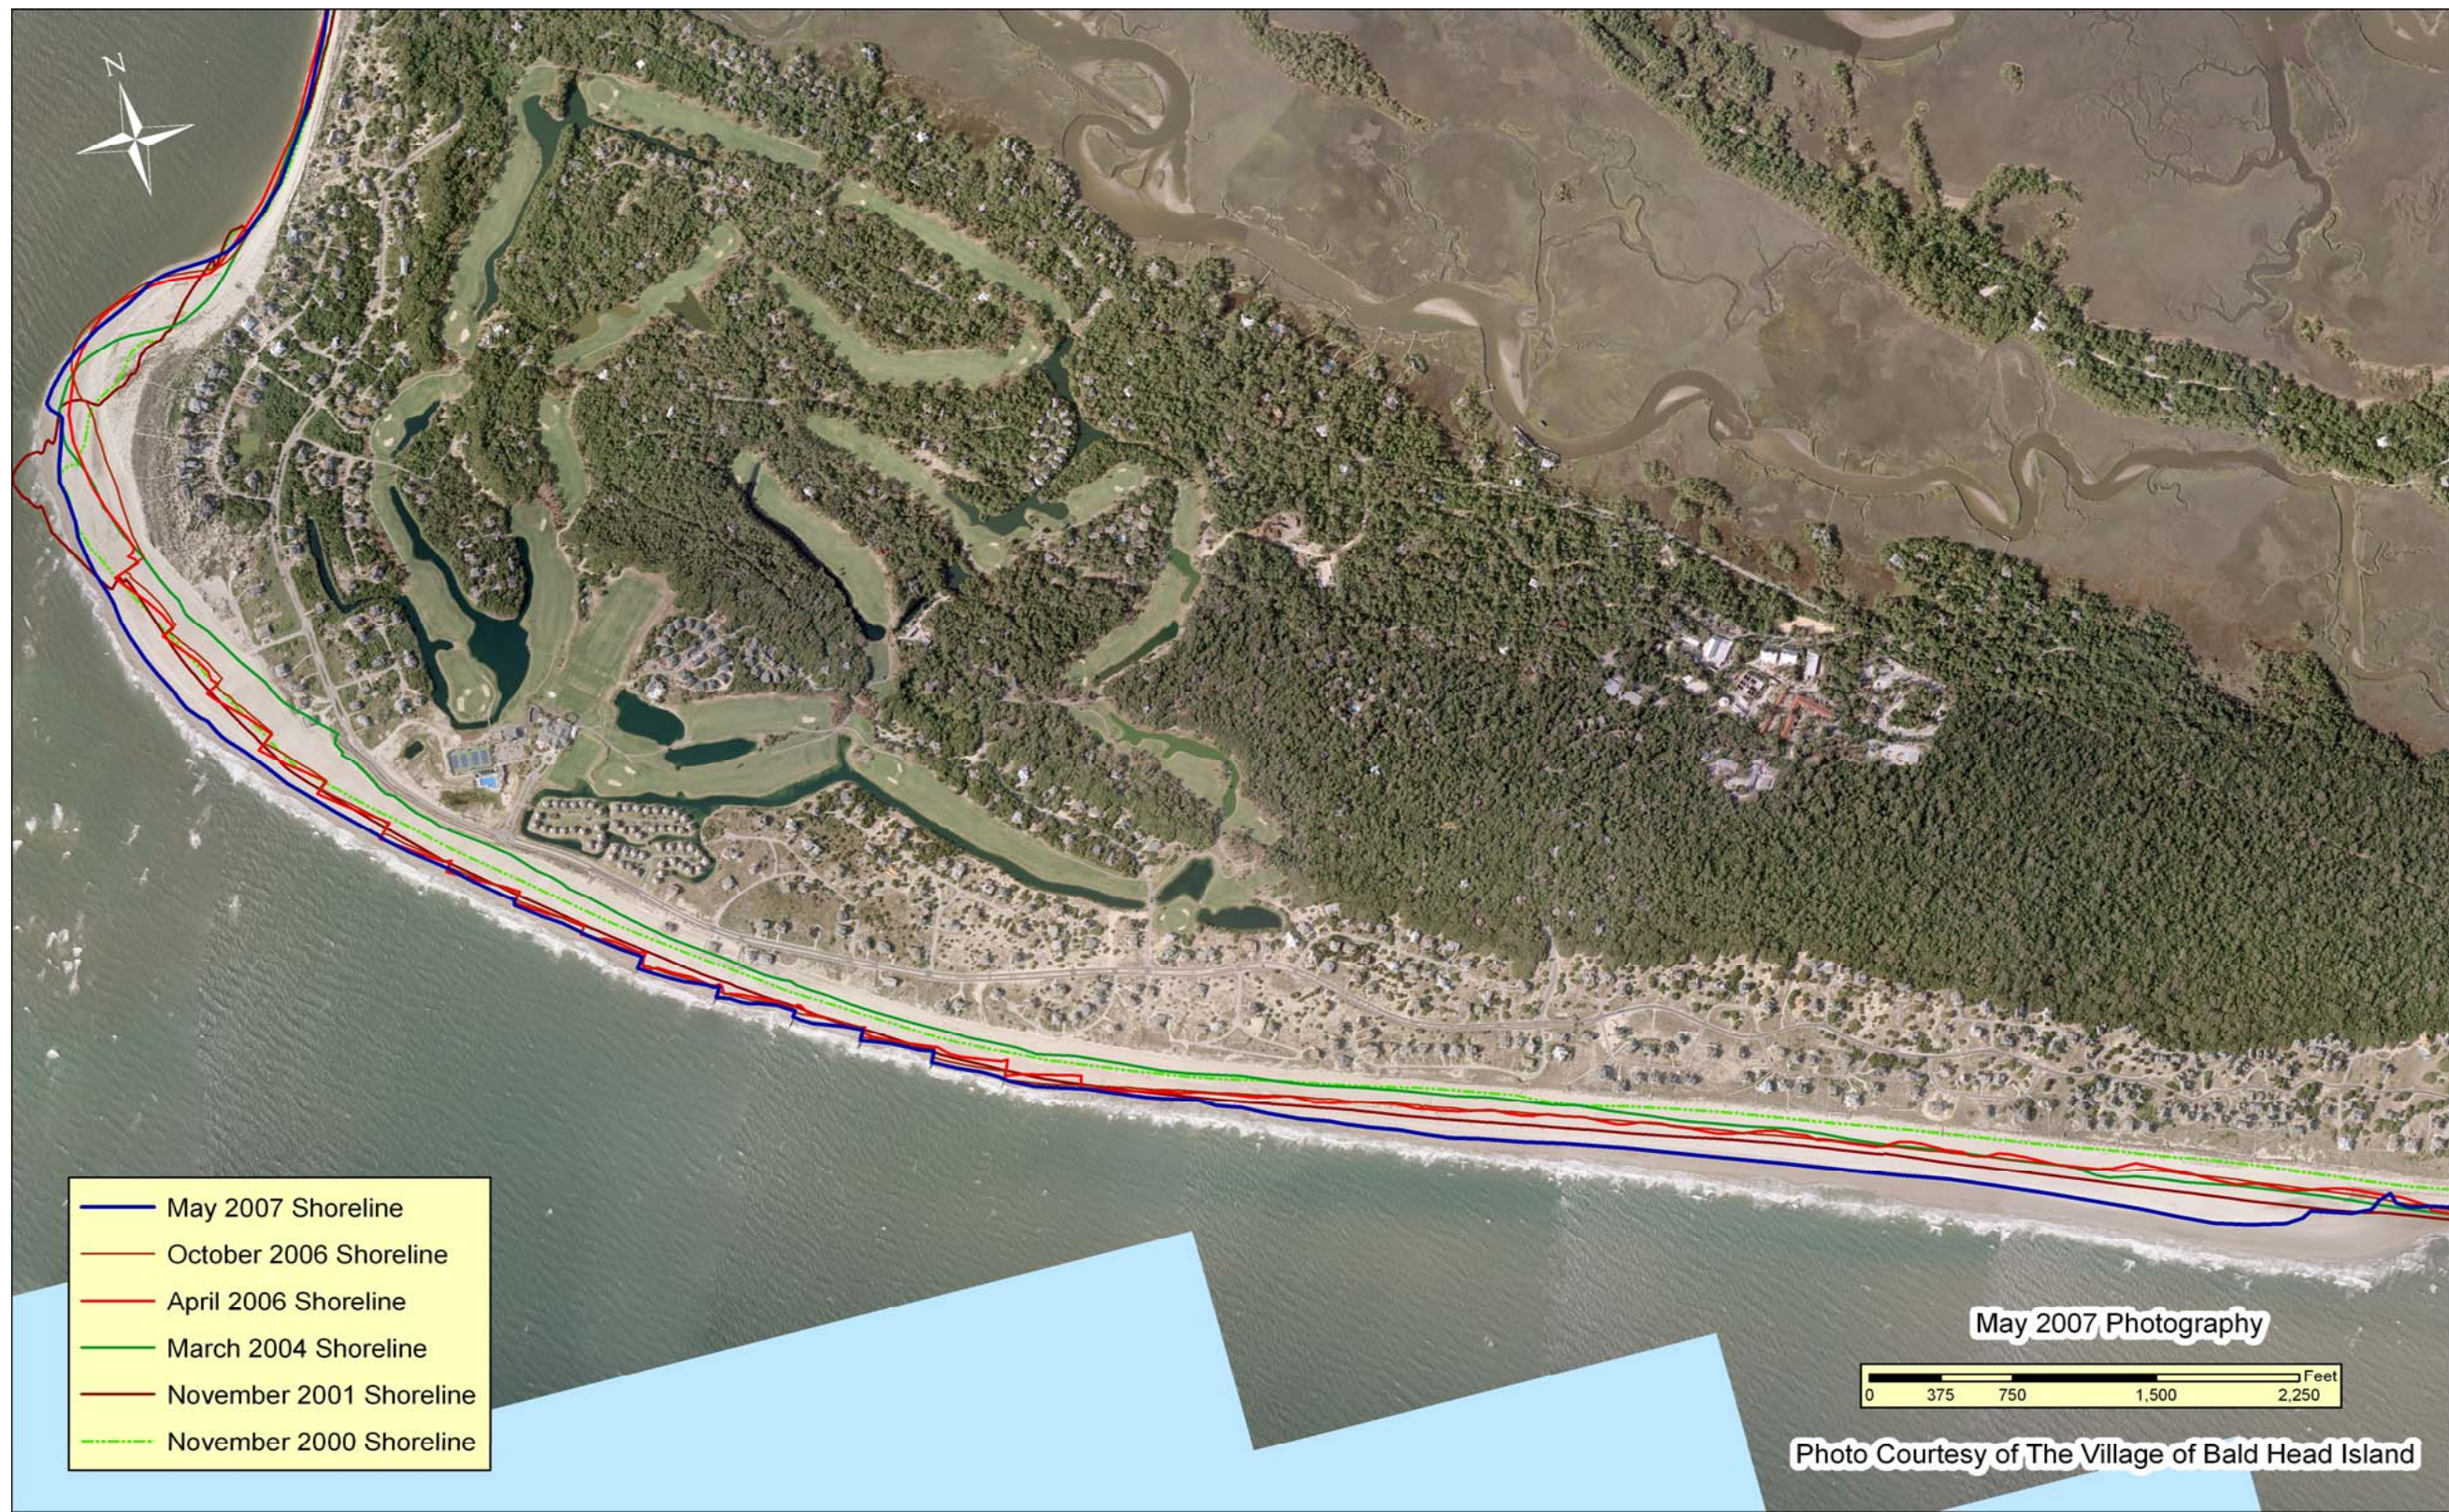
Figure 4.13. Shoreline Comparison: Pre and Post groin field reconstruction and beach disposal
